Development Application for _____	Name of Applicant
Address of site <u>8 Cabarita Road, Avalon Beach</u>

**REPORT TO
MR AND MRS RICHARDS**

**ON
GEOTECHNICAL ASSESSMENT
(In Accordance with Pittwater Council Risk
Management Policy)**

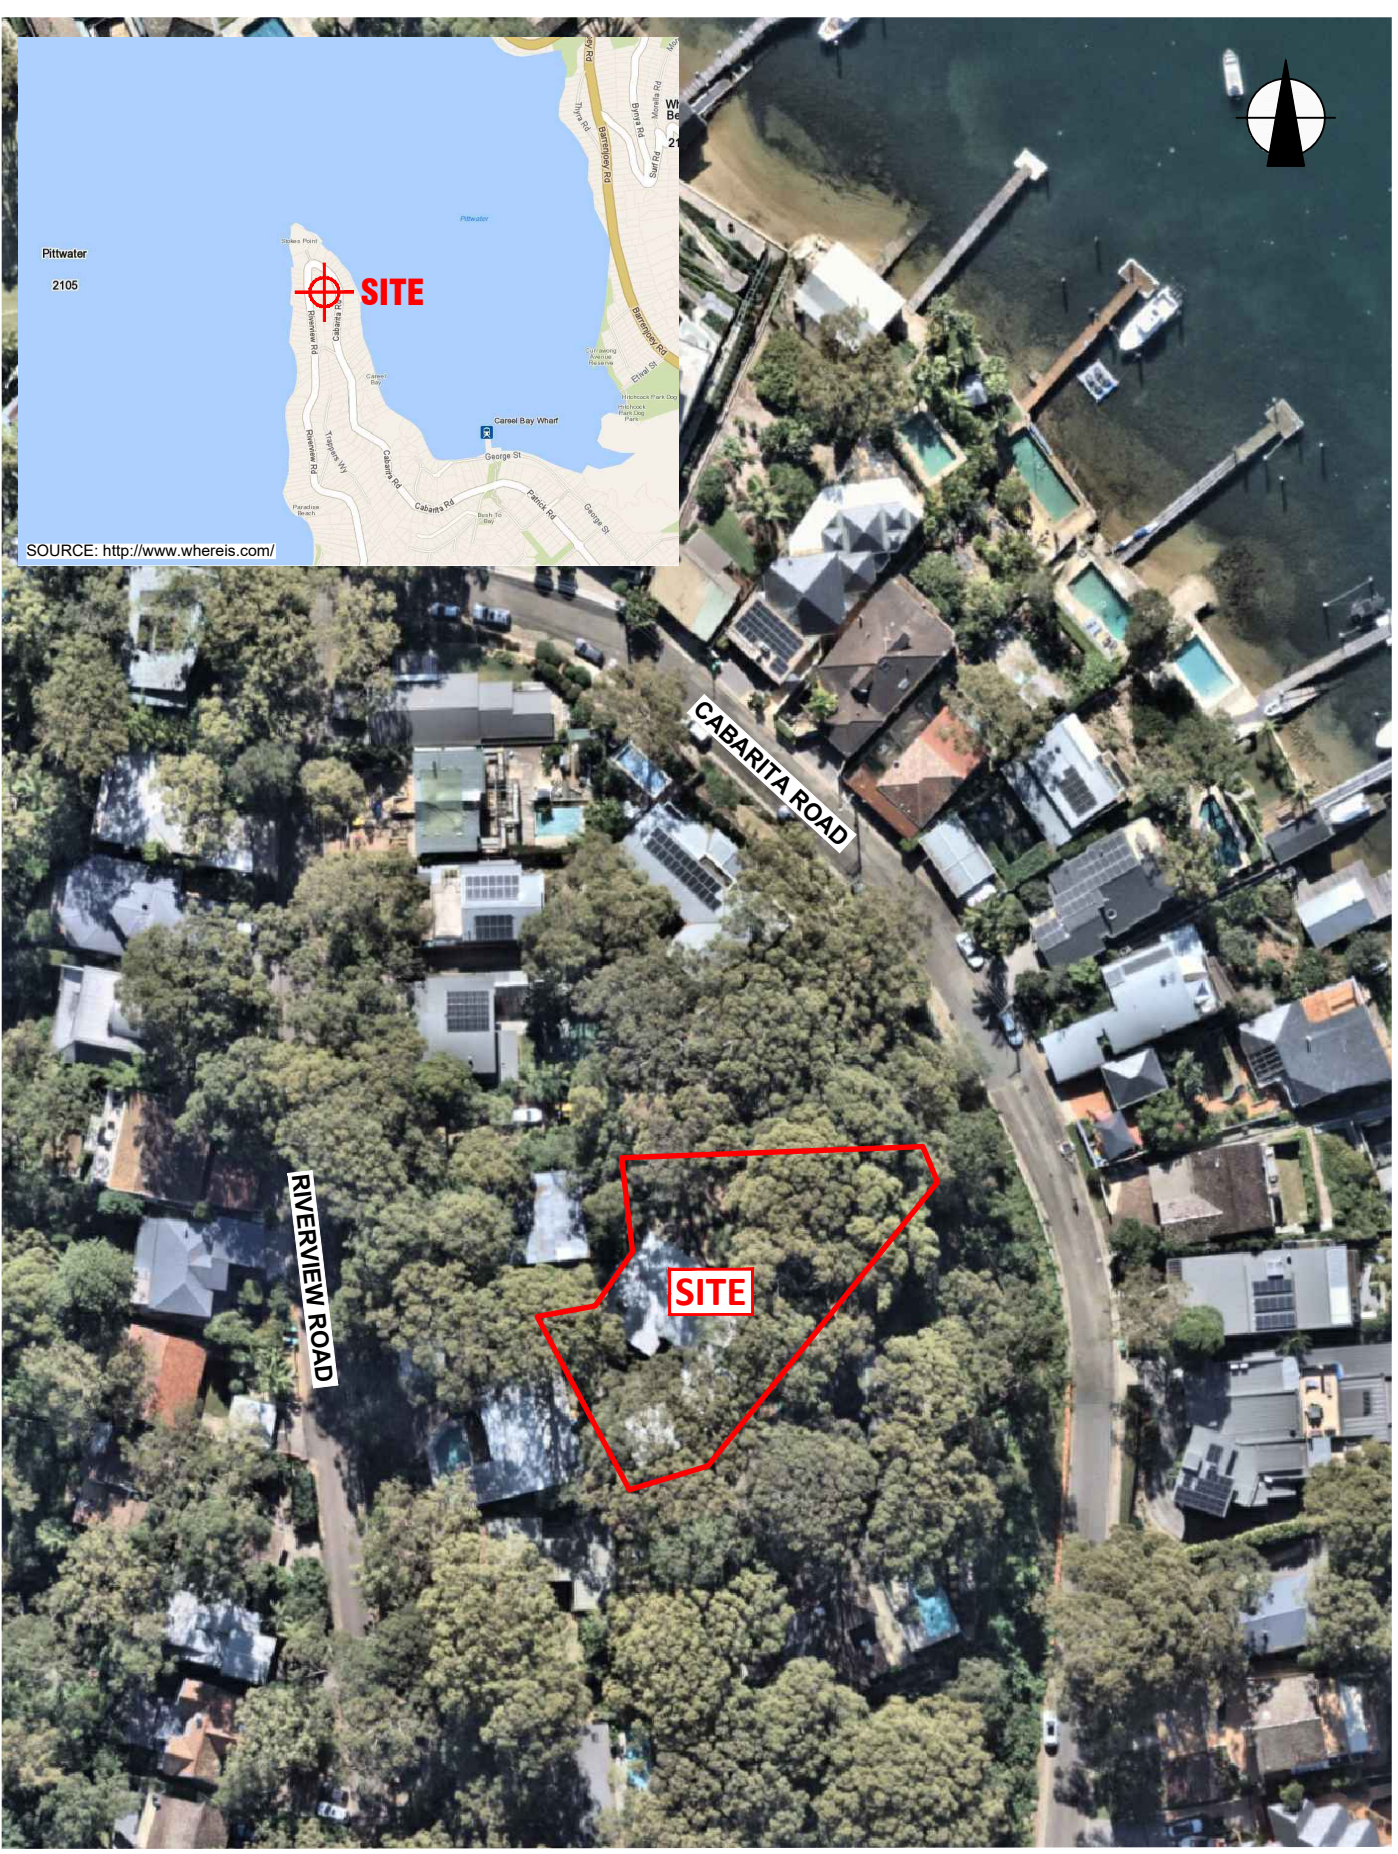
The attached Figure 2 presents a geotechnical sketch plan showing the principal features present at the site. Figure 2 is based on the survey plan carried out by Daniel Golenia (Ref No 230028.1, dated 27 February 2023), which has been incorporated onto Woodman Architects Drawing No DA-03^A. Additional features on Figure 2 have been measured by handheld clinometer and tape measure techniques and hence are only approximate. Should any of the features be critical to the proposed development, we recommend they be located more accurately using instrument survey techniques.

We recommend that the summary of observations which follows be read in conjunction with the attached Figure 2.

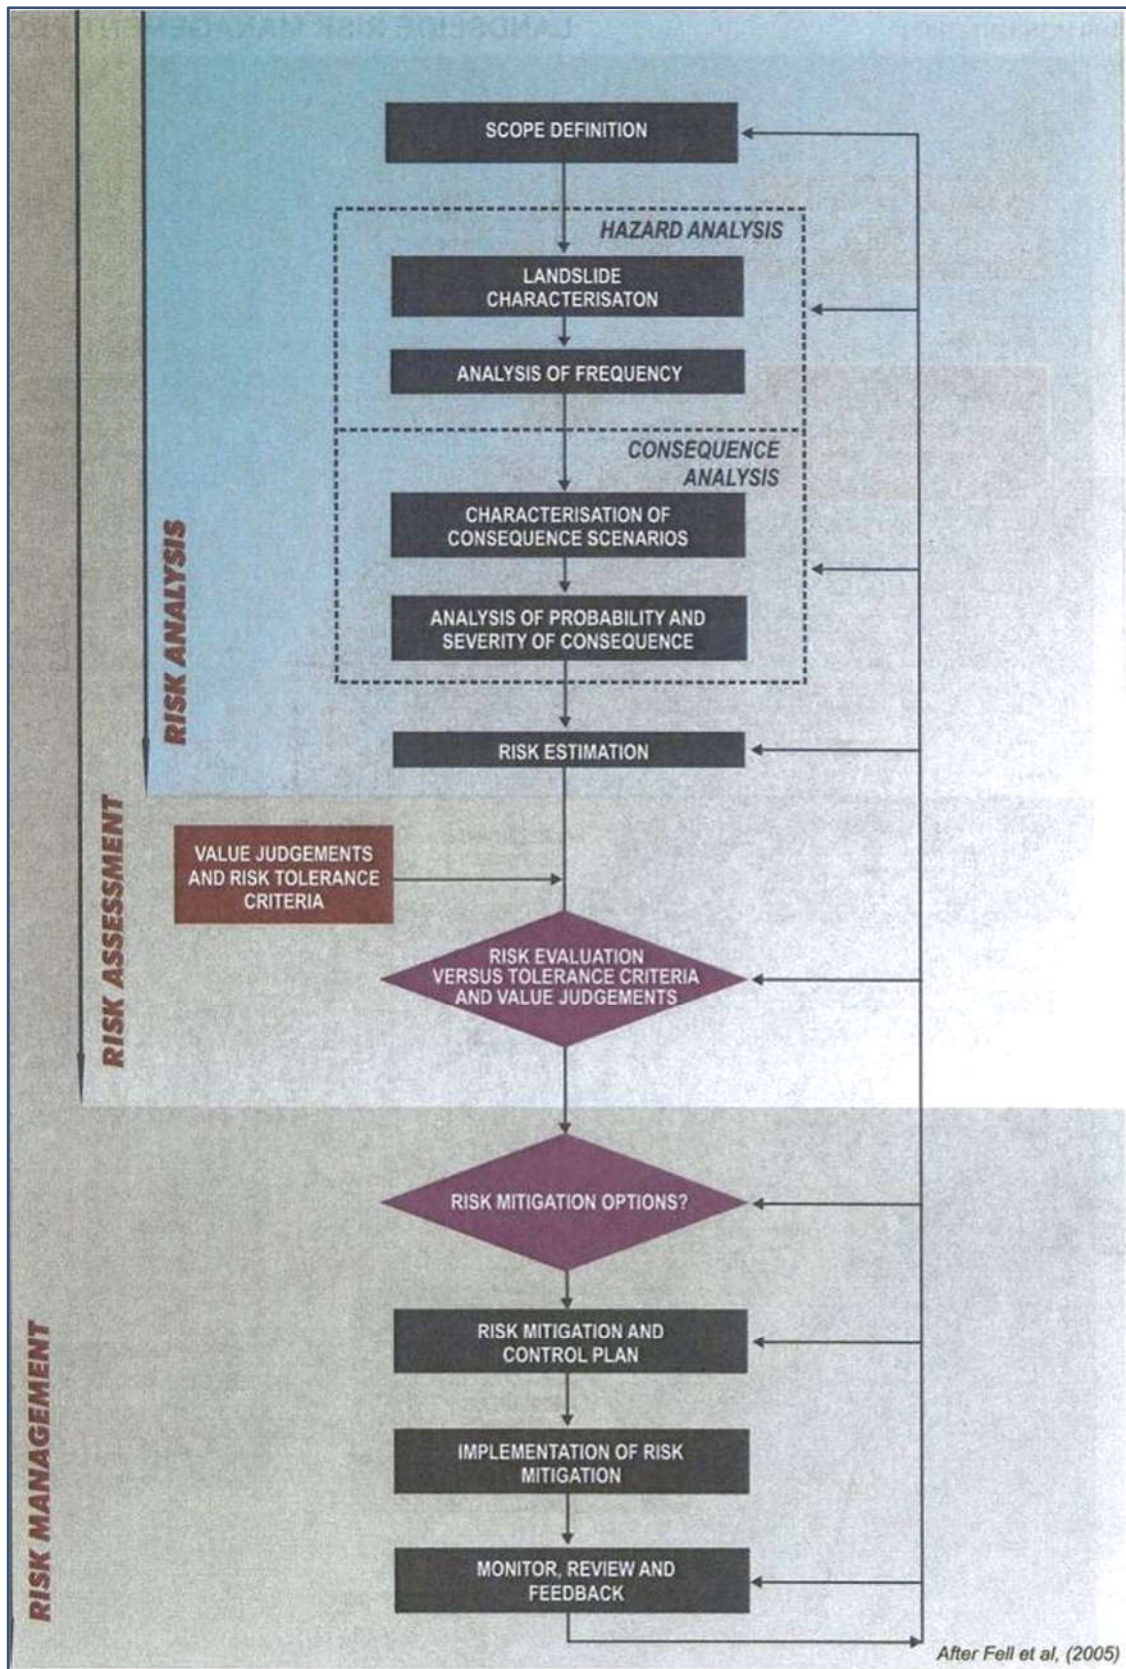
FIGURE A1: Flowchart for Landslide Risk Management.

This figure is an extract from GUIDELINE FOR LANDSLIDE SUSCEPTIBILITY, HAZARD AND RISK ZONING FOR LAND USE PLANNING, as presented in Australian Geomechanics Vol 42, No 1, March 2007, which discusses the matter more fully.

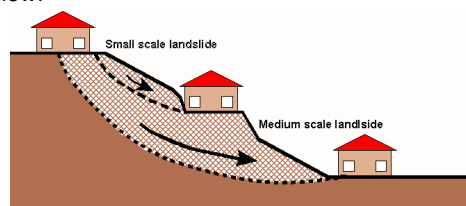
Figure 1

Rotational or circular slip failures (Figure 1) - can occur on moderate to very steep soil and weathered rock slopes (Table 1). The sliding surface of the moving mass tends to be deep seated. Tension cracks may open at the top of the slope and bulging may occur at the toe. The ground may move in discrete "steps" separated by long periods without movement. More rapid movement may occur after heavy rain.

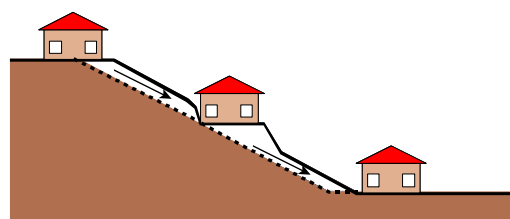
Figure 2

Translational slip failures (Figure 2) - tend to occur on moderate to very steep slopes (Table 1) where soil, or weak rock, overlies stronger strata. The sliding mass is often relatively shallow. It can move, or deform slowly (creep) over long periods of time. Extensive linear cracks and hummocks sometimes form along the contours. The sliding mass may accelerate after heavy rain.

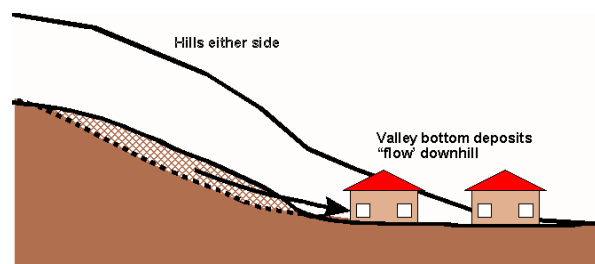
Figure 4

Debris flows and mud slides (Figure 4) - may occur in the foothills of ranges, where erosion has formed valleys which slope down to the plains below. The valley bottoms are often lined with loose eroded material (debris) which can "flow" if it becomes saturated during and after heavy rain. Debris flows are likely to occur with little warning; they travel a long way and often involve large volumes of soil. The consequences can be devastating.
