**REPORT TO
ELIZABETH McCARTNEY**

**ON
GEOTECHNICAL ASSESSMENT
(In Accordance with Pittwater Council Risk
Management Policy)**

**FOR
PROPOSED ALTERATIONS AND ADDITIONS**

**AT
51 GRANDVIEW DRIVE, NEWPORT, NSW**

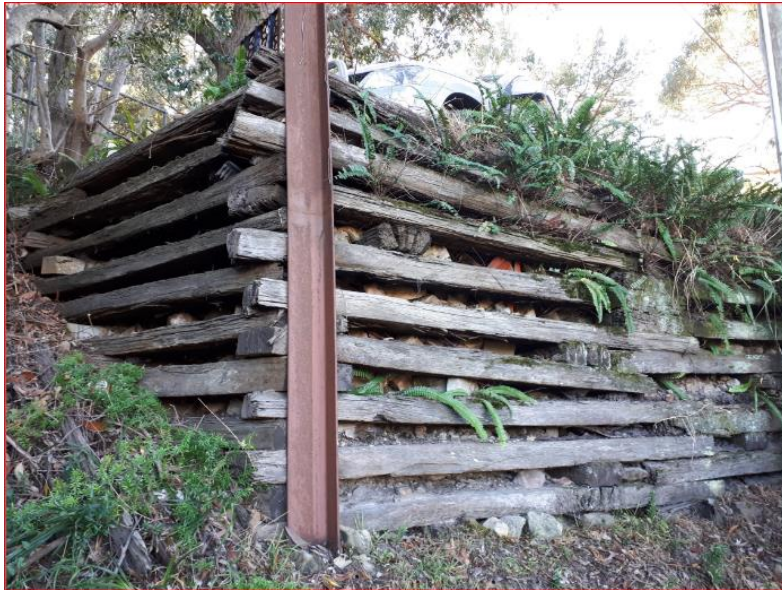
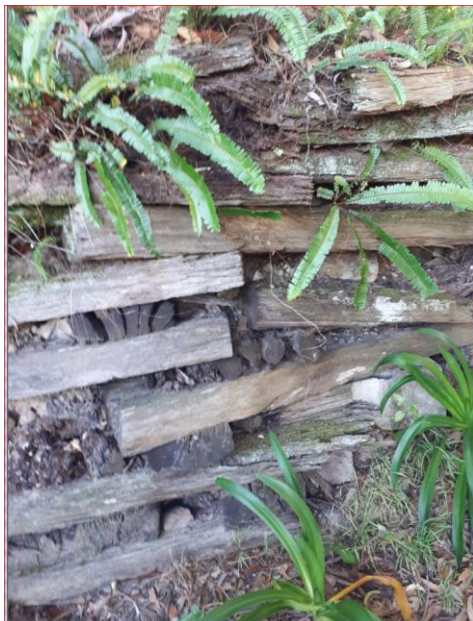
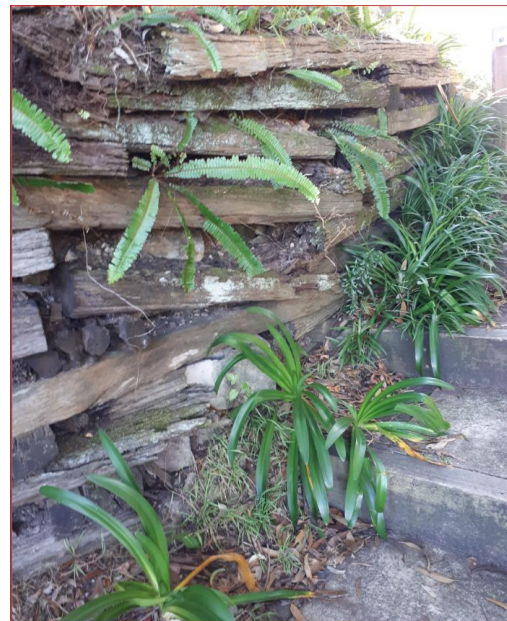
The site has a northern frontage with Grandview Drive, but no driveway into the site. The road reserve is at a bend on the road and there is an unsurfaced (informal) parking bay at street level which is supported by a timber crib retaining wall, also within the council road reserve. The crib-block style timber wall is up to 1.9m in height, but the timber is severely rotten in places and appears to have limited structural integrity. Refer to photos below:

- 7.1.1 The existing timber crib retaining wall within the road reserve to the north-west of the site (Hazard C) is rotten and has lost integrity and in its current state represent an 'unacceptable' risk. Therefore, measures should be undertaken to reduce this risk. The proposed construction of the car stand will reduce the need for the parking area at the top of the existing wall, but it will not completely remove access so others would be able to park there in the future. We recommend that measures be undertaken to restrict access or remove or replace the wall. These works may be somewhat complicated as the hazard is located within the council road reserve and not within the subject site. Initially, we recommend that an exclusion zone be enforced so that cars no longer park within the area at the top of the wall. In the long term, the wall could be removed and the area landscaped or the wall replaced by an engineer designed retaining wall. Retaining wall design parameters, if required, are provided below in 7.1.5. Alternatively, a permanent exclusion zone could be enforced, but that would require physical barriers to restrict access. The exclusion zone would be to persons and vehicles (or other surcharges) within a distance equal to the height of the wall, above and below the wall.

- 7.1.4 The surface water discharging from the new roof and paved areas must be diverted to outlets for controlled discharge to a stormwater system.
- 7.1.5 The only new retaining wall possibly required would be to replace or retain the existing rotten timber wall, currently supporting a road side parking bay, if the use of this bay is to remain in addition to the proposed suspended car stand. There are several appropriate retaining wall options. We expect the preference would be to build a new wall in front of the existing wall, rather than replace the existing wall, to prevent excavation and disposal costs associated with replacement. The existing path/steps provides some space to construct a gravity wall or a masonry wall. However, such a wall must be founded on rock. The depth to rock is unknown at this location and a pier and (stepped) beam footing system may be required. The void between the new wall and the existing timber wall would then be backfilled with free draining gravel or no fines concrete.
