REPORT

GEOTECHNICAL INVESTIGATION

PROPOSED LIGHT POLES

**NOLAN RESERVE, PITTWATER ROAD,
NORTH MANLY, NSW**

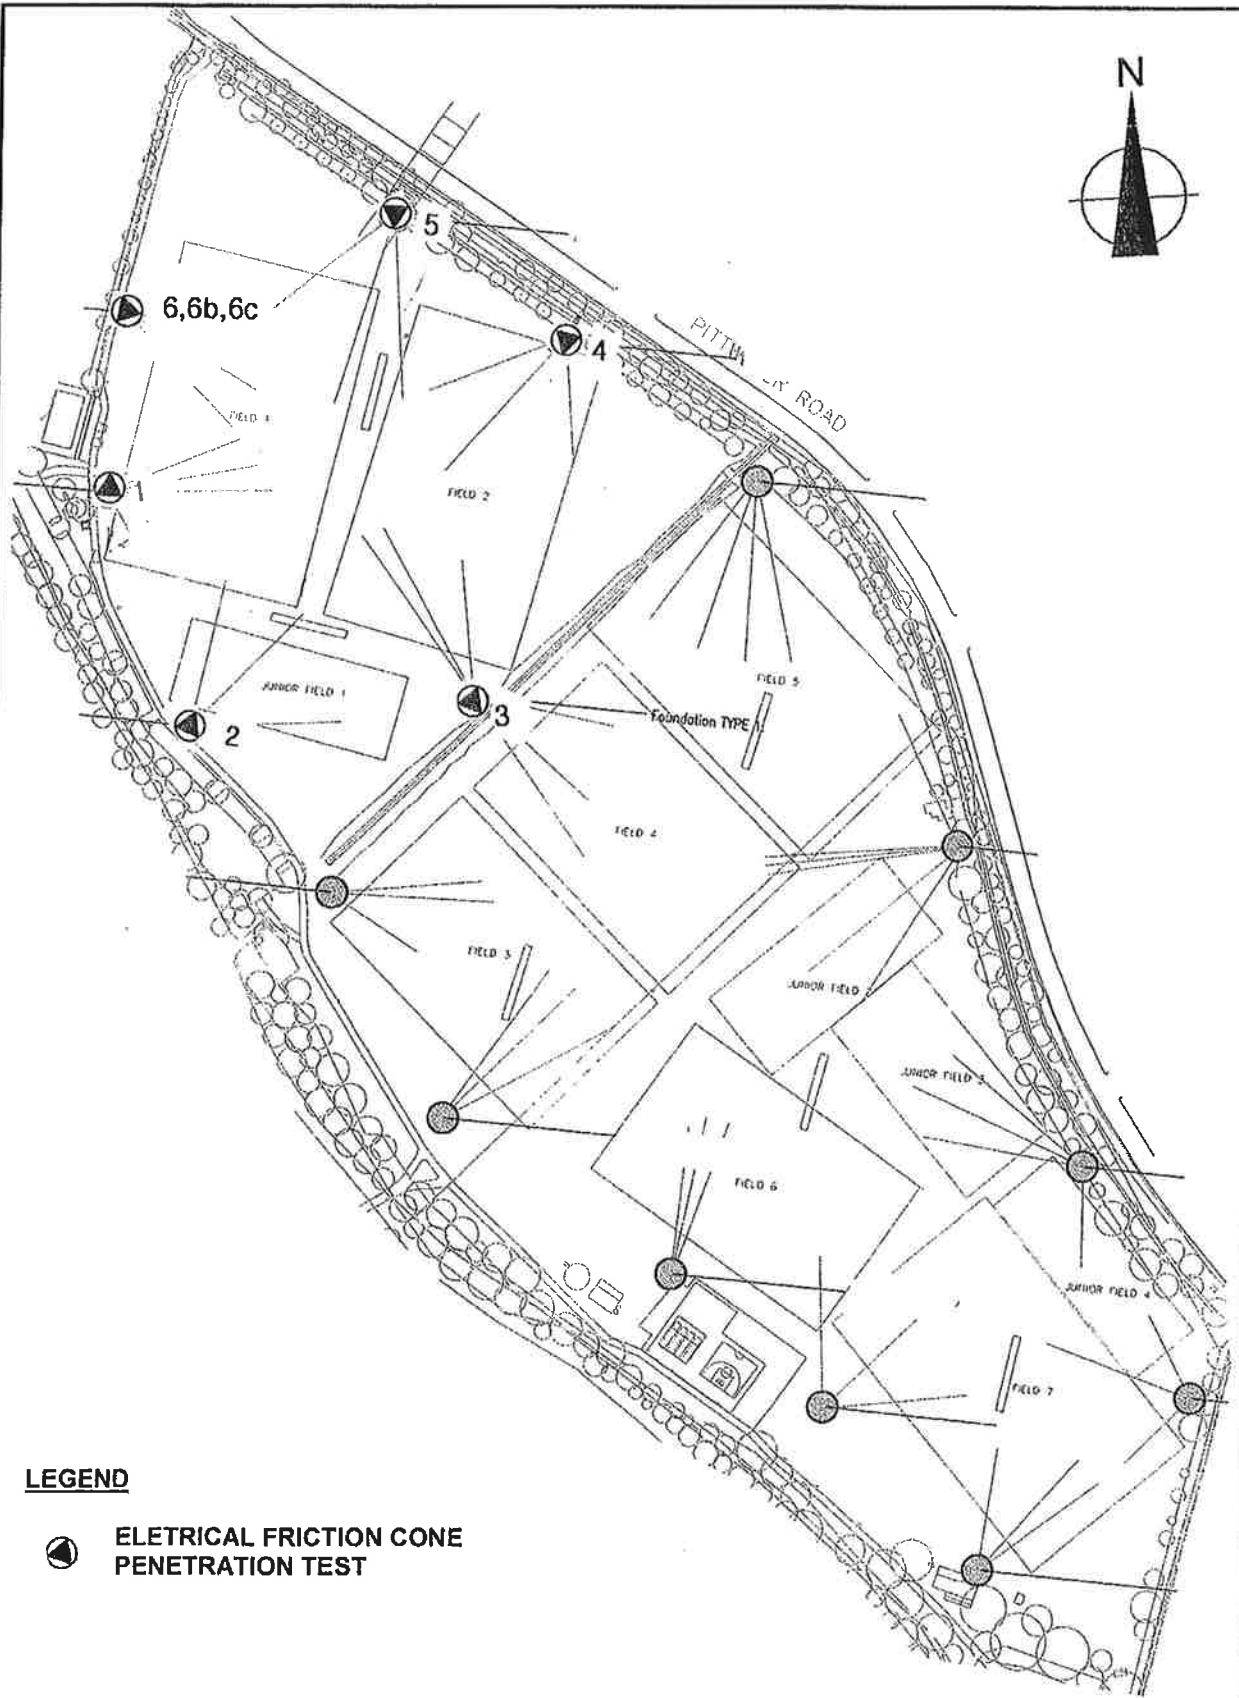
INVESTIGATION LOCATION PLAN

locations were located as close as practical to the marked pole locations. Prior to testing, the test locations were checked for underground services using electronic service detection equipment.
