**RE: Construction Certificate No. 05/307/01
Warriewood Aged Care Facility,
6 – 14 Macpherson Street, Warriewood**

CONSTRUCTION CERTIFICATE

Client: **ANGLICAN RETIREMENT VILLAGES**
 Project: **WARREWOOD BROOK BULK EARTHWORKS CONTRACT**
 Title: **SEDIMENT & EROSION CONTROL PLAN**

Warriewood Retirement Village Water Management Report

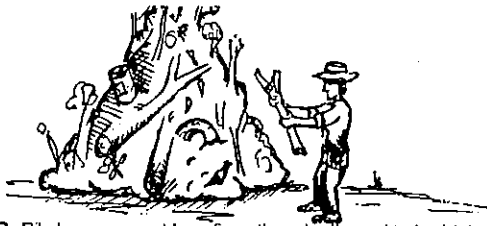
WRONG

WRONG: Pile burns are not bon-fires, they don't need to be high. This pile will be too hot. Pile Burns must be constructed from natural vegetation only, not household or building rubbish.

Weed burn piles should not be stacked too high, as excessive heat generated by high (>2 metre) piles may adversely affect the viability of the native seed stored in the soil. Unburnt piles should not be left on-site for more than 6 months as they may provide habitat for feral animals.

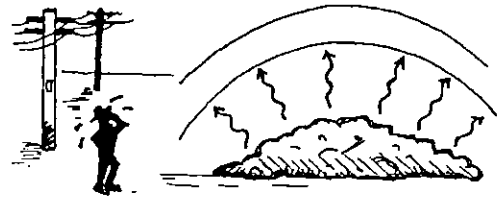
Give power lines a wide berth. Consider the radiant heat and smoke the burn will generate.

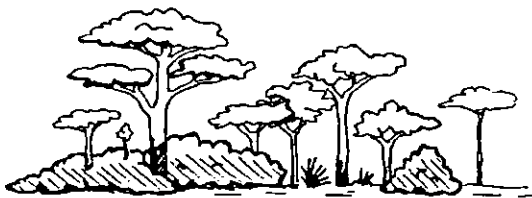
WRONG: Don't pile vegetation around the base of trees or directly under low canopy. Don't plant new trees near piles that are planned for burning.

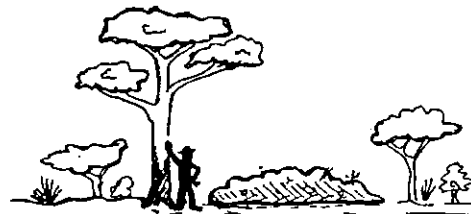
Try to choose a space with open canopy away from the base of trees. Wait until the piles have been burnt or removed before planting

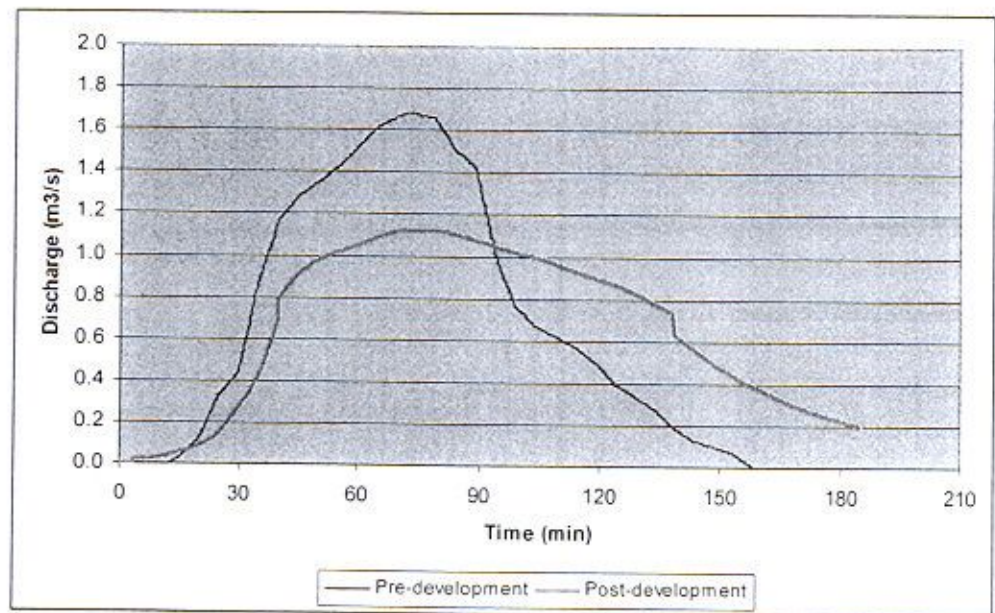
Figure 4 Comparisons of Event Hydrographs
