Report Title: Geotechnical Report 13 Kariboo Close, Mona Vale

Report Date: 15/7/21

GEOTECHNICAL INVESTIGATION:

New Pool at 13 Kariboo Close, Mona Vale

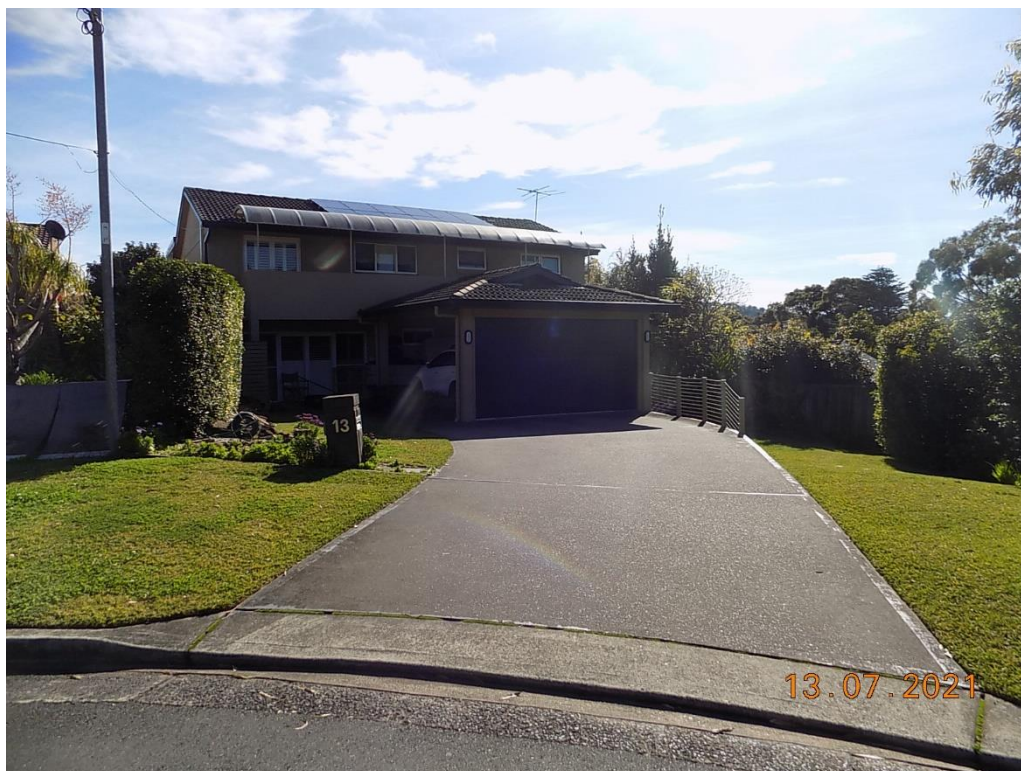
Photo 1

- 2.3** At the road frontage, a concrete driveway runs to a stable clad carport attached to the SE side of the house (Photo 1). The two-storey, rendered brick house is supported on brick walls and brick piers (Photo 2). The brick walls show no significant signs of movement and the brick piers appear to stand vertical (Photo 3). A gently sloping lawn extends off the NW side of the house to the common boundaries (Photo 4). A single-storey timber framed and clad granny flat sits in the N corner of the property and is supported on timber posts (Photo 5). The foundations appear to be in good condition.

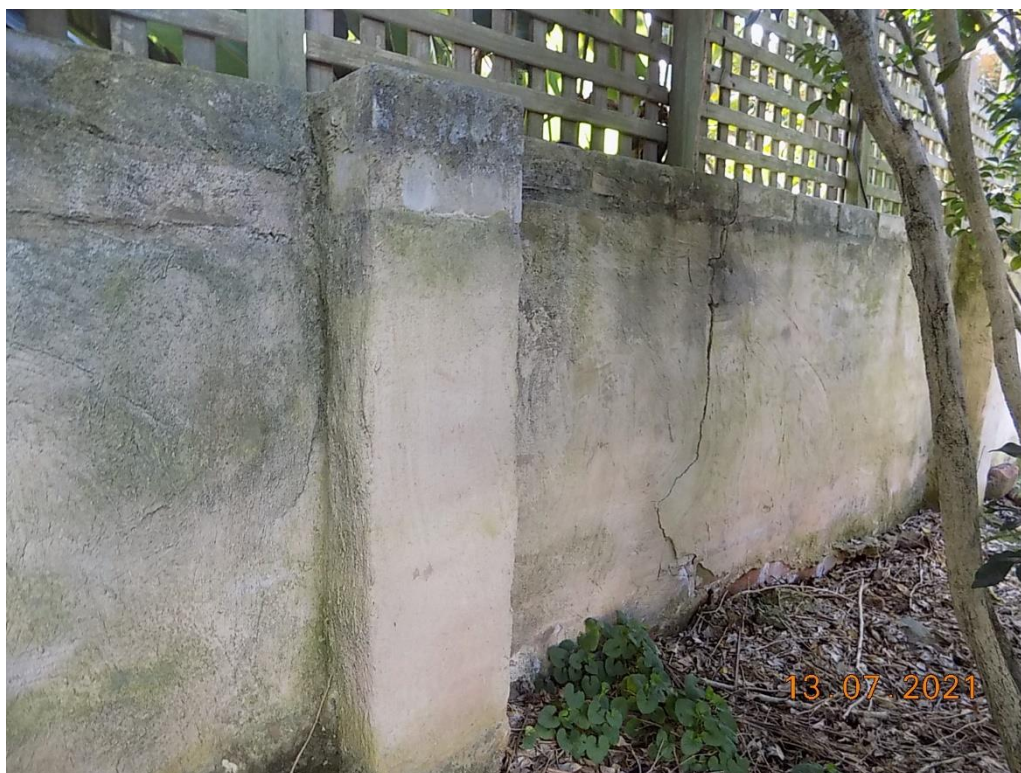
Photo 6

AUGER HOLE 1 (~RL34.2) – AH1 (Photo 6)

Depth (m)	Material Encountered
0.0 to 0.4	TOPSOIL , clayey soil, dark brown, fine to medium grained, fine traces of organic matter, soft, damp.
0.4 to 0.8	CLAY , mottled red, orange, and grey clay derived from Extremely Low Strength Shale, fine grained, very stiff, dry.

Refusal on rock @ 0.8m. Auger grinding on rock surface. No watertable encountered.

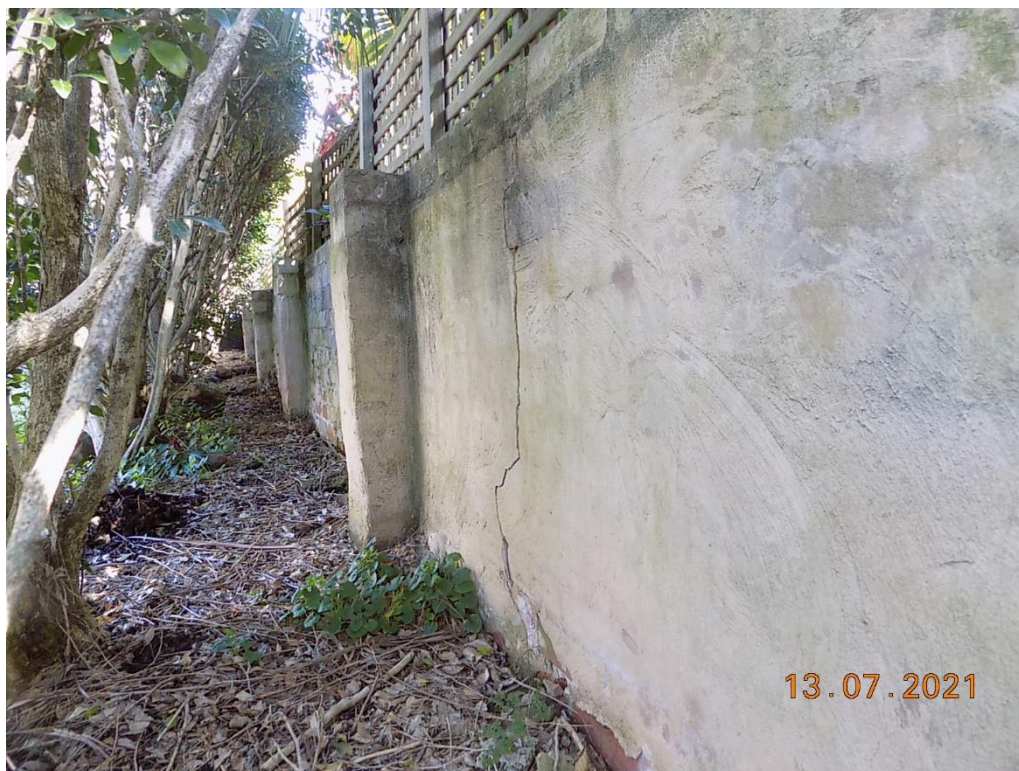
Photo 7

AUGER HOLE 2 (~RL34.2) – AH1 (Photo 7)

0.0 to 0.1 **TOPSOIL** dark brown, loamy with some fine organic matter.

0.1 to 0.3 **Fill** Brown to yellow brown, disturbed soil and clay.

0.3 to 0.7 **Silty Loam** Grey brown, powdery dry.

End of hole @ 0.7m in silty loam. No water table encountered.
