Marine Habitat Survey

158A (Lot 51) McCarrs Creek Road, Church Point

Report Date: 28 June 2023

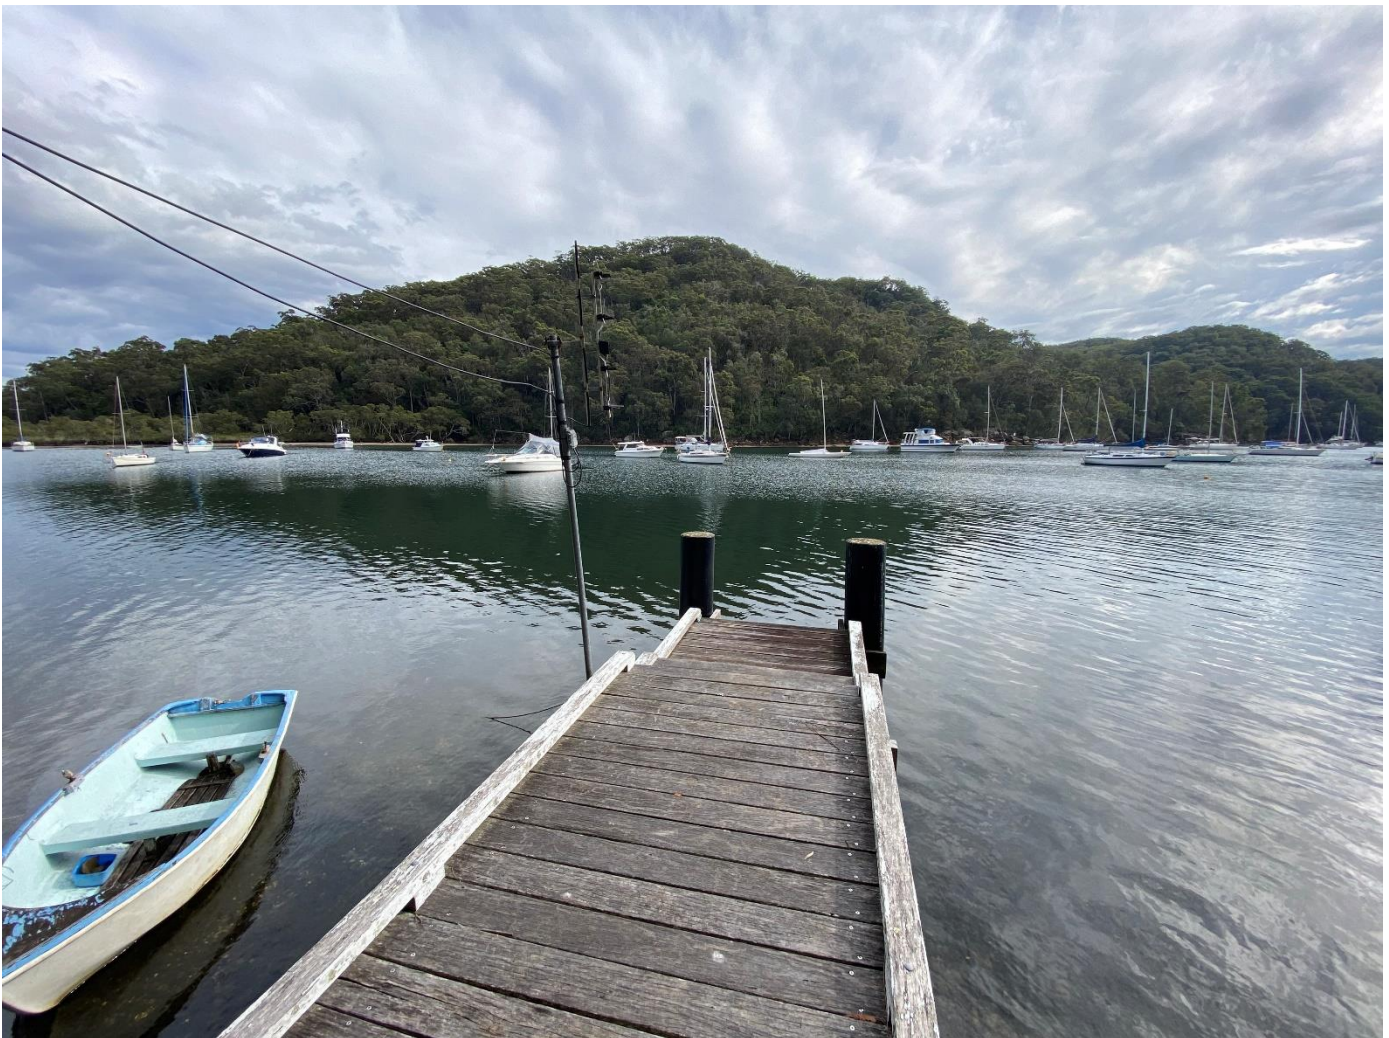
The proposal utilises the inner stone section of the existing jetty and extends approximately 13 m further seaward than the existing structure (Figure 3 and 4).

Figure 3: Existing waterfront structures at the Subject Site.

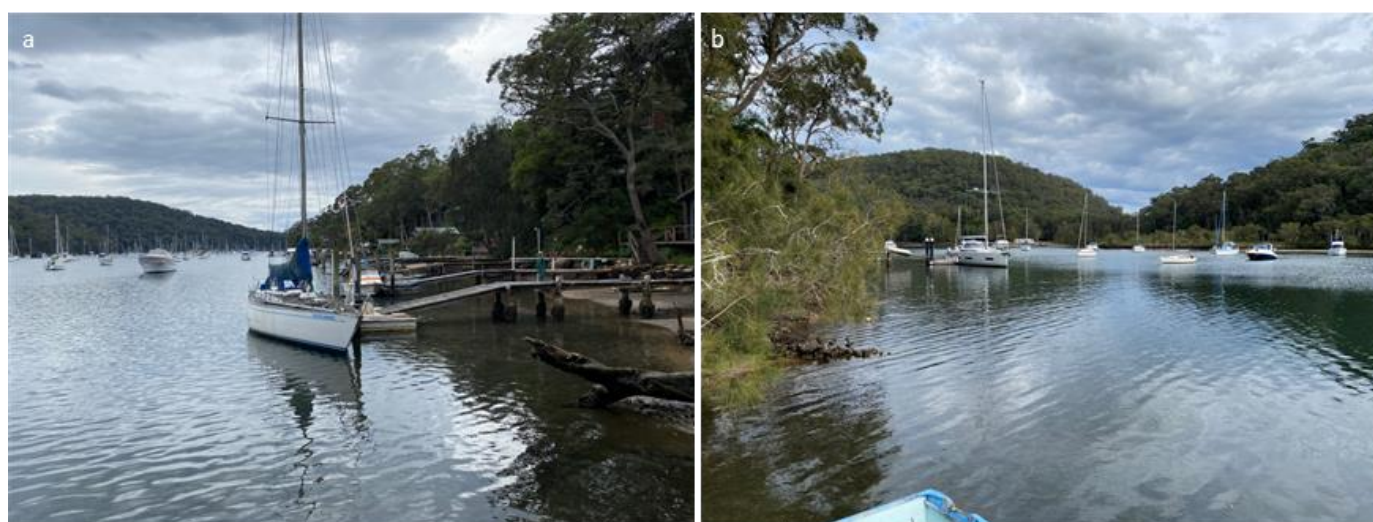
The adjoining shoreline is a minimally modified residential waterfront that backs onto a densely vegetated escarpment, rising approximately 40 m to McCarrs Creek Road, with a westerly aspect across McCarrs Creek. The waterfront at the Subject Site comprised of naturally vegetated rock escarpment and sandy shore, with a sandstone block jetty footing and stairs, and a timber jetty. Waterfront structures to the northeast of the Subject Site included timber jetties, ramps and pontoons, whilst to the southwest the waterfront comprised of natural shore and rocky intertidal, with a jetty, ramp and pontoon further upstream (Figure 5).

Figure 5: Waterfront structures to the (a) northeast and (b) southwest of the Subject Site.

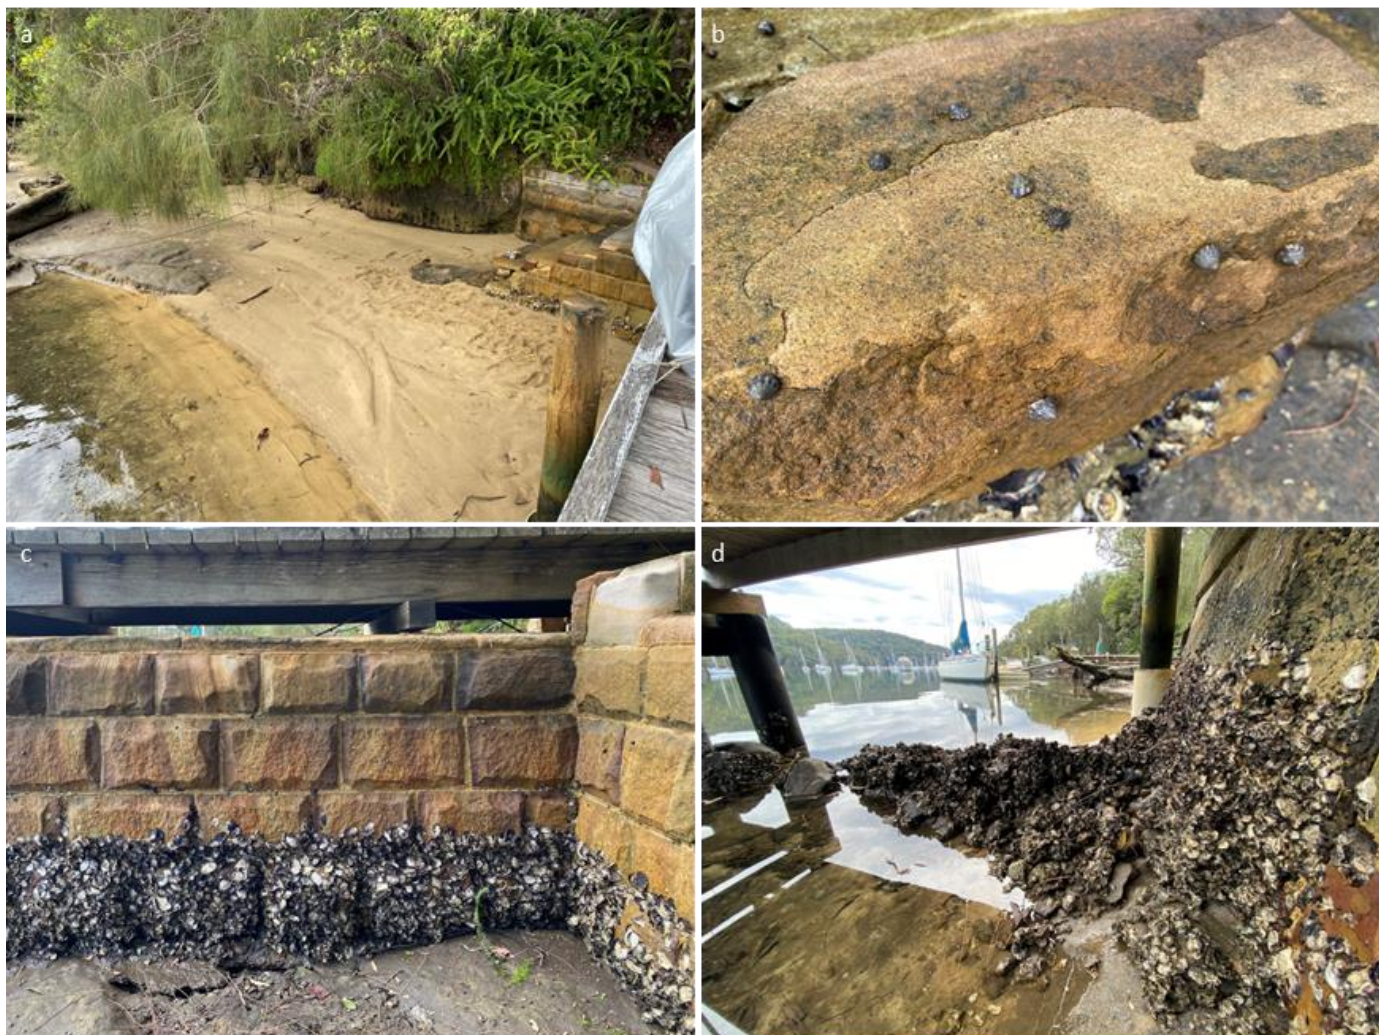
The intertidal habitat within the Study Area consisted of a combination of natural soft sandy shore, rock boulders and rock platform, and artificial habitat provided the lower sandstone block jetty and stairs, and existing piers (Figure 6). High intertidal habitat provided by the sandstone jetty sides and stairs supported sessile and mobile invertebrate species, including False Limpets (*Cellana tramoserica*) and Striped Conniwinks (*Bembicium nanum*) (Figure 6). On lower sections of the jetty in the mid intertidal zone, biota was dominated by dense assemblages of Sydney Rock Oysters (*Saccostrea glomerata*), with occasional presence of Mulberry Whelks (*Morula marginalba*), *B. nanum* and *C. tramoserica* (Figure 6). These species were observed in similar communities on the rock boulders and lower jetty and ramp piles in the low intertidal zone (Figure 6).

No intertidal vegetation including any mangroves or intertidal seagrasses occurred in the Study Area.

Figure 6: Typical intertidal habitat at the Subject Site, showing (a) natural soft sandy shore with natural rock formations and sandstone jetty stairs, (b) high intertidal habitat with *B. nanum*, (c) lower sandstone jetty side with dense *S. glomerata*; and (d) low intertidal habitat of rock boulders and lower piles populated by invertebrate species.

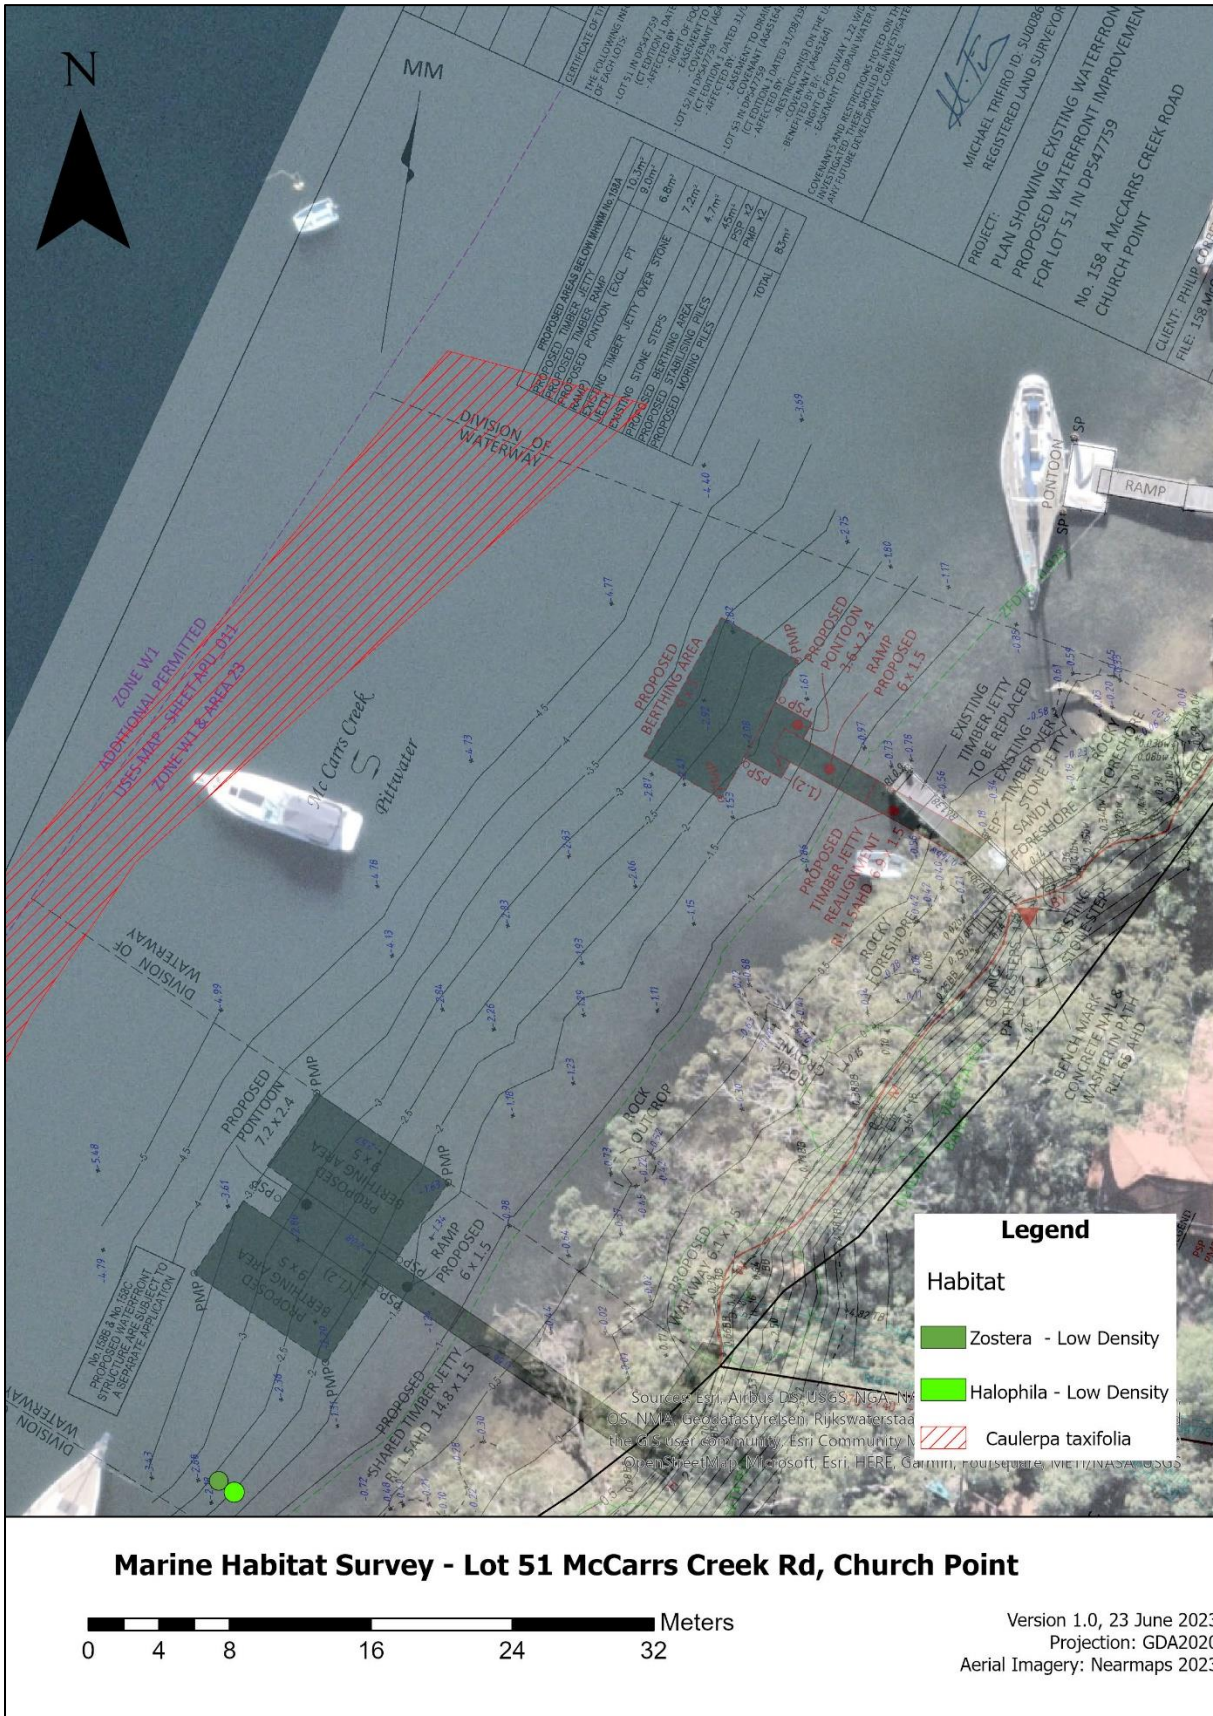
The invasive green alga *Caulerpa taxifolia* was observed in a high-density bed on the silty soft sediment on the western border of the Study Area.

Figure 8: Habitat map showing seagrasses within the Study Area.
