Dear Chief Executive Officer
Re
Submission DA 2020/1596
6 Mitchell Road
Palm Beach

Retaining Wall Stability

The aim of this letter is to assess the stability of a retaining wall above the subject property.

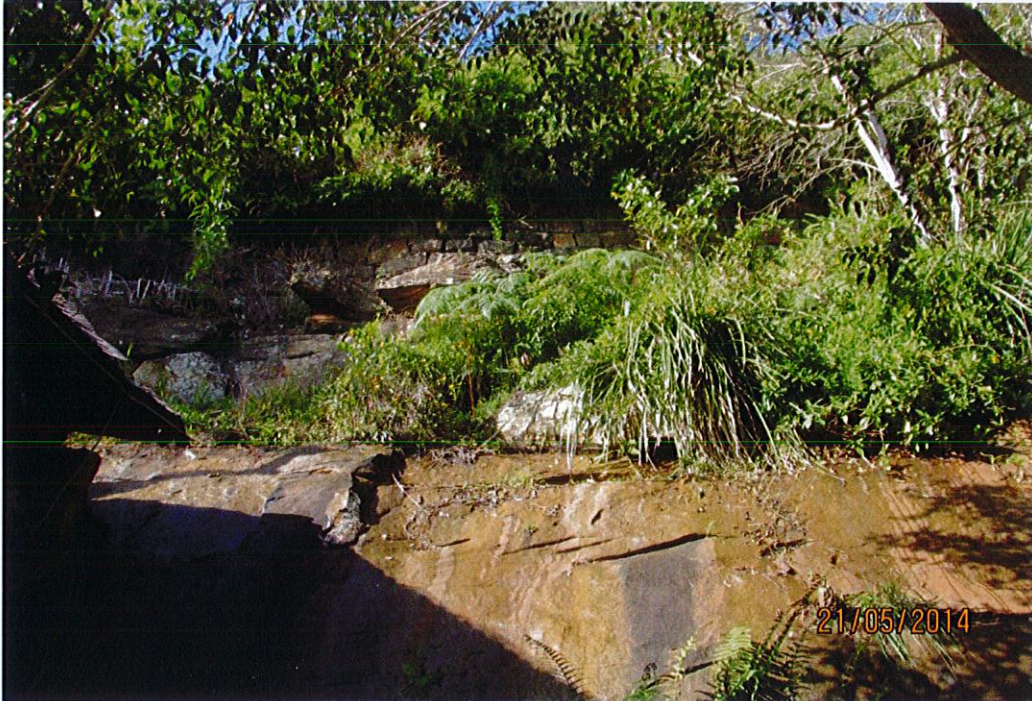
Photo 1

The slope of the subject property rises steeply above the house. A sandstone face rises to just beyond the upper boundary. At the crest of the face a sandstone block wall supports a fill that forms a level lawn on the property above at No. 15 Florida Road (Photo 1). This property is accessed from above via the Bible Garden.

We recommend the wall be remediated to bring it to current engineering standards.

In our opinion this would be most easily and safely achieved by constructing a sprayed concrete wall over the existing wall. It is possible starter bars for this wall could be drilled directly into the rock below but given the walls estimated height rock anchors may be required to support it. A catch fence should be installed on the rock face below prior to any works being carried out to protect the house below from any construction related movement.

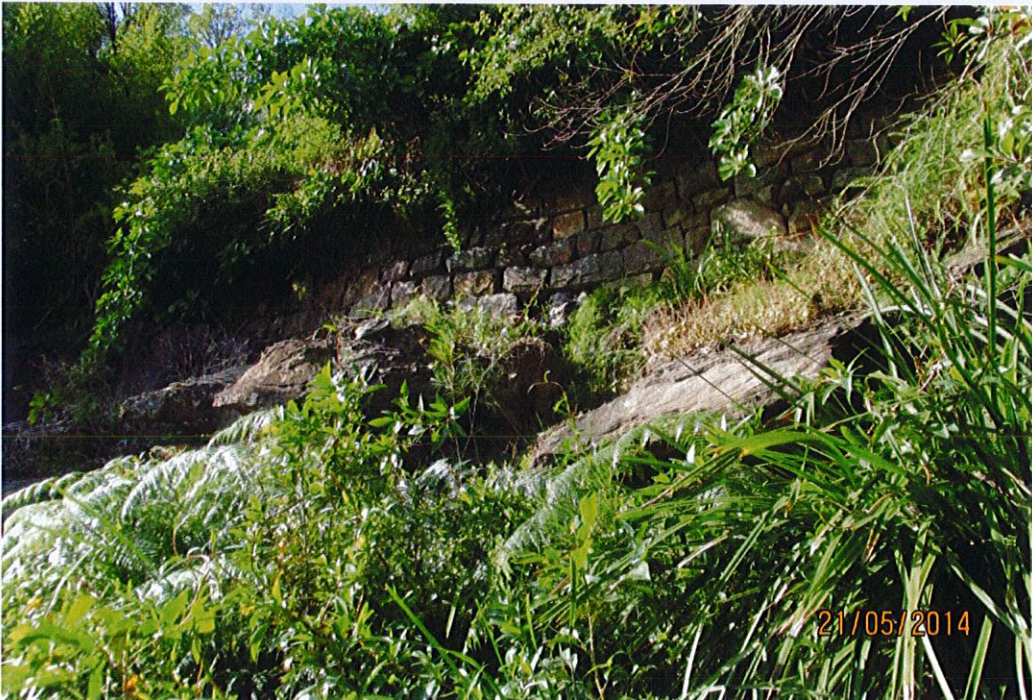
Photo 2

The retaining wall is constructed of rough sandstone blocks and is of dry stack construction. It appears to be one course thick and is estimated to be ~ 3.0m high. The top of the wall is obscured by vegetation growing over it from behind making a height estimate difficult. The wall shows some movement in the form of bulging that appears to be due to the root action of vegetation growing behind the wall (Photo 2). Although it is likely the vegetation has caused the wall to move the roots are also playing a large part in stabilising the fill behind the wall and it should not be removed while the wall is in its current state. Most of the wall can be seen to be supported on sandstone bedrock but in two locations the wall is founded on old stumps. One of these stumps has totally rotted out and in this location the wall is bridging the void (Photo 3). The other stump appears to be a drainage path and soil has been washed from below the stump (Photo 4 & 5). If left further rainfall runoff could undercut the wall in this location.
