## 52 Raglan Street, Manly NSW

### Statement of Heritage Impact

Prepared for Northern Beaches Council

September 2019—Final

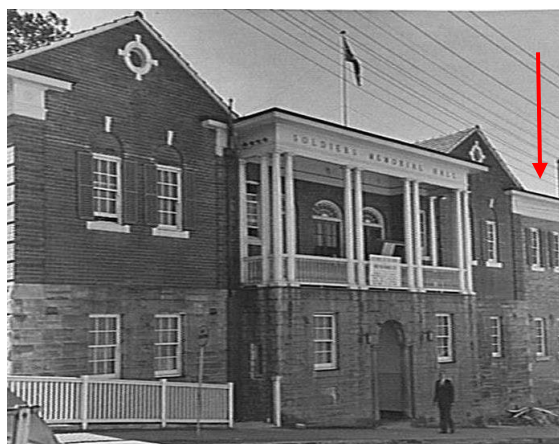
In the 1950s, the memorial hall underwent several additions and alterations. In 1953, 26 years after the memorial hall was first opened, Trenchard, Smith, Maisey and Morgan accepted a tender for additions to the 'Memorial Club building, Manly' (Figure 10). A 1957 photograph of the memorial hall indicates that these additions were likely an extension to the eastern side of the building (Figure 11).

Figure 11. 1957 photograph of Manly Soldiers Memorial Hall with extension marked with a red arrow (Photographic Illustrators P/L in Manly Local Studies Image Library 001/001488).

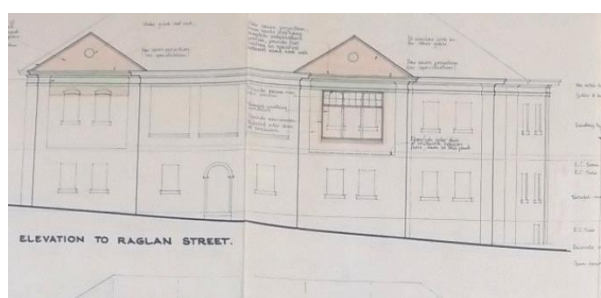
Plans dated from 1971 indicate that several original floor and ceiling panels were removed and replaced, as well as the demolition of several partitions. At this time, the upper ground floor bathroom was refurbished. An undated 'working drawing' attached to the 1971 plan indicates further works included installation of a timber dais, installation of a kitchen and changes to the observation lounge including new beams and carpeted flooring (Figure 12). It is likely that during the 1971 alterations that the 'observation lounge' was bricked in and the large windows installed. Elevation plans of Raglan Street indicate a design similar to the current Raglan Street façade (Figure 13 and Figure 14).

Figure 13 1971 working drawing indicating the 'bricking in' of the Raglan St observation deck and installation of windows (Unknown Author provided by Northern Beaches Council)

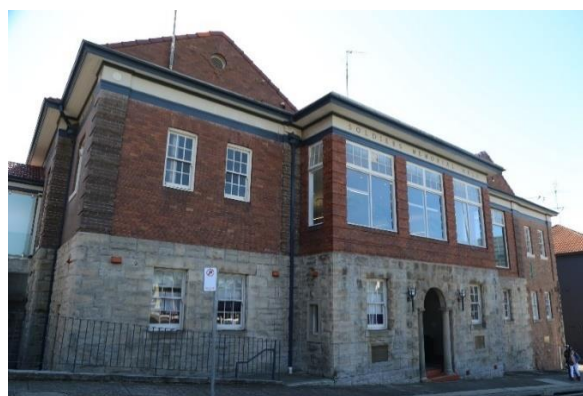
Figure 14. 2019 image showing alterations to the Raglan Street exterior (Extent Heritage)

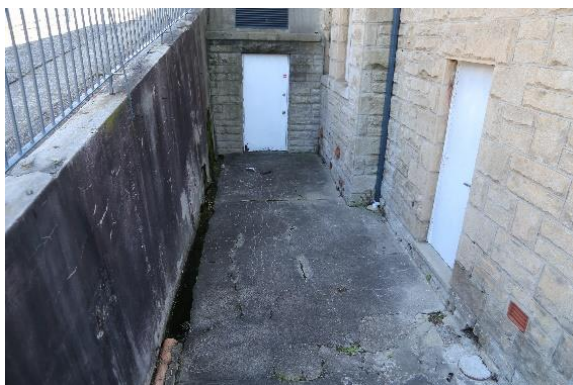
The Kangaroo Street exterior doors were in poor condition with evidence of damage from rising damp (Figure 17 and Figure 18). The front entry on Raglan Street has been altered, with installation of a modern door and tiled exterior stairs (Figure 19). Beneath the modern stairs evidence of terrazzo tile (potentially original) was identified. The extent of this tile beneath the modern additions is currently unknown (Figure 20). The exterior sandstone was in fair condition, with evidence of some deterioration of mortar between courses (Figure 21 and Figure 22).

Figure 17. View of two exterior doors on Kangaroo Street.

- Replace the lower ground exterior doors on Kangaroo Street with a like for like replacement;
- Replace the front main door and stairs on Raglan Street with a DDA compliant option:

Replace the lower ground exterior doors on Kangaroo Street with a like for like replacement.	<p>Replacement of exterior doors with a like-for-like replacement is in keeping with the maintenance policies, which state, '<i>where repairs [...] are required, new material should closely match original materials.</i>' Additionally, the exterior doors are not considered to be an original or significant element. New paint should match the existing exterior colour scheme.</p> <p>The impact is <b>negligible</b>.</p>
	The new Raglan St entrance door will be a clear glass auto-sliding door in a powder coated aluminium frame in Dulux ironstone, satin finish.	<p>The current heavy aluminium frame of the existing door on Raglan Street is considered to be highly intrusive. It is understood the new door will be set back further from the front facade and will be constructed in a charcoal coloured aluminium frame. This is considered to be a less visually intrusive option and is in keeping with the conservation policies outlined in the previous report.</p> <p>The impact is <b>minor</b> but represents a positive change.</p>

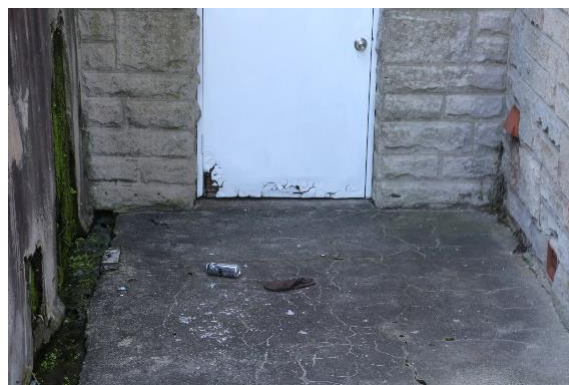
Figure 18. Close-up of exterior door on Kangaroo Street.

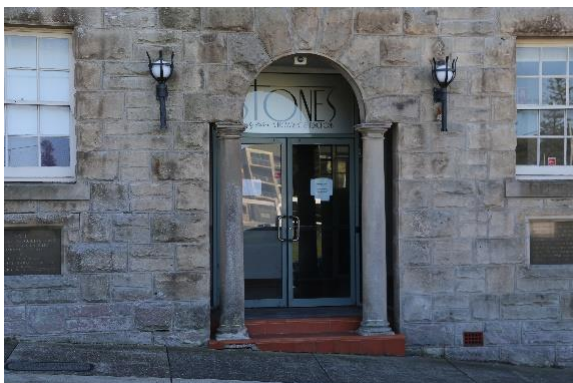
Figure 19. Front entry on Raglan Street.

- The original columns will be retained; however, the tiled stairs will be replaced with a DDA compliant step ramp;
  - The new door will be a clear glass auto-sliding door in a powder coated aluminium frame in Dulux ironstone, satin finish;

<p>The original columns will be retained; however, the tiled stairs will be replaced with a DDA compliant step ramp</p> <p>New concrete slab to replace existing; this will require demolition of the existing tiles and concrete floor in the vestibule/foyer.</p> <p>Minor refurbishment as required for DDA compliancy. This includes replacing the current vestibule/foyer with a DDA compliant entry section including a stair ramp. This will require demolition of the existing tiles and concrete floor in the vestibule, the new floor will be a combination of vinyl and carpet tiles.</p>	<p>Refurbishment will require removal of the modern tile in the vestibule and lobby, and removal of the existing concrete slab. There is no impact to heritage fabric associated with the removal of the modern tile and slab, however previous investigation has shown that original 1920s terrazzo tile may remain under the modern tile. It is understood terrazzo does not have an appropriate slip rating for an entry to a building and that applying a slip coating will alter the look of the tile.</p> <p>Council should investigate the extent of the terrazzo that may remain, and effort should be made to retain this fabric. Recommendations for this are presented in Section 9.</p> <p>The new proposed tiles are dark-grey, a visually appropriate colour which will match the other</p> <p>Provided the mitigation methods outlined in Section 8.4.2 are followed, the impact of this work will be minor. The impact is required for the building to meet DDA compliance requirements, and will be mitigated through salvage and reuse of the terrazzo tiles in an acceptable new location.</p>

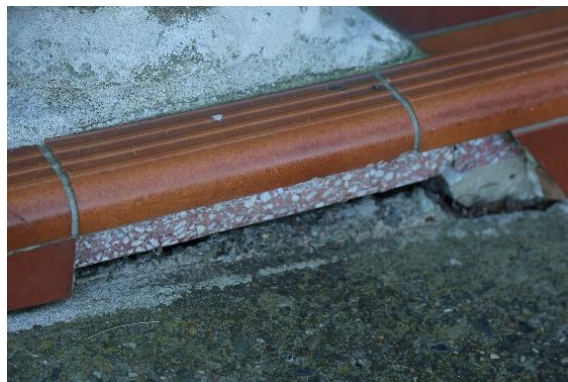
Figure 20. Detail showing the (potentially original) terrazzo tile beneath the modern stairs at the Raglan Street entrance.

- Effort should be made to retain the terrazzo tiled stair fabric, if possible. This retention could take several forms, depending on the extent and integrity of the tiles, including:
  - Salvage and re-use as a skirting within the vestibule or;
  - If, due to condition or quality of tiles re-purposing is not a viable option, segments of terrazzo at the base of the stone columns can be exposed and repaired. Both above options are aligned with the maintenance policies, which suggests retention of material in order to *‘successfully interpret various stages of use’*.

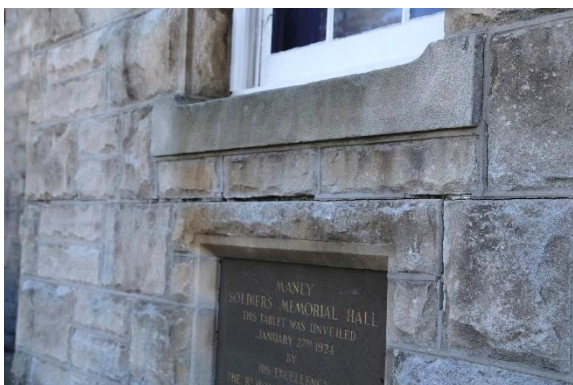
Figure 21 Example of exterior sandstone showing deteriorating mortar.

- Sandstone fixes and repair, as necessary;
- Installation of two temporary secure construction material and waste storage compounds- one in the lower ground exterior and one in the rear carpark;

- It is recommended that Northern Beaches Council undertakes a moisture reading of the exterior sandstone. Dependent upon the results of this reading, further intervention to mitigate salt impacts is likely to be required. This would potentially involve a poultice to remove salts and moisture on the exterior sandstone prior to subsequent repair of mortar.

- During works, especially to the Raglan Street entrance and vestibule, columns and other fabric including surrounding sandstone will need to be appropriately protected to avoid any damage.
- Use a traditional lime mortar recipe for any repointing works - typically 1(lime):3(sand). Match the colour and composition of the mortar to that found in the vicinity of the repair. Testing of the existing early or original mortar may be required to obtain a satisfactory match.
- Where a hard, cementitious mortar has been used as a repointing agent, remove and repoint with a traditional lime mortar recipe.

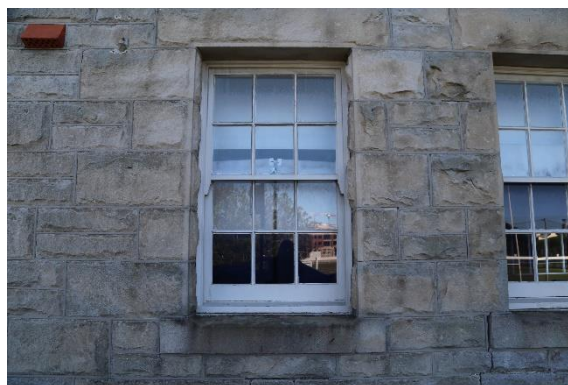
Figure 22 Example of exterior sandstone and window.

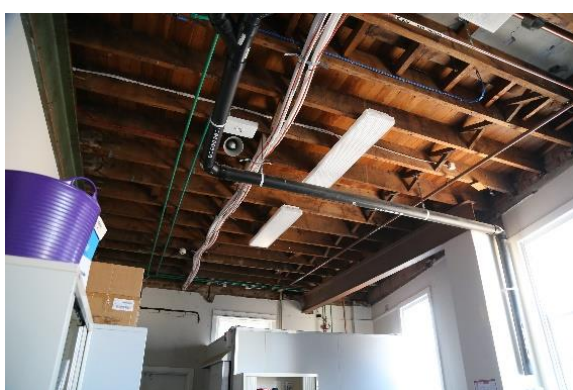
Located within the 1950s extension to the east is a cool room and storage area. In this area, the 1950s floorboard of the upper ground floor are visible (Figure 29 and Figure 30). The lower ground floor bathrooms have been refurbished and are of modern construction (Figure 31).

Figure 29. Lower ground cool room showing underfloor

- Refurbishment of bathrooms, including the replacement of two toilets and installation of partitions and grabrails for DDA compliance;
- Removal of cool room and undertake patch repair work to walls, windows and floors as necessary;

Area	Proposed works	Built Heritage Assessment
	Removal of cool room and undertake patch repair work to walls, windows and floors as necessary.	<p>There is no heritage impact to heritage fabric associated with removal of the cool room, which is not an original element and does not contribute to the item's significance. There will be a positive heritage impact on the windows which are currently masked by the cool room and will undergo repair work as necessary. Methods for patch repair are outlined in Section 8.</p> <p>The proposed works have the potential to retain the exposed underfloor of the ground floor floorboards, visible from the lower ground floor cool room. This is aligned with the maintenance policies, which suggests retention of such material in order to 'successfully interpret various stages of use.' This would aid in providing an interpretive element regarding the 1957 addition of the building.</p> <p>The impact is <b>negligible</b> but also represents a positive change.</p>

- After the removal of the cool room, patch repair works should be undertaken in accordance with the methods outlined in the maintenance report. If after removal of the cool room it is determined that there has been a loss of heritage fabric (i.e. the rear window has had the lower half of its frame removed) reconstruction of these features would be considered best practice.

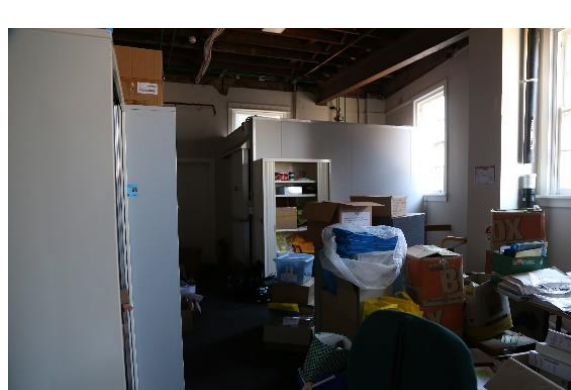
Figure 30. Lower ground cool room.

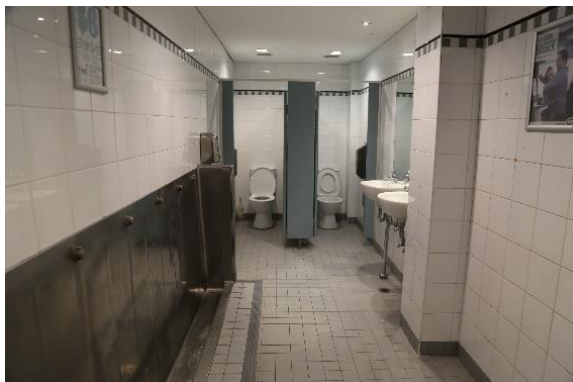
Figure 31. Lower ground floor men's bathroom.

Refurbishment of bathrooms, this will involve replacement of two toilets and installation of partitions and grabrails for DDA compliance.	There is no heritage impact associated with the minor refurbishment of the lower ground floor bathrooms. These have been significantly altered over time and no original heritage fabric is known to exist in these locations. The impact is <b>no change</b> .

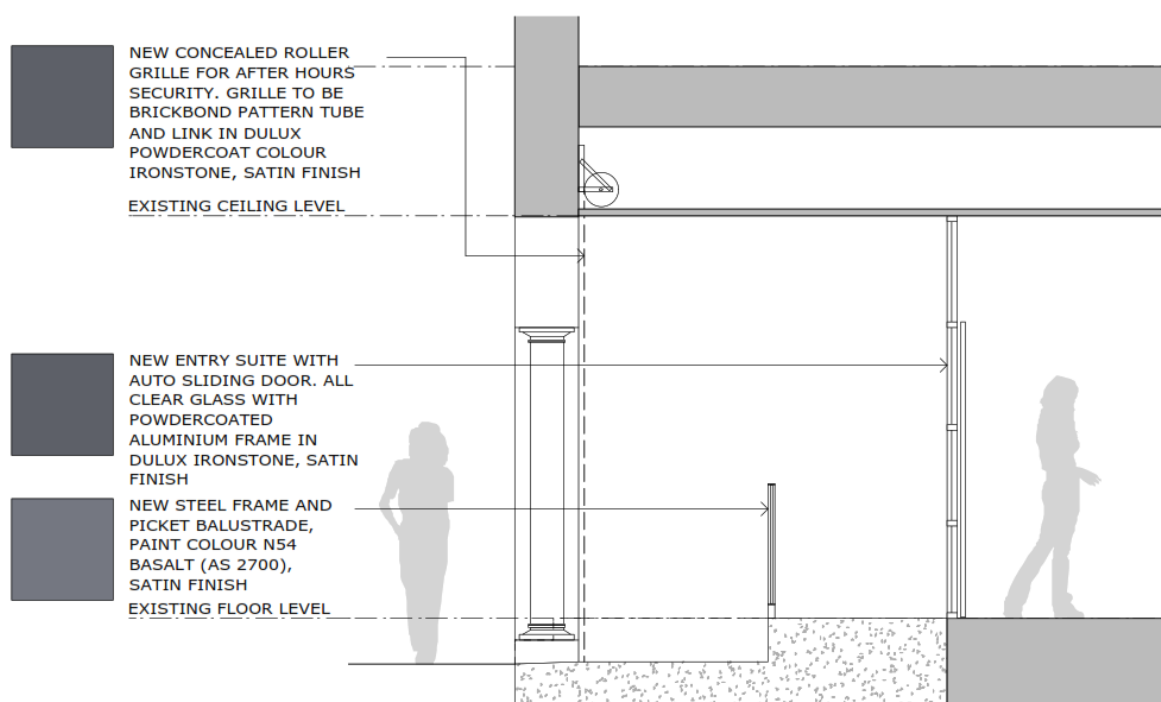
Figure 34 Section Drawing, Lower Ground Floor Entry (Building Assets Planning Design and Delivery Northern Beaches Council).

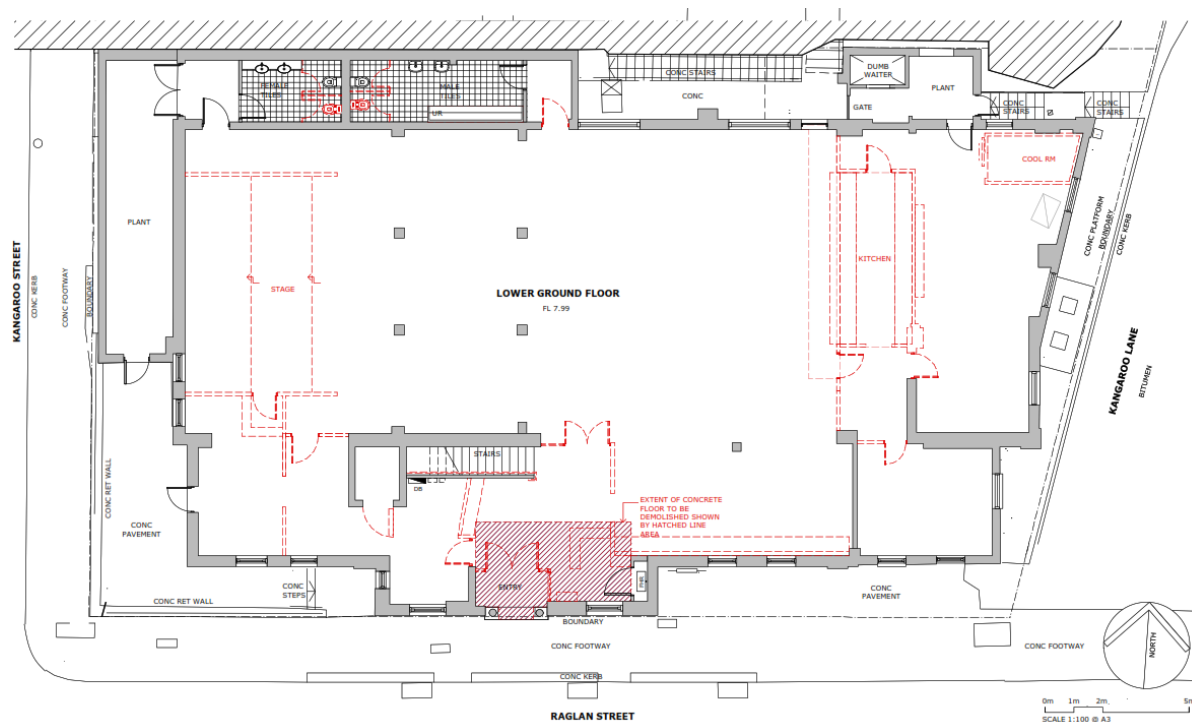
Figure 35 Raglan Street Lower Ground Floor Demolition Plan (Building Assets Planning Design and Delivery Northern Beaches Council).

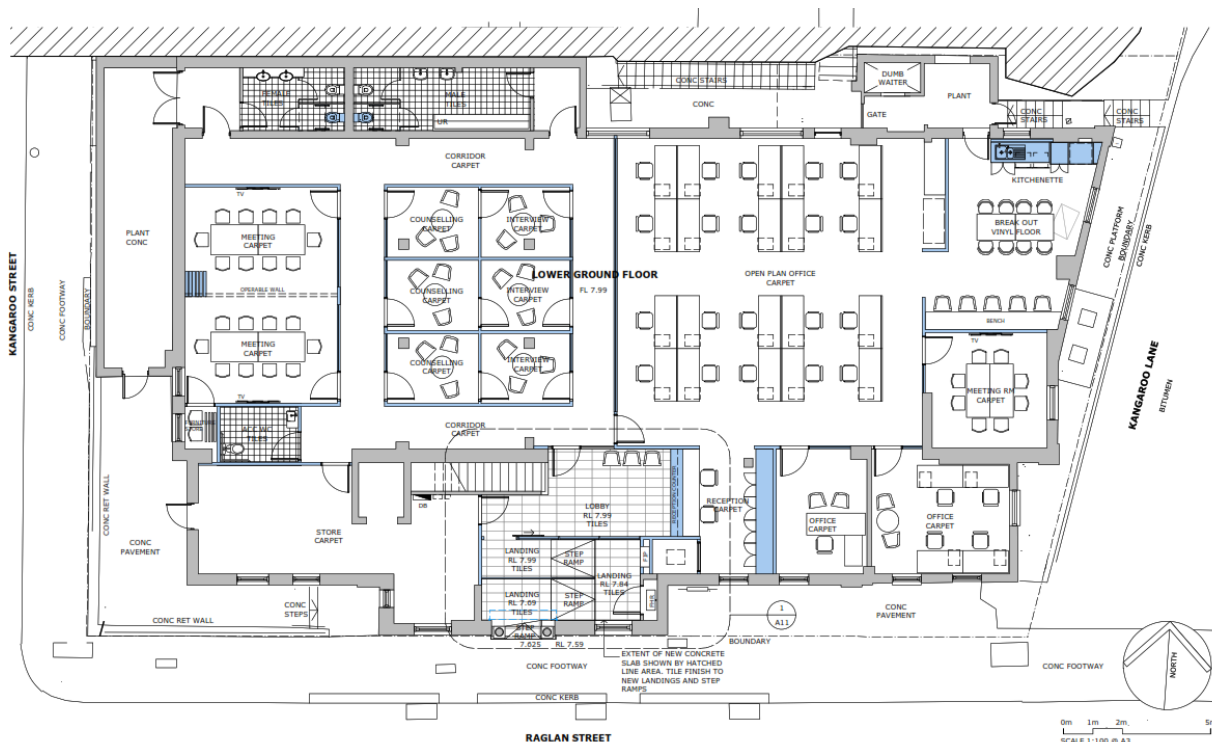
Figure 36 Raglan Street Lower Ground Floor Proposed Community Hub Layout (Building Assets Planning Design and Delivery Northern Beaches Council).

- Installation of partitions within the main lower ground floor area to facilitate the use of the space for meetings, interview and counselling rooms and as an open plan office.
