PRELIMINARY ASSESSMENT: Acid Sulfate

For Alterations and Additions at **139 Lagoon St, Narrabeen**

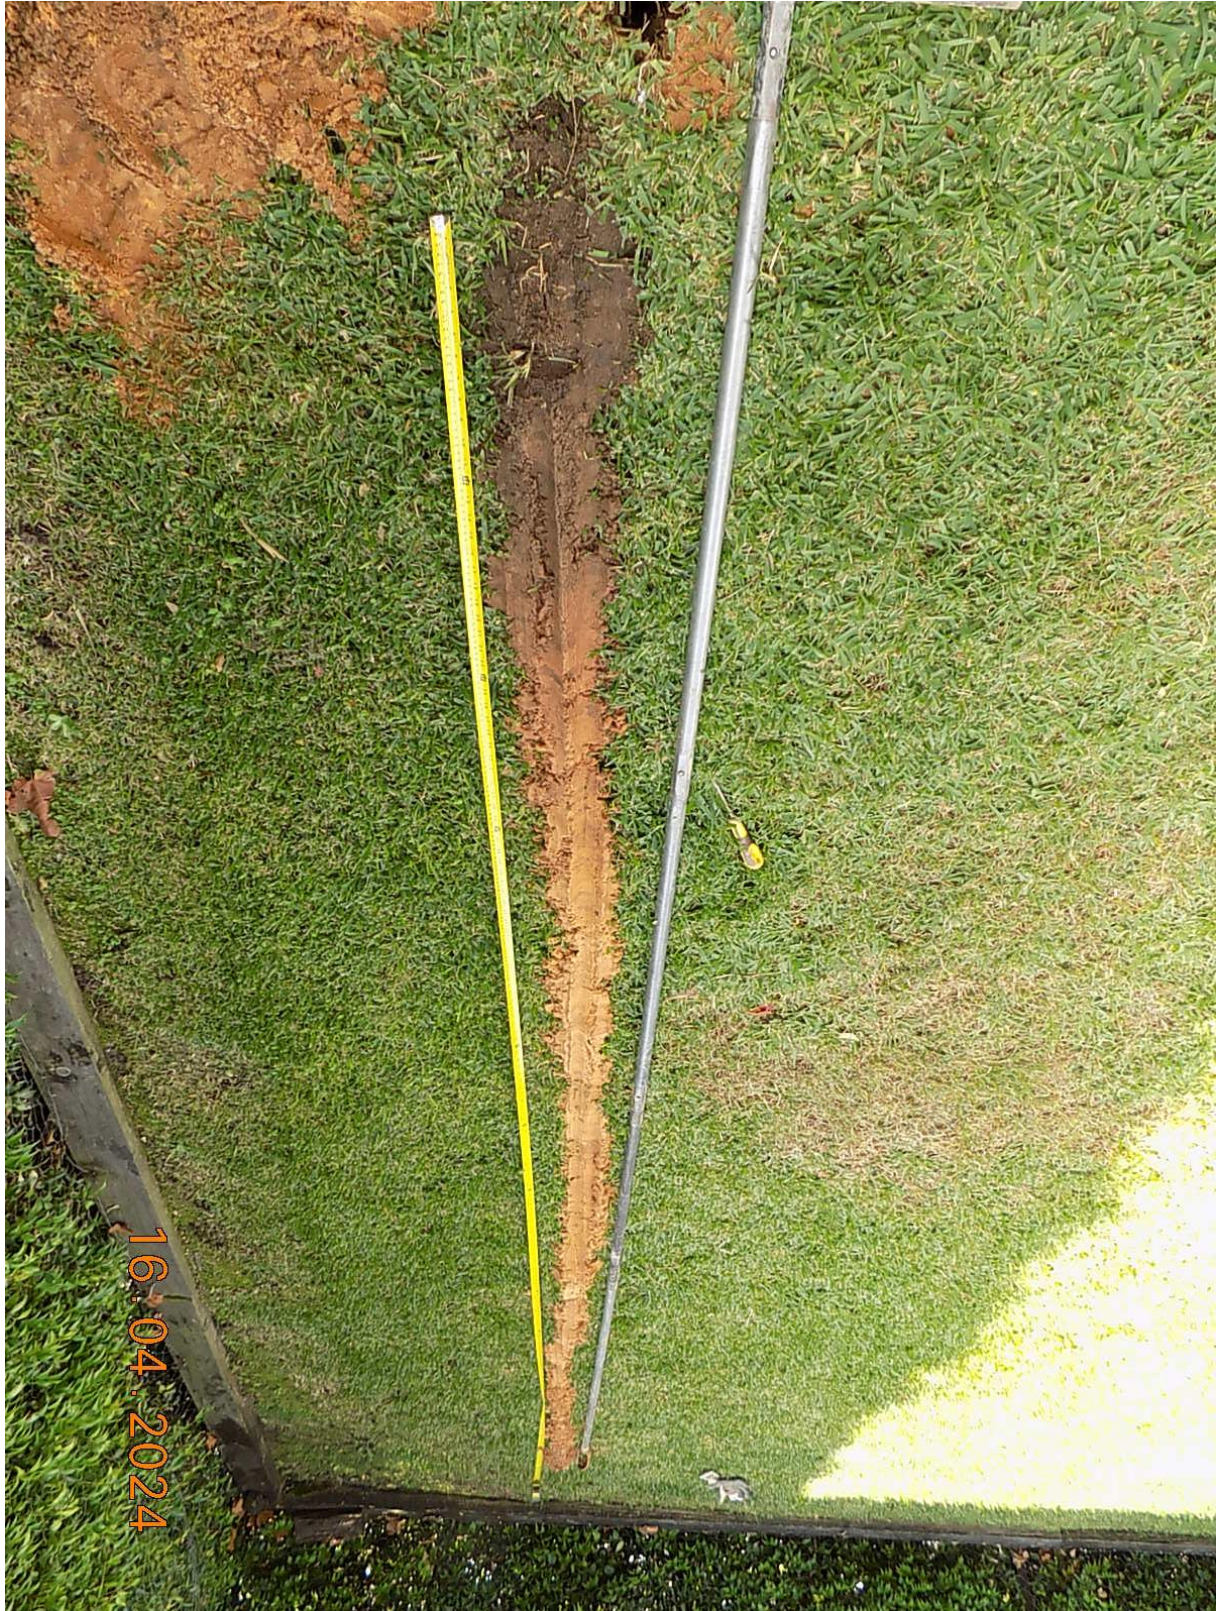
Photo 1: AH1 – Downhole is from top to bottom

AUGER HOLE 1 (~RL7.9) – AH1 (Photo 1)

Depth (m)	Material Encountered
0.0 to 0.2	SANDY FILL , dark brown, medium dense, dry, fine to coarse grained, rock fragments and fine organic material (roots) present.
0.2 to 0.5	LOAMY SAND , brown, medium dense, dry, medium grained, fine organic material (roots) present.
0.5 to 4.4	SAND , orange, orange brown, yellow brown, medium dense, dry to moist, medium grained.

End of hole @ 4.4m in Sand. No water table encountered.

TEST: AH1	FIELD pH & PEROXIDE RESULTS				
Sample depth (m)	pH _F	30% Peroxide reaction	pH _{FOX}	pH _F - pH _{FOX}	SS=Shell J=Jarosite R=Roots
0.2	7.4	M	7.1	0.3	R
0.5	7.4	M	7.1	0.3	R
1.0	7.3	M	7.1	0.2	-
1.5	7.3	M	7.1	0.2	-
2.0	7.3	M	7.2	0.1	-
2.5	7.3	M	7.3	0	-
3.0	7.4	M	7.3	0.1	-
3.5	7.5	M	7.4	0.1	-
4.0	7.7	M	7.6	0.1	-
4.4	7.9	M	7.9	0	-

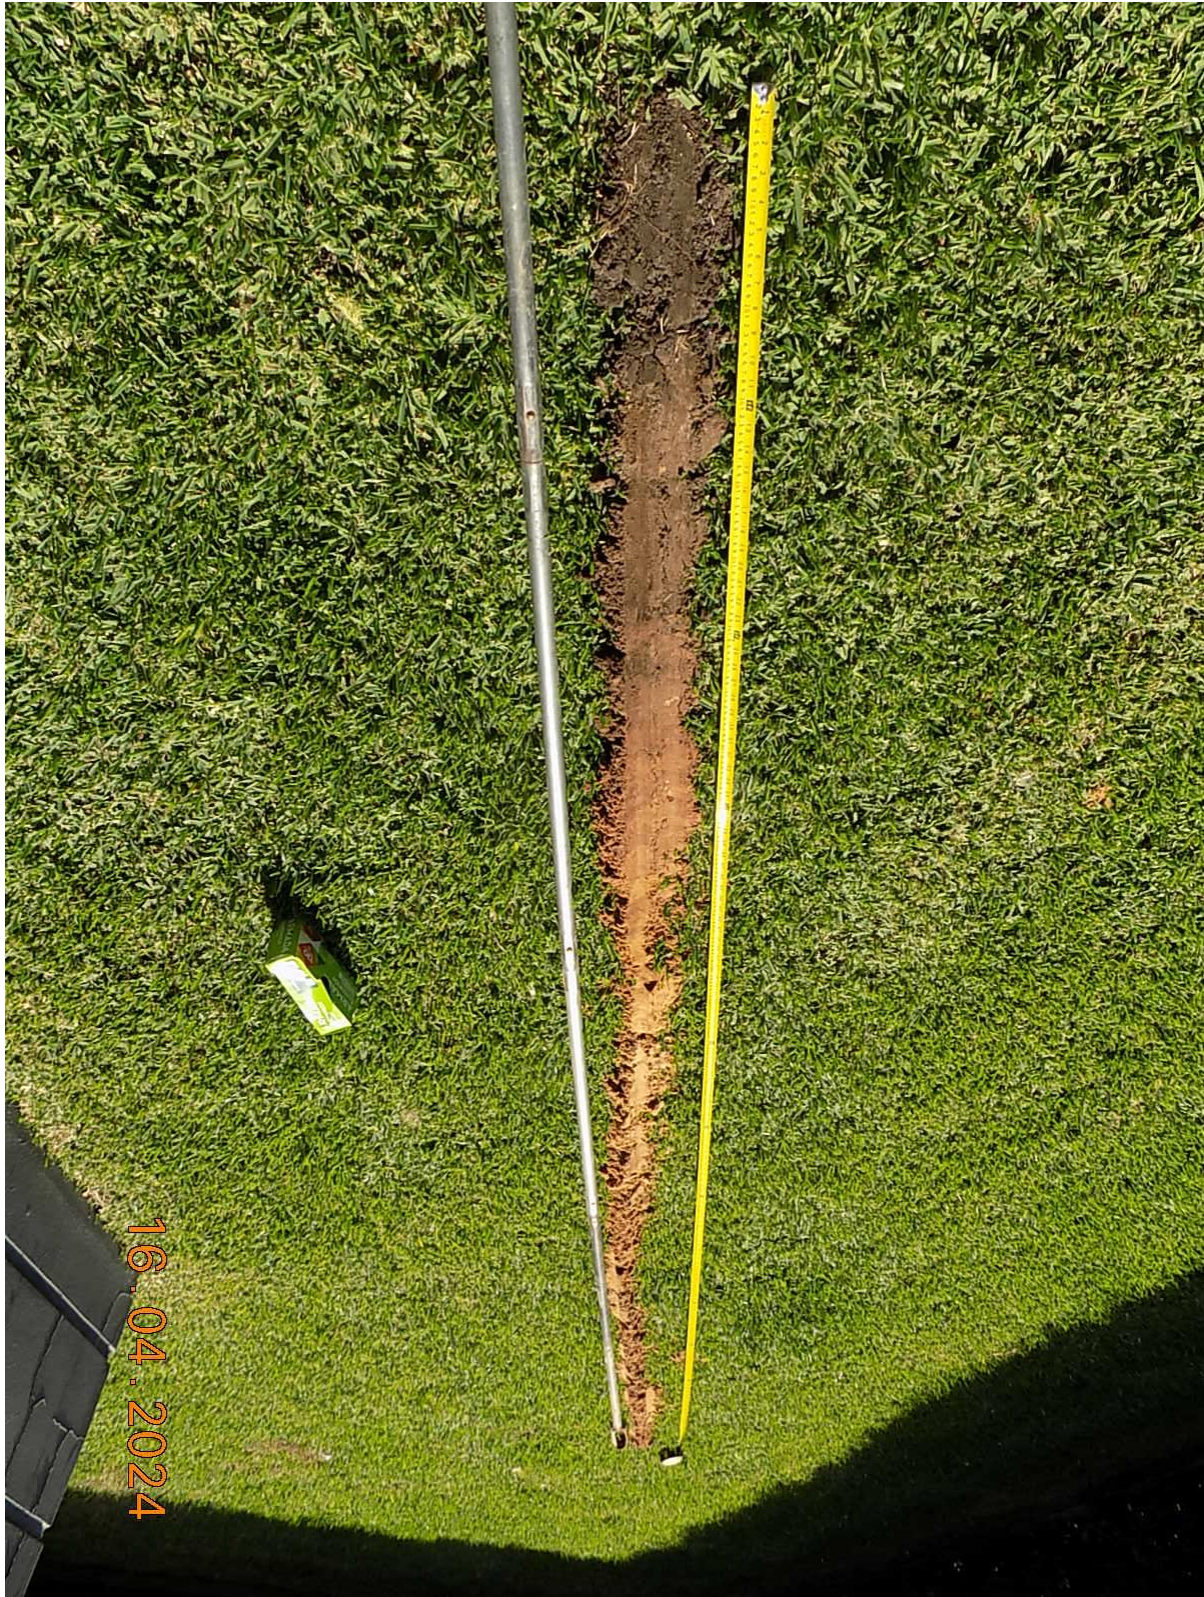
Photo 2: AH2 – Downhole is from top to bottom

AUGER HOLE 2 (~RL8.0) – AH2 (Photo 2)

Depth (m)	Material Encountered
0.0 to 0.3	SANDY FILL , dark brown, medium dense, dry, fine to coarse grained, rock fragments and fine organic material (roots) present.
0.3 to 0.7	LOAMY SAND , brown, medium dense, dry, medium grained, fine organic material (roots) present.
0.7 to 4.4	SAND , orange, orange brown, yellow brown, medium dense, dry to moist, medium grained.

End of hole @ 4.0m in Sand. No water table encountered.

TEST: AH2	FIELD pH & PEROXIDE RESULTS				
Sample depth (m)	pH _F	30% Peroxide reaction	pH _{FOX}	pH _F - pH _{FOX}	SS=Shell J=Jarosite R=Roots
0.2	7.8	M	7.7	0.1	R
0.5	7.8	M	7.7	0.1	R
1.0	7.7	M	7.6	0.1	-
1.5	7.7	M	7.6	0.1	-
2.0	7.7	M	7.6	0.1	-
2.5	7.8	M	7.8	0	-
3.0	7.8	M	7.8	0	-
3.5	7.8	M	7.7	0.1	-
4.0	8.0	M	7.9	0.1	-

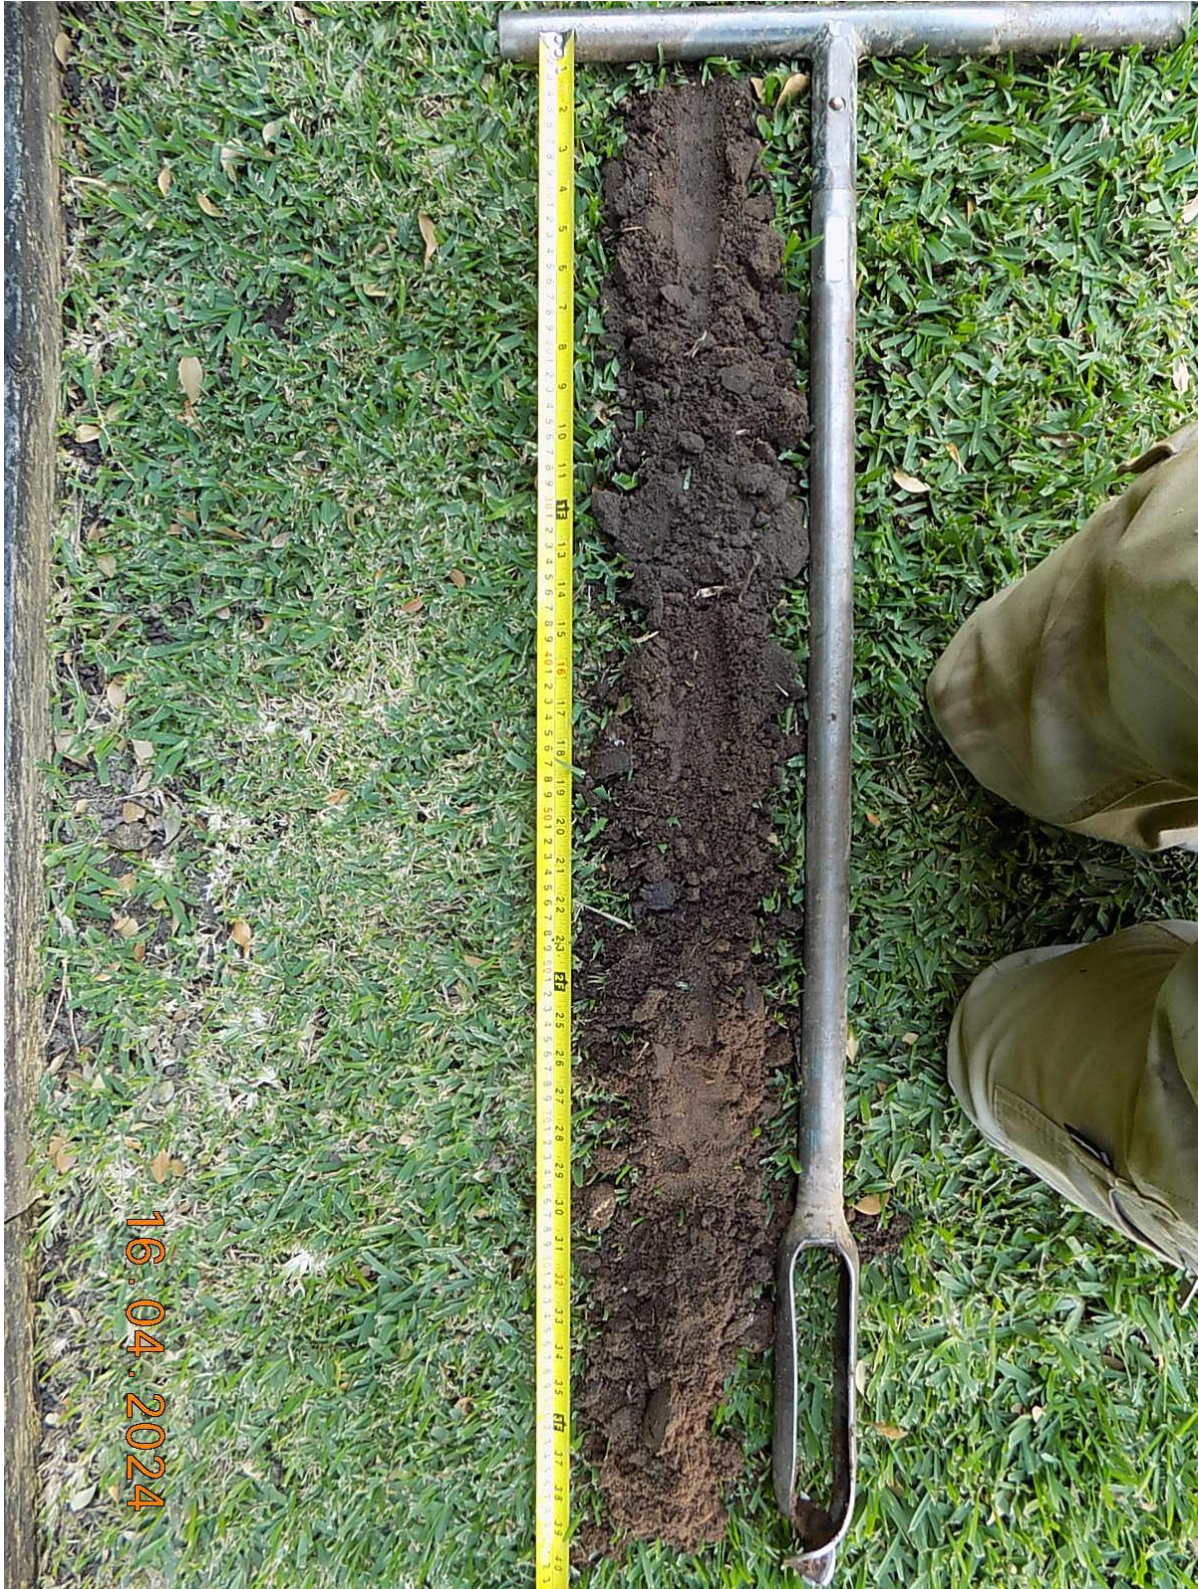
Photo 3: AH3 – Downhole is from top to bottom

AUGER HOLE 3 (~RL7.8) – AH3 (Photo 3)

Depth (m)	Material Encountered
0.0 to 0.6	SANDY FILL , dark brown, medium dense, dry, fine to coarse grained, rock fragments and fine organic material (roots) present.
0.6 to 1.0	LOAMY SAND , brown, medium dense, dry, medium grained, fine organic material (roots) present.

End of hole @ 1.0m in Loamy Sand. No water table encountered.

TEST: AH3	FIELD pH & PEROXIDE RESULTS				
Sample depth (m)	pH _F	30% Peroxide reaction	pH _{FOX}	pH _F - pH _{FOX}	SS=Shell J=Jarosite R=Roots
0.5	6.4	H	6.3	0.1	R
1.0	7.0	M	6.9	0.1	R

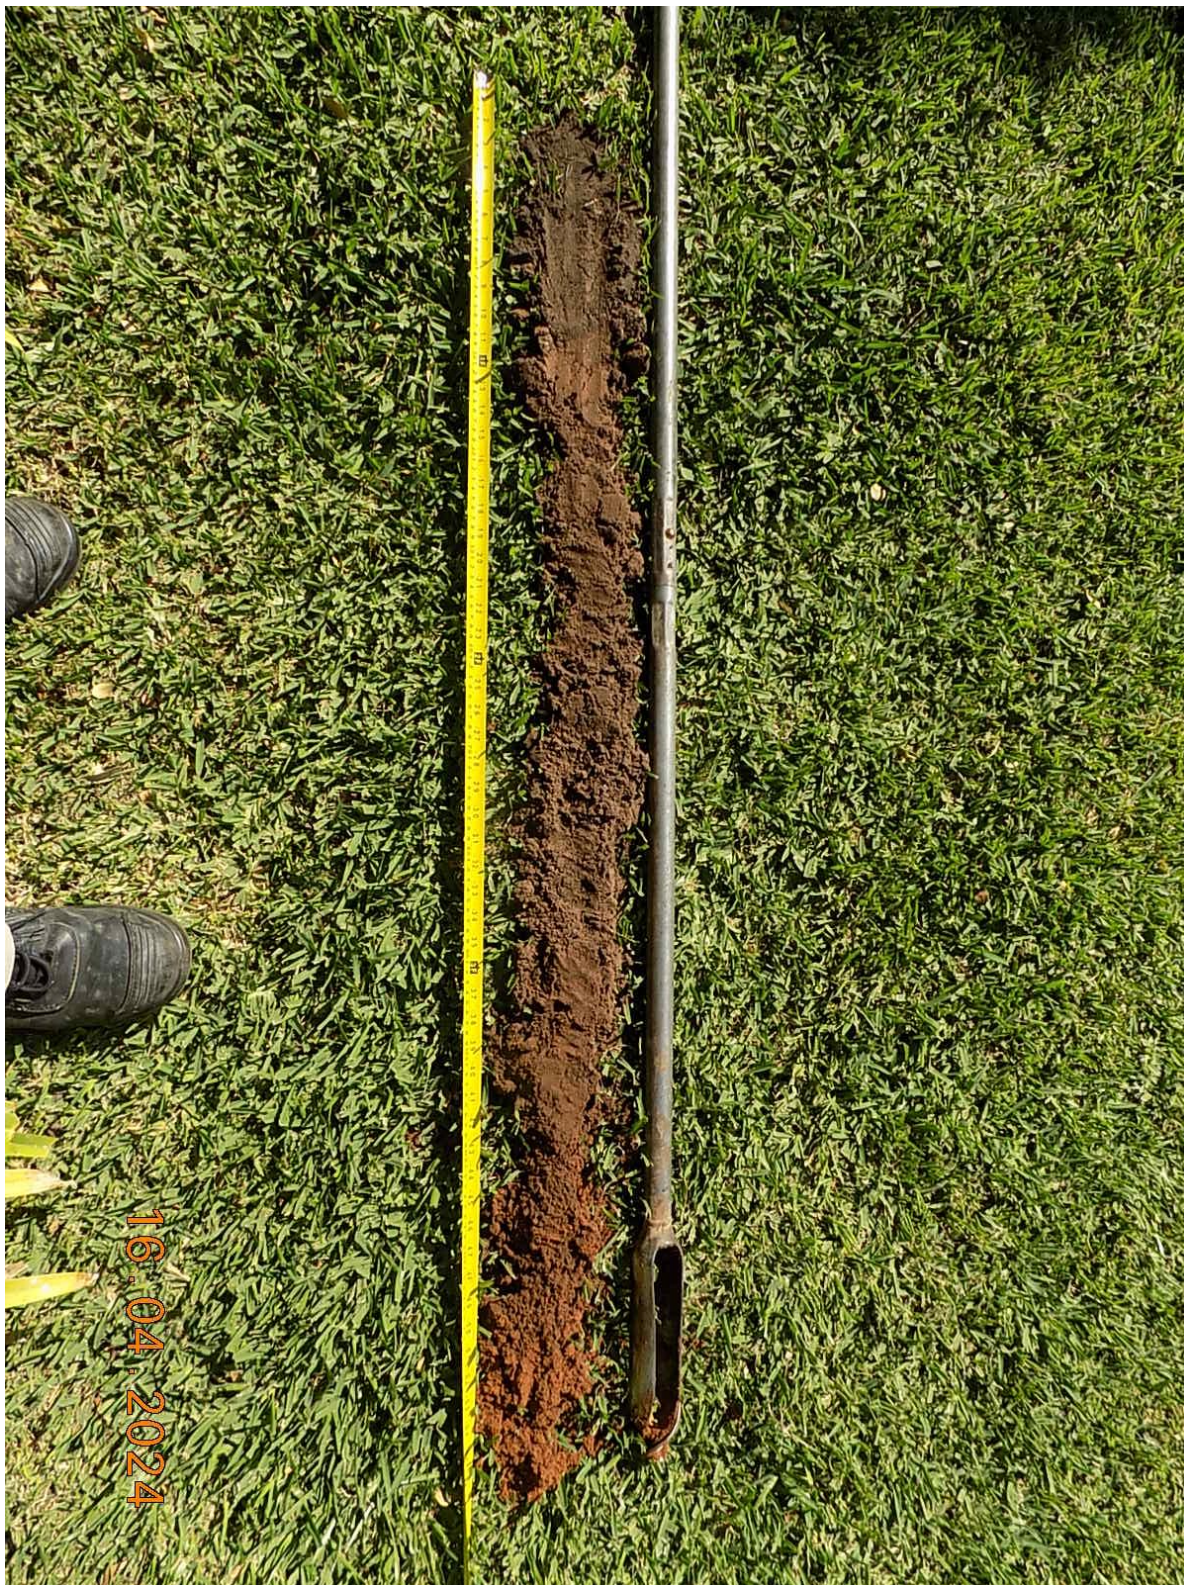
Photo 4: AH4 – Downhole is from top to bottom

AUGER HOLE 4 (~RL7.9) – AH4 (Photo 4)

Depth (m)	Material Encountered
0.0 to 0.3	SANDY FILL , dark brown, medium dense, dry, fine to coarse grained, rock fragments and fine organic material (roots) present.
0.3 to 1.0	LOAMY SAND , brown, medium dense, dry, medium grained, fine organic material (roots) present.
1.0 to 1.5	SAND , orange, orange brown, yellow brown, medium dense, dry to moist, medium grained.

End of hole @ 1.5m in Sand. No water table encountered.

TEST: AH4	FIELD pH & PEROXIDE RESULTS				
Sample depth (m)	pH _F	30% Peroxide reaction	pH _{FOX}	pH _F - pH _{FOX}	SS=Shell J=Jarosite R=Roots
0.2	7.2	M	7.2	0	R
0.7	7.3	M	7.3	0	-
1.2	7.4	M	7.4	0	-
