J4741. 13th January, 2023. Page 1.

GEOTECHNICAL INVESTIGATION:

New Garage and Alterations and Additions at 22 Loch Street, Freshwater

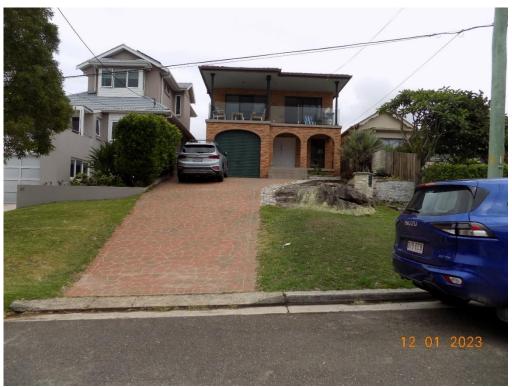
Photo 1

- 2.3 At the road frontage, a concrete driveway runs up the slope to a garage on the W side of the house (Photo 1). Medium Strength Sandstone was observed to be outcropping at the road frontage and steps up the slope (Photo 2). The two-storey brick house is supported on brick walls. Access to the foundation space of the house was not available at the time of inspection. However, the external walls of the house show no signs of significant cracking. A gently sloping lawn extends from the E side of the house to the E common boundary (Photo 3).

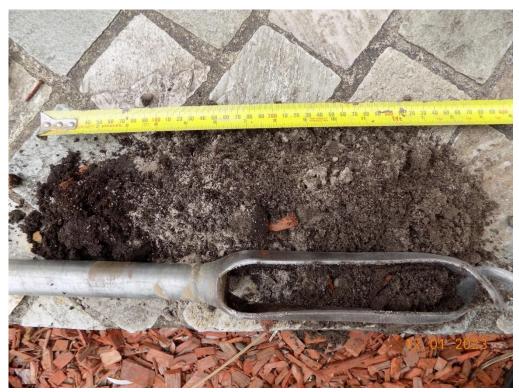
Photo 4 (AH1 - Downhole from Left to Right)

AUGER HOLE 1 (~RL49.4) – AH1 (Photo 4)

Depth (m)	Material Encountered
0.0 to 0.5	TOPSOIL, sandy soil, dark brown, medium dense, damp, fine to
	medium grained with fine trace organic matter.
0.1 to 0.4	SAND , grey-white & grey-brown, dense, dry, medium grained with fine
	trace organic matter.

Refusal @ 0.4m. Auger grinding on the rock surface. No water table encountered.
