Pacific Lodge 15-23 Fisher Road, Dee Why

Proposed Mixed Use Development Heritage Assessment

August 2018 **REF: 1816: HA** Issue 01

Tropman & Tropman Architects

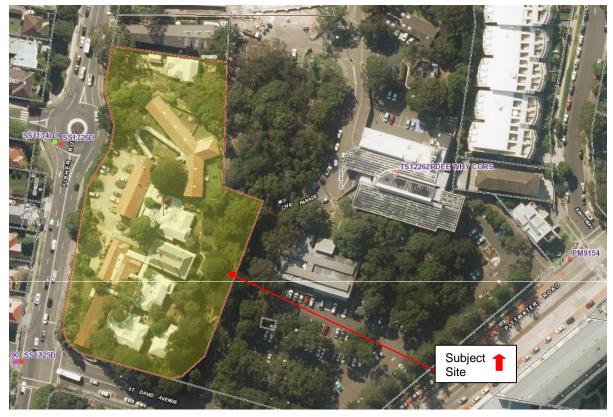
Figure 1 Pacific Lodge context, aerial image. Source SIX Maps

The subject site is located at 15-23 Fisher Road, Dee Why. The subject site is irregularly shaped and is bound on the north by an apartment complex and a large car park, on the east by Civic Parade, on the south by St David Avenue, and on the west by Fisher Road. Refer to Figures 1.

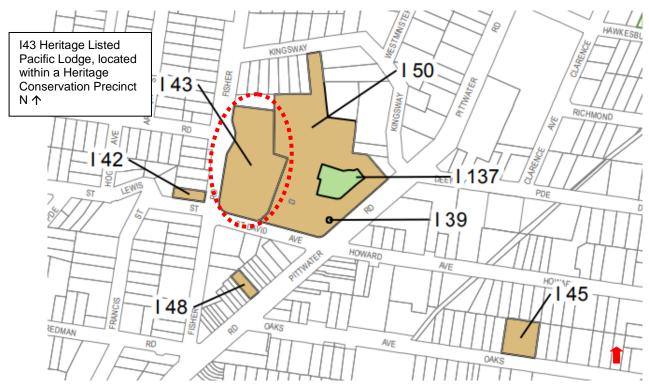
Figure 2: Warringah Council LEP 2011 (updated 30 June 2017) Map – Heritage Conservation showing heritage items and heritage conservation areas. Map id. no.: 1800 COM HOB 010AA 005 20160407

The subject site is listed as a local heritage item and is also located within a heritage conservation area. Other heritage items within the vicinity of the site include the Warringah Library to the east on Civic Parade, and the Fire Station on Fisher Road to the west.

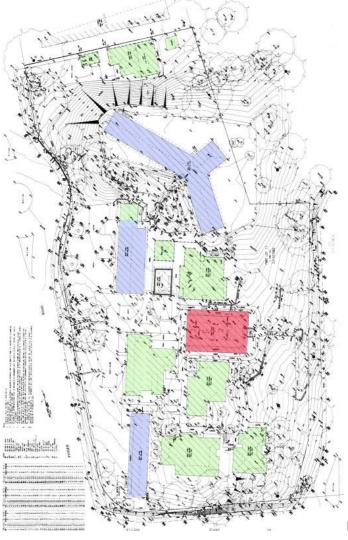
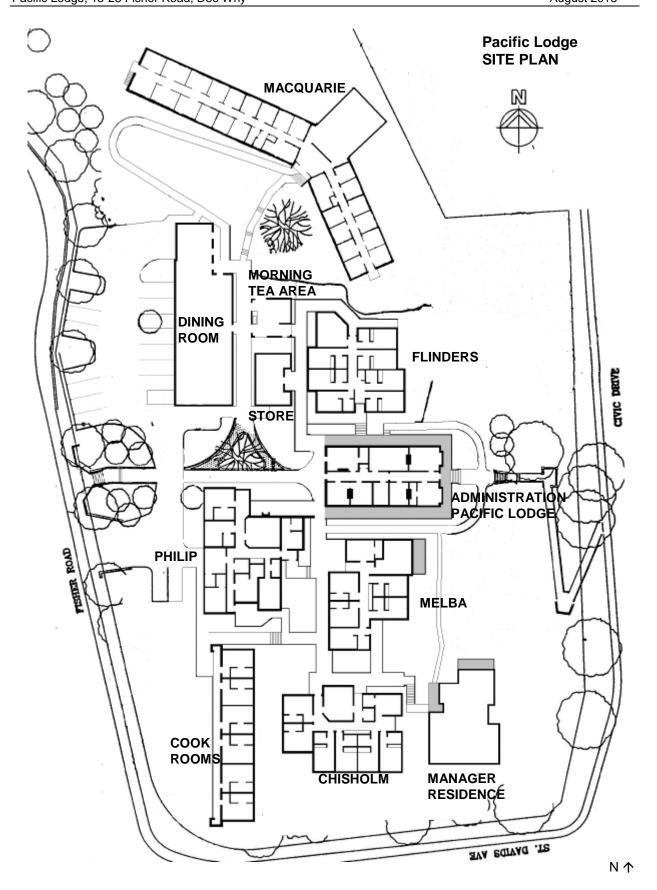
Figure 4: Site plan, Pacific Lodge.

The drawing below is a graphic summary of the ages of construction of the existing built features. The summary was prepared from documentary sources and not on-site physical inspection.

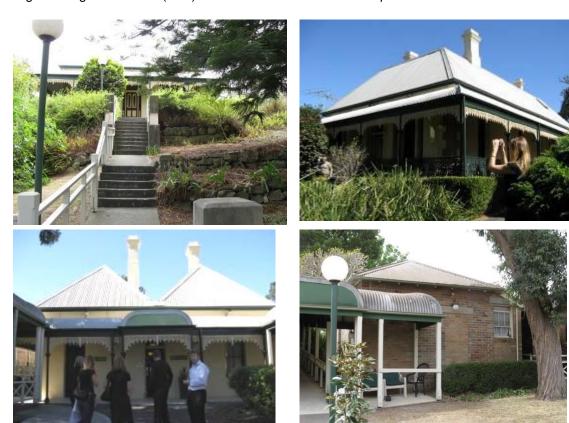
Figure 5: 1892 Pacific Lodge Administration & adjacent c1911 Store / Amenities building

The 1892 Pacific Lodge Administration is a single storey, substantial, elevated rendered masonry Victorian Filigree building. The front (east) façade presents with a steep hipped corrugated metal roof. The rear (west) elevation presents with a double hipped corrugated metal roof. The building has tall rendered decorative chimneys and a wrap around verandah with a corrugated metal bullnosed roof, and decorative iron lace work and balustrading with a Salvation Army Home of Rest insignia design. The front (east) elevation also has decorative quoins.

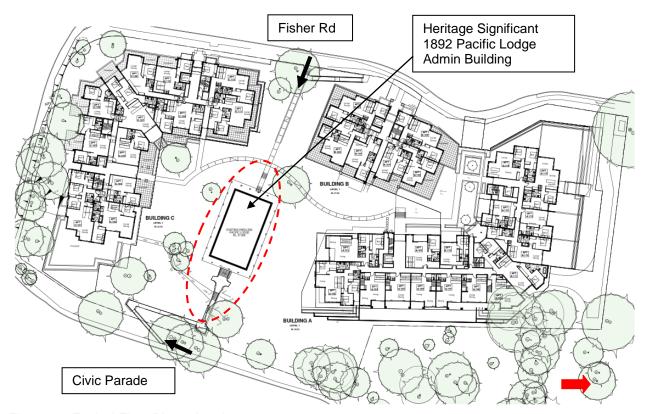
Figure 6a: Typical Floor Plan & Landscape

- Retention of 1892 Pacific Lodge Administration Building, including front and rear entry steps/ramp accessed off Civic Parade and off Fisher Road. Refer to Figures 6a, 6b and 6c;
- Demolition of all existing remaining buildings on the subject site;
- Construction of 130 No. apartments, Blocks A, B & C
- Construction of 191 No. of underground car parks over two levels accessed off Fisher Rd.
 Refer to Figures 6d.
- Construction of Commercial space -addressing Civic Parade. Refer to Figures 6d.

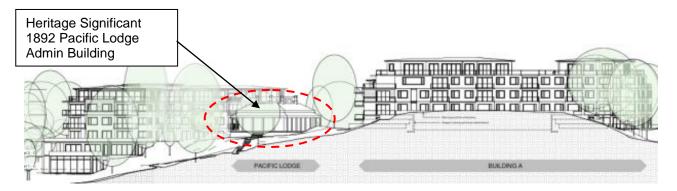
Figure 6b: Civic Parade Elevation

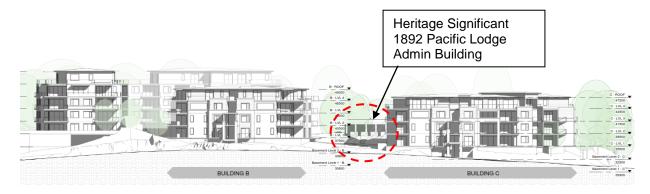
Figure 6c: Fisher Road Elevation

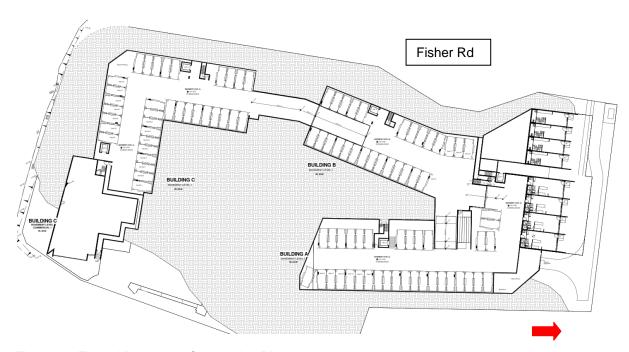
Figure 6d: Typical Basement Car parking Plan

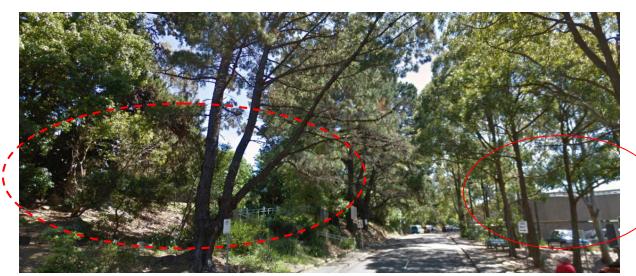
Figure 8: Civic Parade view indicating subject site on left and **I 50** (Dee Why Public Library) and **I 137** (Civic Centre Landscaping) on right.

The heights of proposed development building forms respect the adjoining Heritage Precinct. The impact of proposed development has minimal impact upon building setbacks and forms associated with the Warringah Council Heritage Conservation Zone which includes Items **I 50** & **I 137** as they are located below grade, well away from the subject site and screened by landscaping, refer to Figures 7, 8 and 9.;

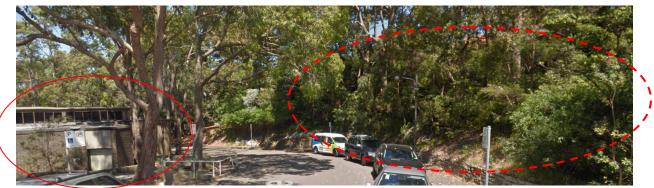
Figure 9: Civic Parade view indicating subject site on right and I 50 (Dee Why Public Library) and I 137 (Civic Centre Landscaping) on left.

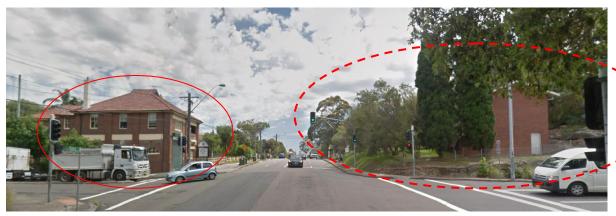
Figure 10: Fisher Road view indicating I 42 (fire station on left) and subject site (on right)

Similarly, Item I 42 is located below grade, opposite the subject site and potentially screened by landscaping, refer to Figures 10 and 11.

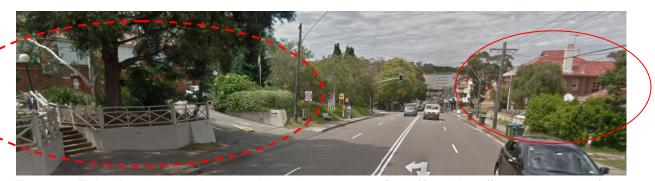
Figure 11: Fisher Road view indicating subject site entry steps (on left) and I 42 (fire station on right)

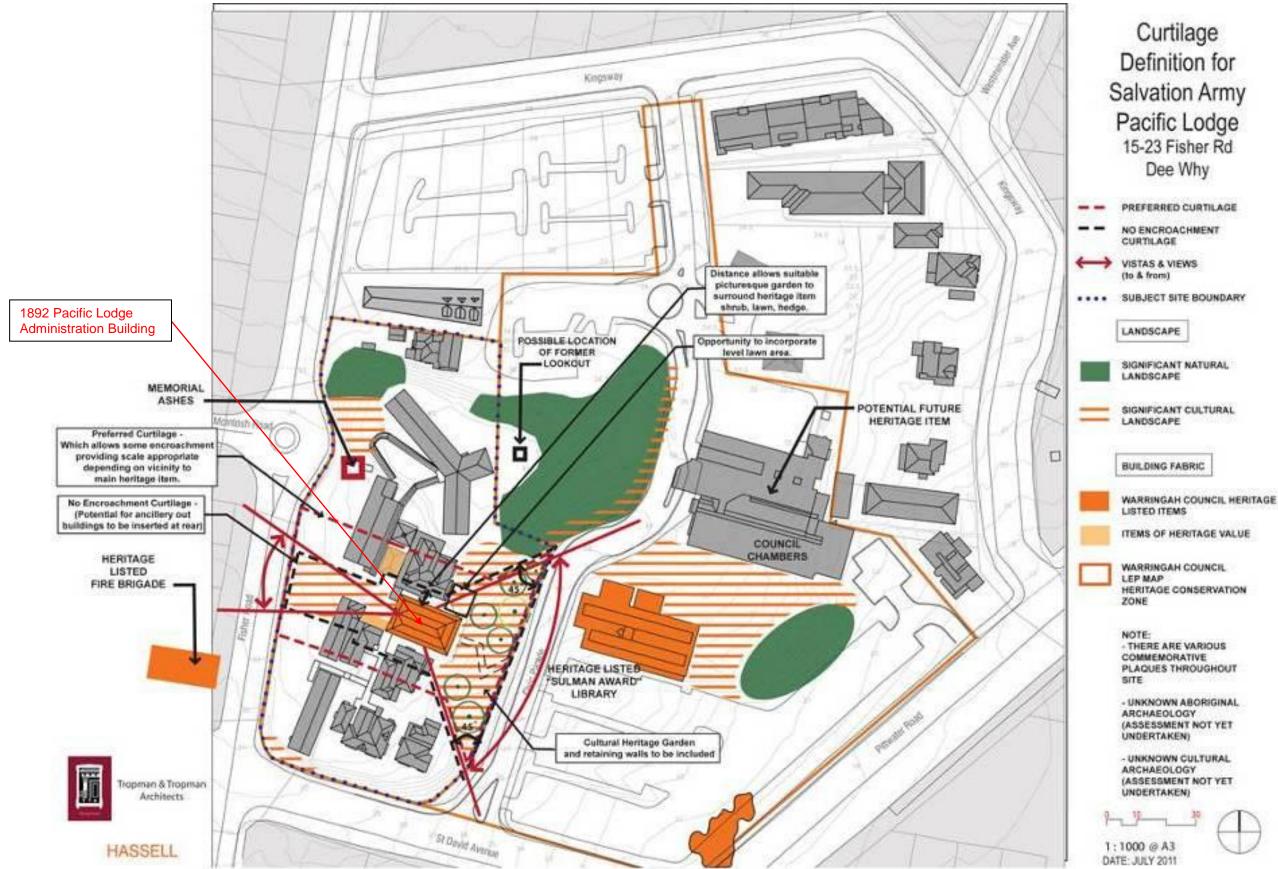
Figure 12: Curtilage definition of the subject site.

A preliminary heritage curtilage for the heritage significant building only has been defined to assist the design of potential future development opportunities. The curtilage takes into consideration landscape, both natural and cultural, vistas to and from the site, adjacent council heritage conservation zones. Refer to Figure 12.

The preliminary Immediate Curtilage identified in Figure 12, defines a zone which allows for a cultural landscape proportional to the scale of the subject building form. The original 1892 heritage significant Administration Building was a residential structure situated in the landscape with terraced gardens including an adjacent level lawn recreational area to the north that was possibly a croquet lawn, Figure 5a. Acknowledging that this cannot be recreated, and given the existing context, this curtilage is proposed as the most acceptable zone. This immediate curtilage is largely defined by the remaining original period garden which slopes down to Civic Parade and includes mature European trees and shrubs, terraces, garden walls, rock outcrops, a pathway and steps – identified in Figure 12.

2.	Setbacks:	a) 1892 Administration Building: Immediate Curtilage (i) Generally no building development permitted in Immediate Curtilage. Refer to Curtilage Definition – Fig.6	С	Generally appears to comply
		(ii) Immediate Curtilage: Minimum setback 14.0m from edge of existing north & south verandahs.	С	Generally appears to comply
		(iii) Low-rise development is permitted in Immediate Curtilage if building function supports use of 1892 Administration Building.	С	Generally appears to comply

b)	 1892 Administration Building: No Encroachment Curtilage: (i) No building development permitted in 'No Encroachment Curtilage'. Refer to Curtilage Definition - Fig. 6 and Conservation Policies. 	С	Generally appears to comply
