Acid Sulfate Soil Management Plan

316 Hudson Parade, Clareville

Report No: E25588.E14_Rev1

PROJECT
Replacement of Marine Structures
316 Hudson Parade
Clareville NSW 2107

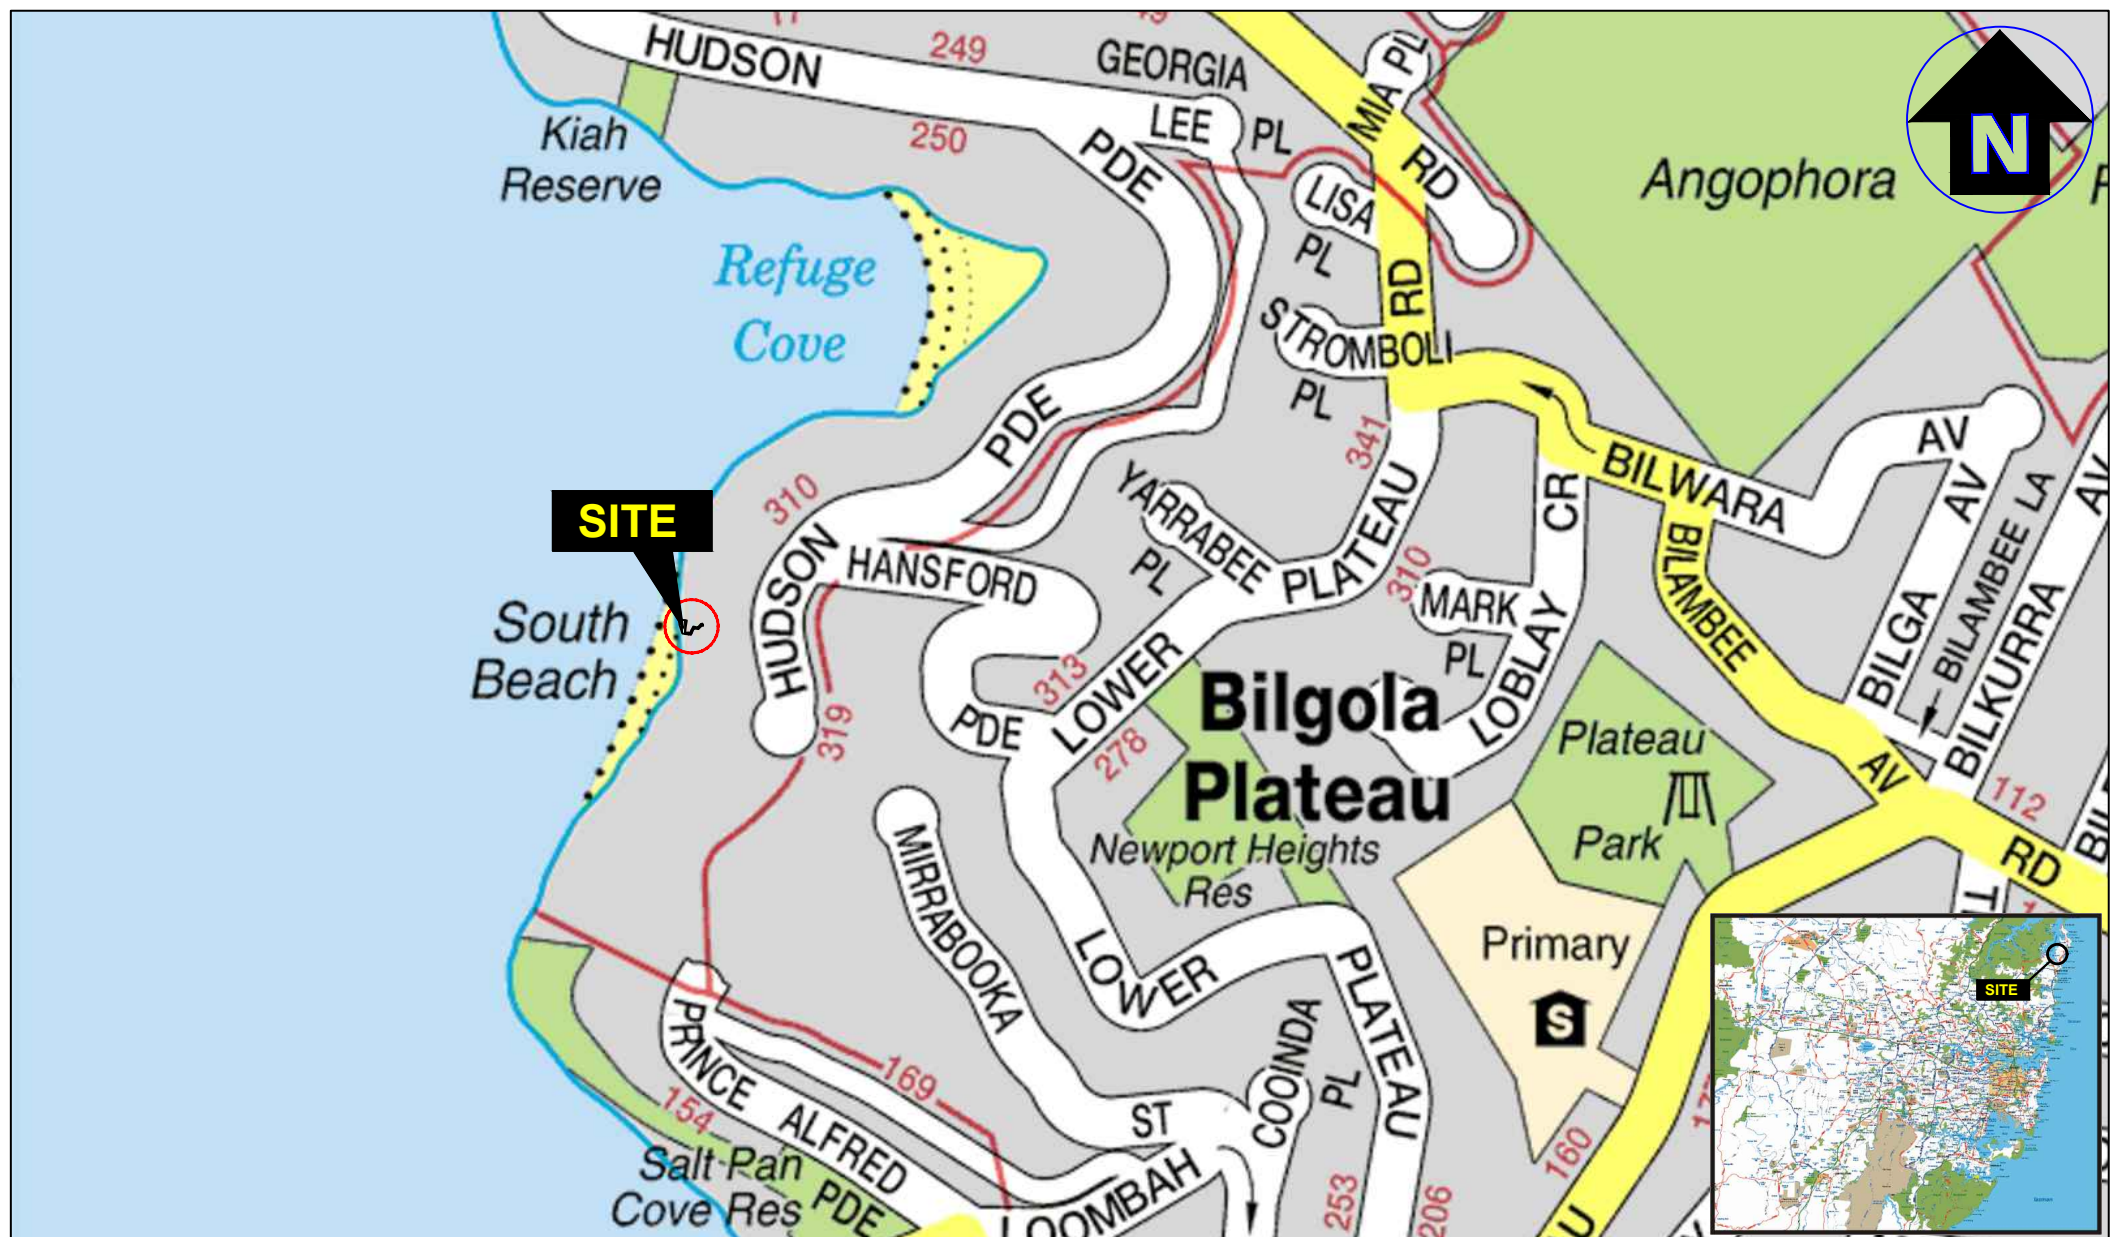
A.1 Figure 1 - Site Location

The site is located 26km north of the Sydney central business district (CBD), within the Local Government Area (LGA) of Northern Beaches Council, as shown in **Figure 1, Appendix A**. It is further identified as a portion of Lots 1 & 2, in Deposited Plan (DP) 827733 and it is understood that a portion of Crown Land (Pittwater), adjacent to Lot 2 (DP) 827733, is also part site covering an area of approximately 263 m². The existing structures and proposed redevelopment occupies a portion of the site, in particular an occupied single level shed, with a boat ramp and a timber jetty, as depicted in **Figure 2, Appendix A**.

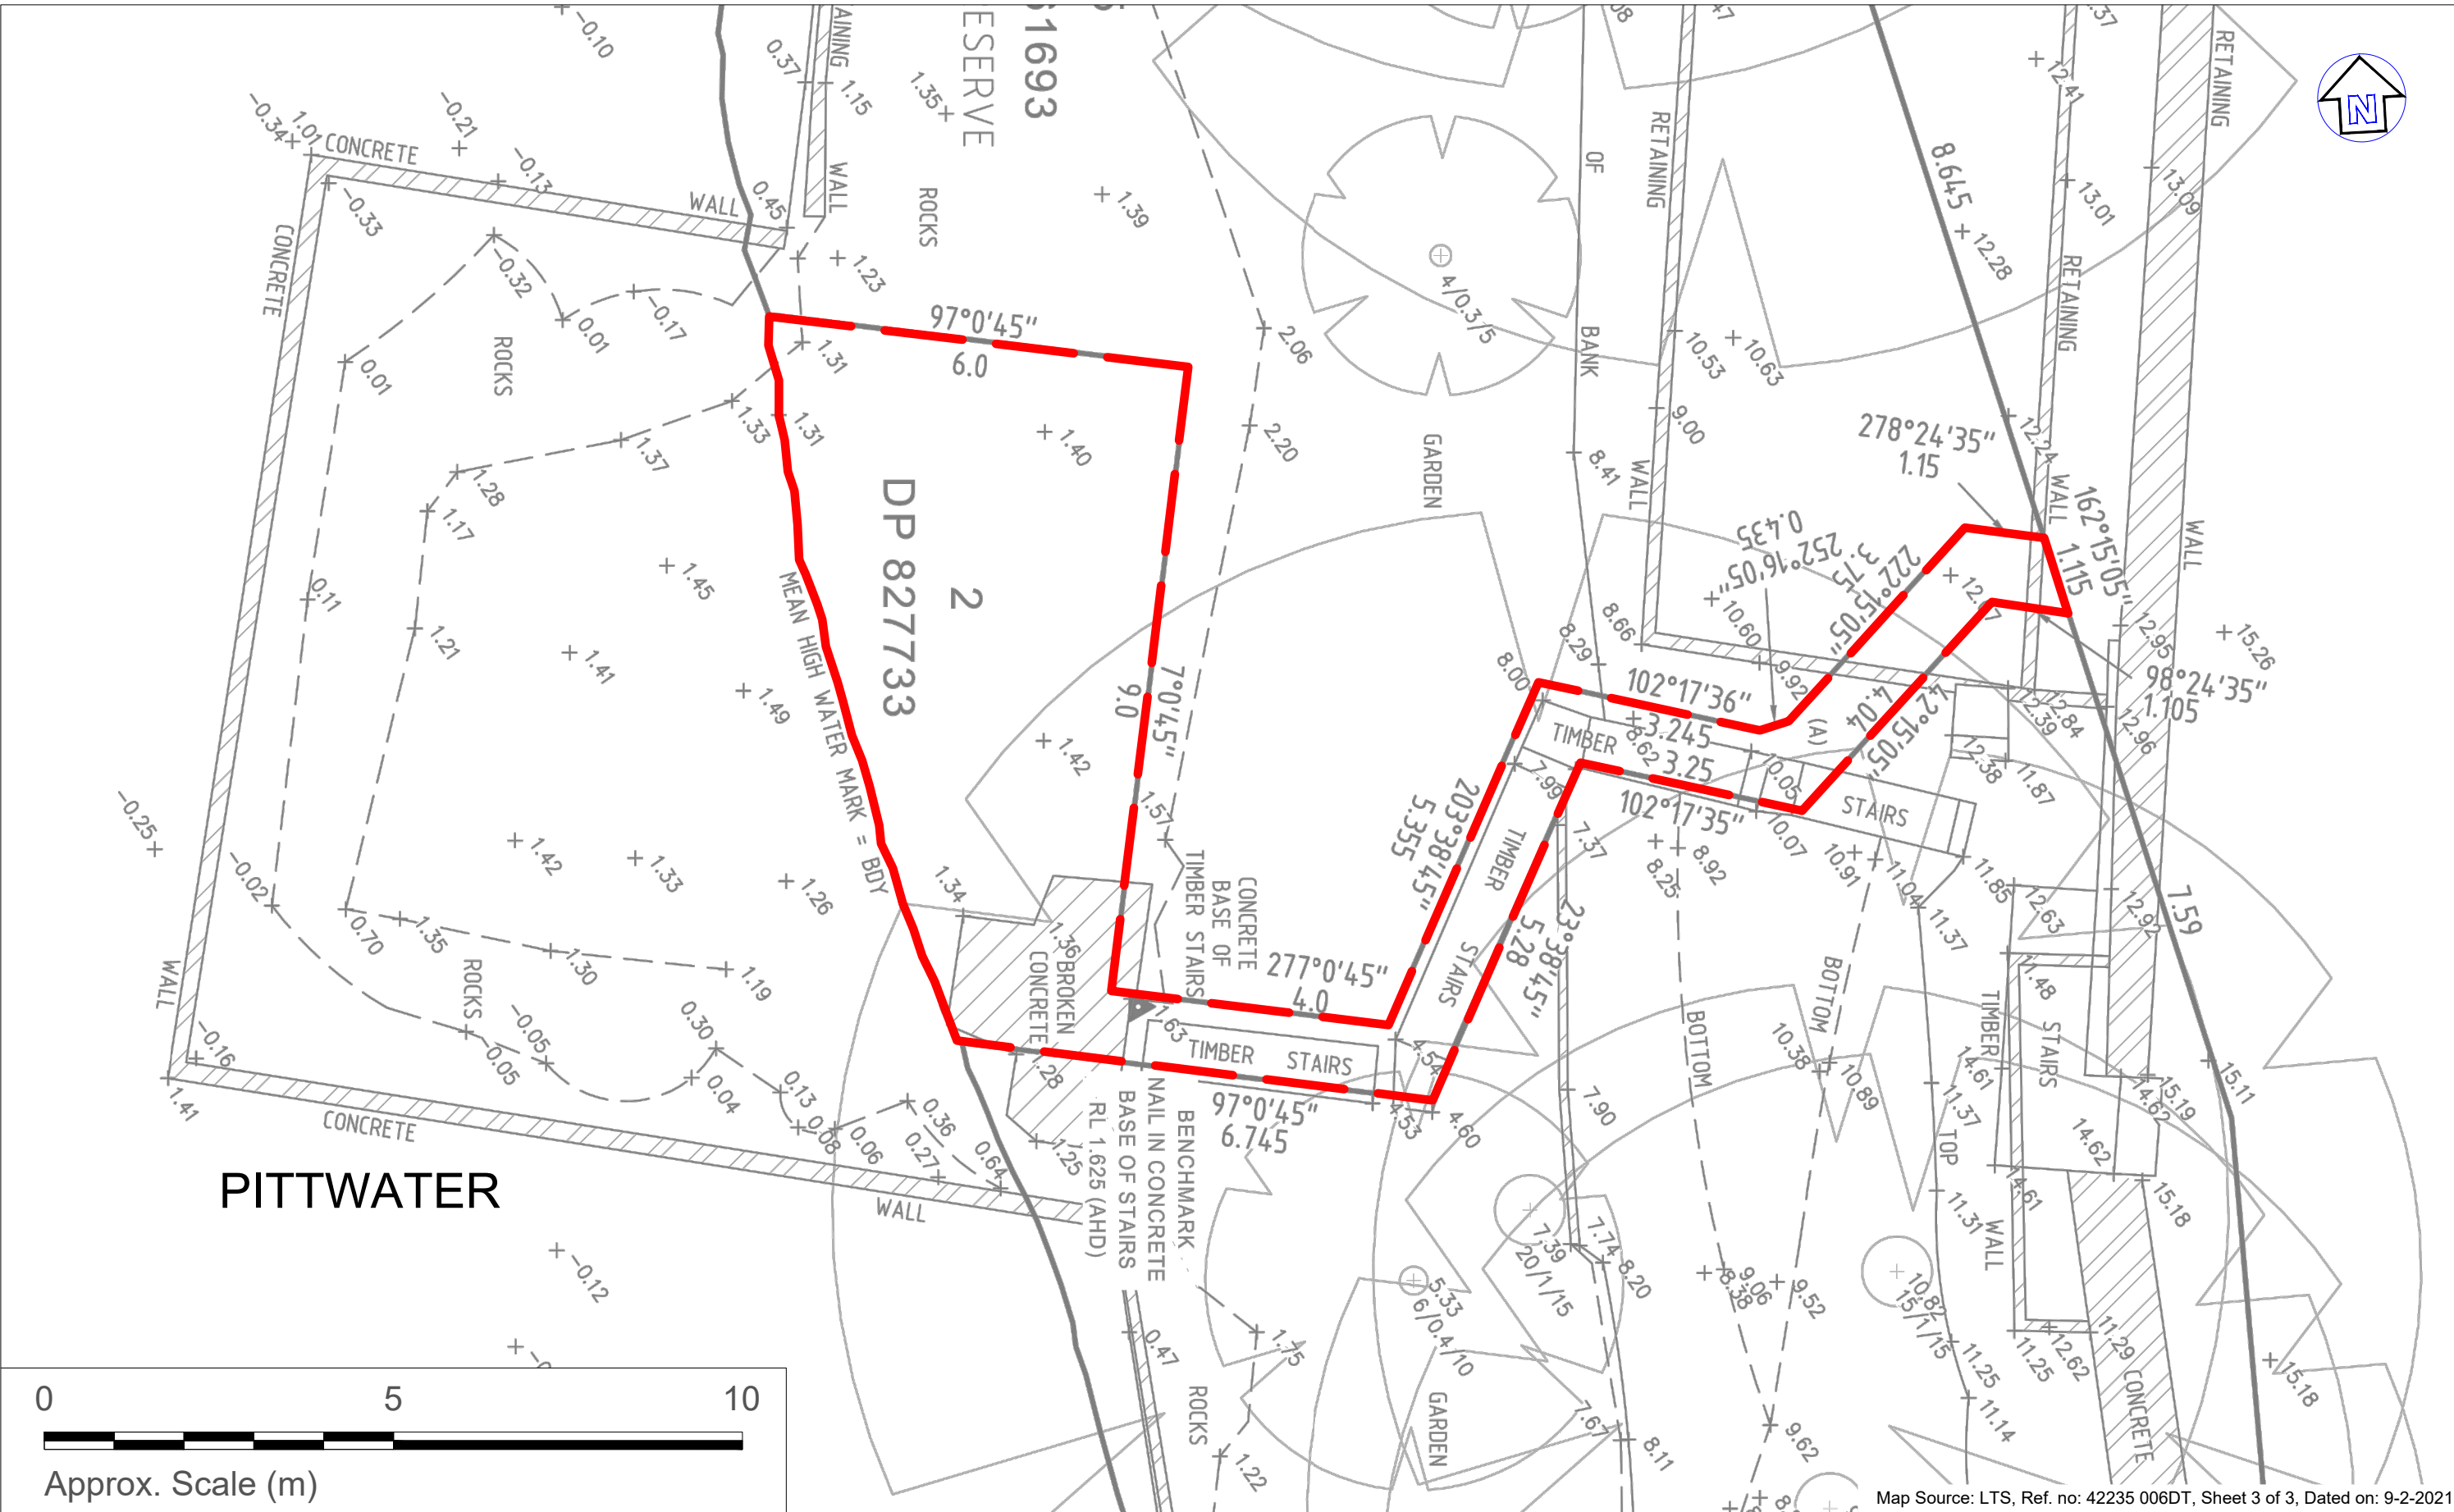
Figure:
2
Project: E25588.E14_Rev1

- Site boundary*
- *Portion of Crown Land in Pittwater detailed in Appendix B - Proposed Development Plan

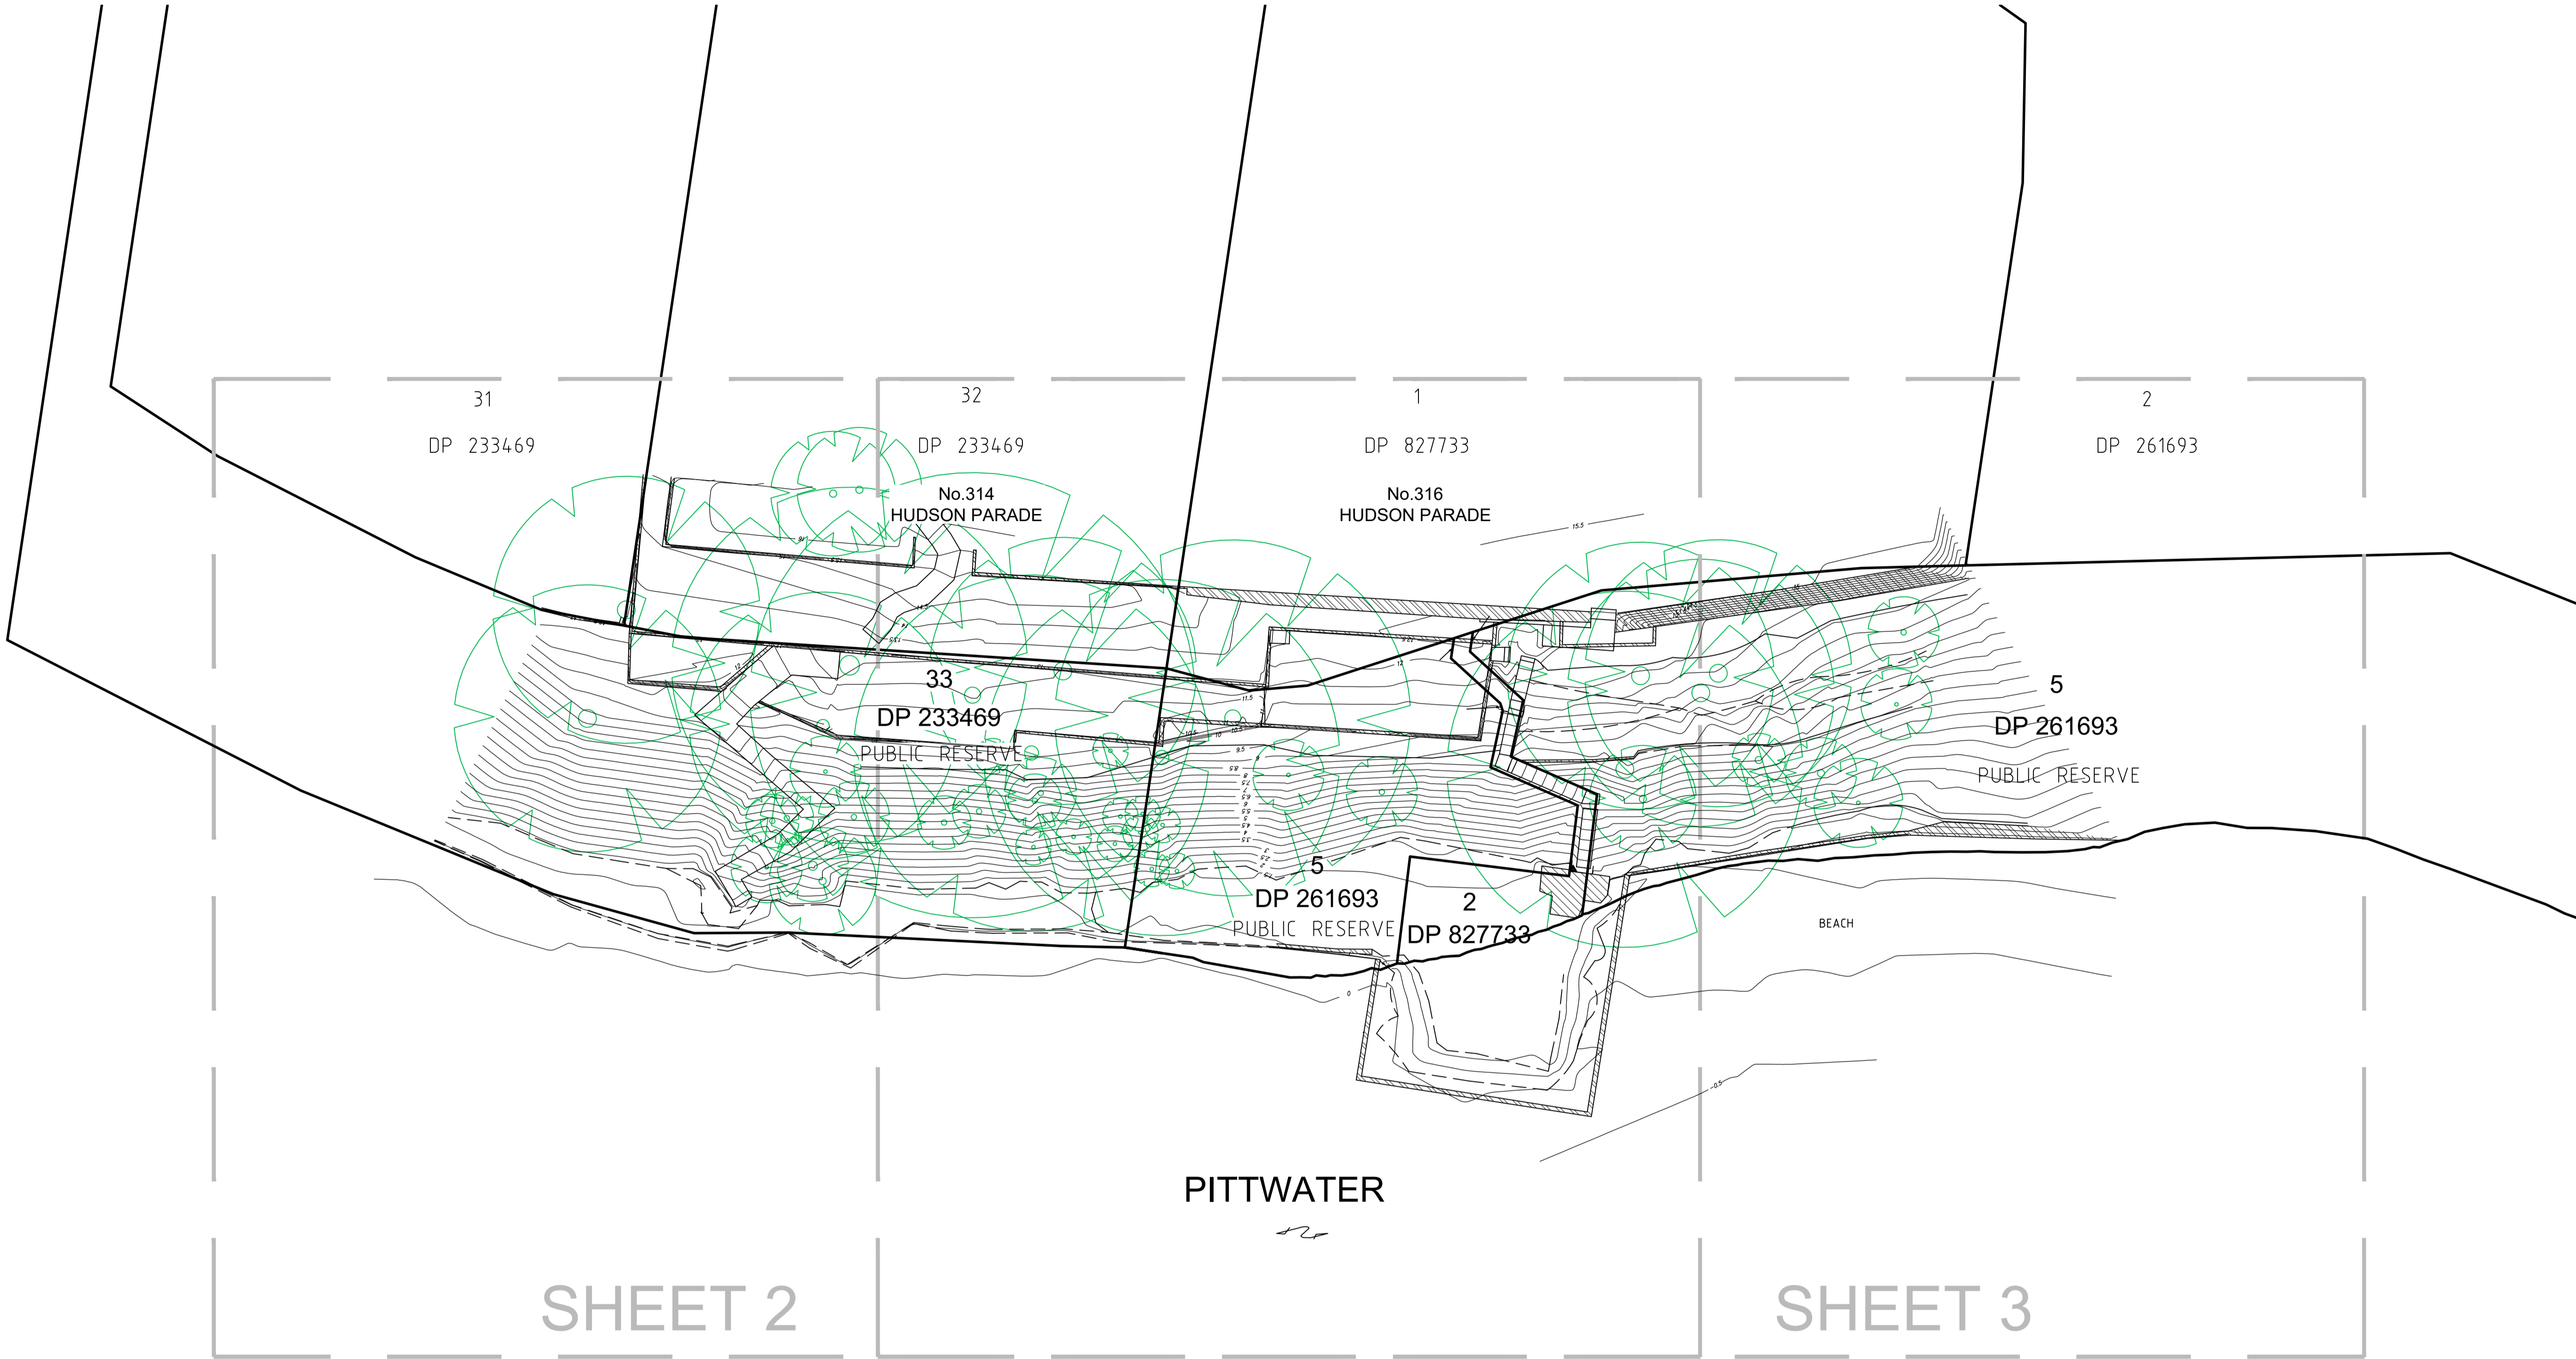
Client TONY WALLS
Drawing title
PLAN OF DETAIL AND LEVELS OVER PART OF LOTS 32 & 33
IN DP 233469, LOT 5 IN DP 261693 AND LOTS 1 & 2 IN
DP 827733 AT No 314-316 HUDSON PARADE, CLAREVILLE

datum
AHD
site Area
N/A
LGA
NORTHERN BEACHES
reference number
42235 006DT
scale
1:100
date of survey
13/08/2020
SHEET
3
2

According to the sites survey plan (Refer to **Appendix B**), the following attributes were found to be present:

- The site drops down steeply to the Pittwater Bay direction through a series of relatively low height but closely spaced sandstone cliff lines;
- Plants noted along the cliff included small to large trees and shrubs. The diversity of vegetation indicated that phytotoxicity was not a concern for site soils;
- The site is south of Refuge Cove and north of south Beach.
- The site connects to the property at lot 1 DP827733 via existing timber stairs within the cliff.
- Retaining wall also found to be present between the site and the neighbouring property at lot 1 DP827733.
- Concrete wall located west of the mean high water mark.

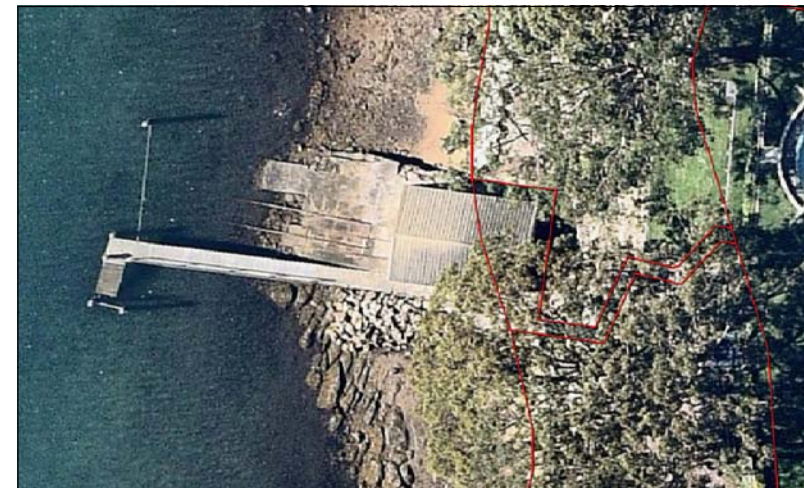
Approximate position of _____
retention wall (blue) - refer to
Figure 1
