Combined Preliminary and Detailed Site Investigation

Green Renovation Works
Bayview Golf Course, Bayview, NSW

Final Report

P2309440JR04V01
September 2023
Prepared For Bayview Golf Club

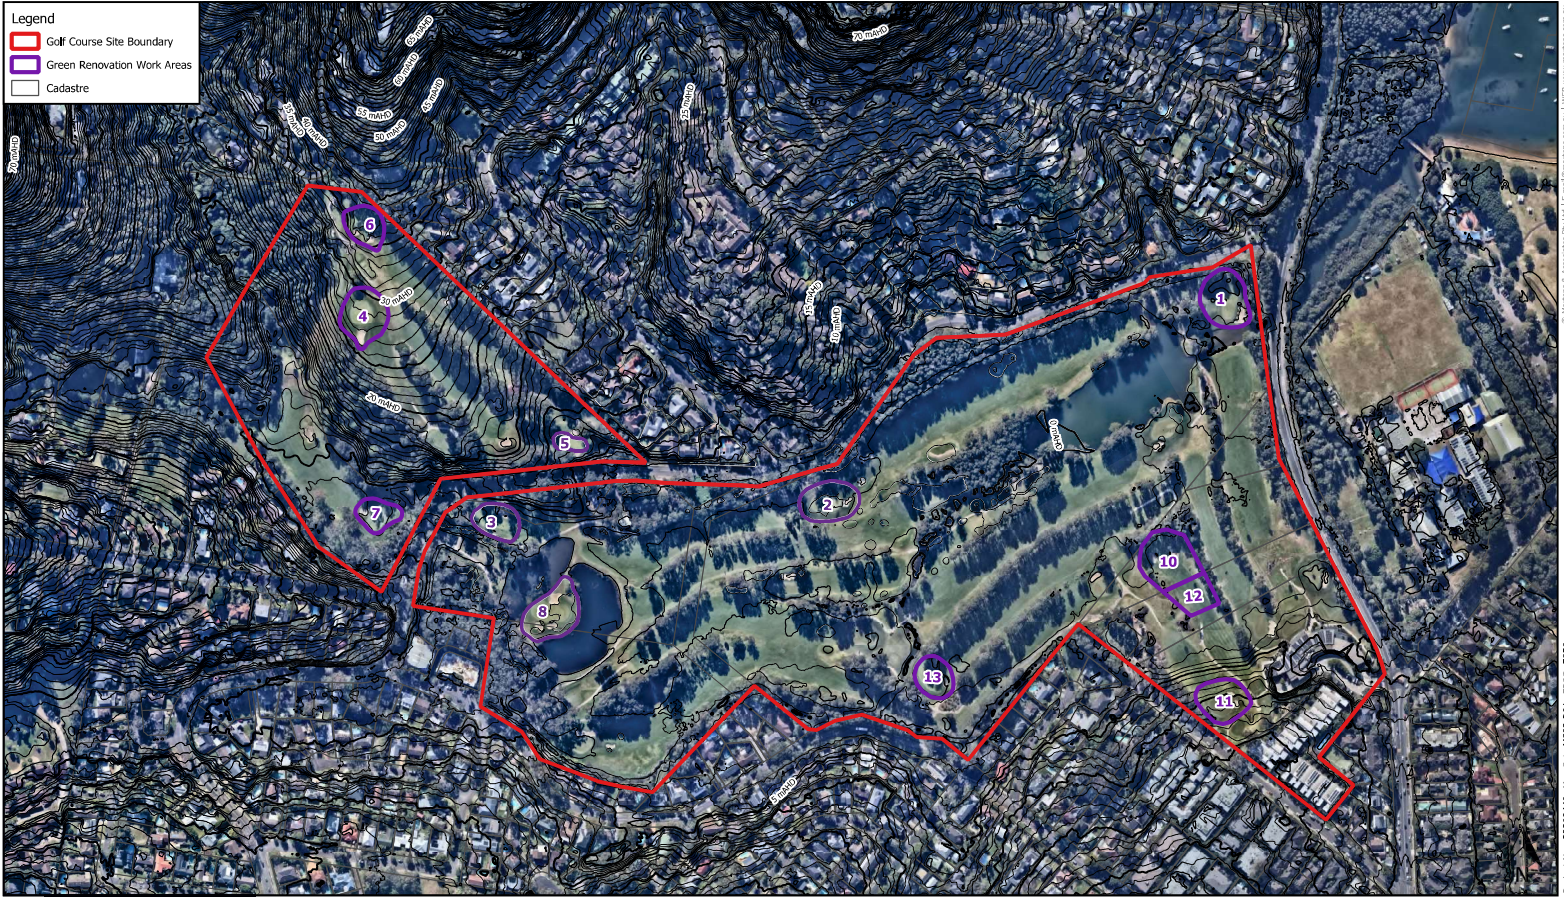
Map Title / Figure:
Proposed Green Renovation Work Area

- Golf Course Site Boundary
- Green Renovation Work Areas
- Cadastral

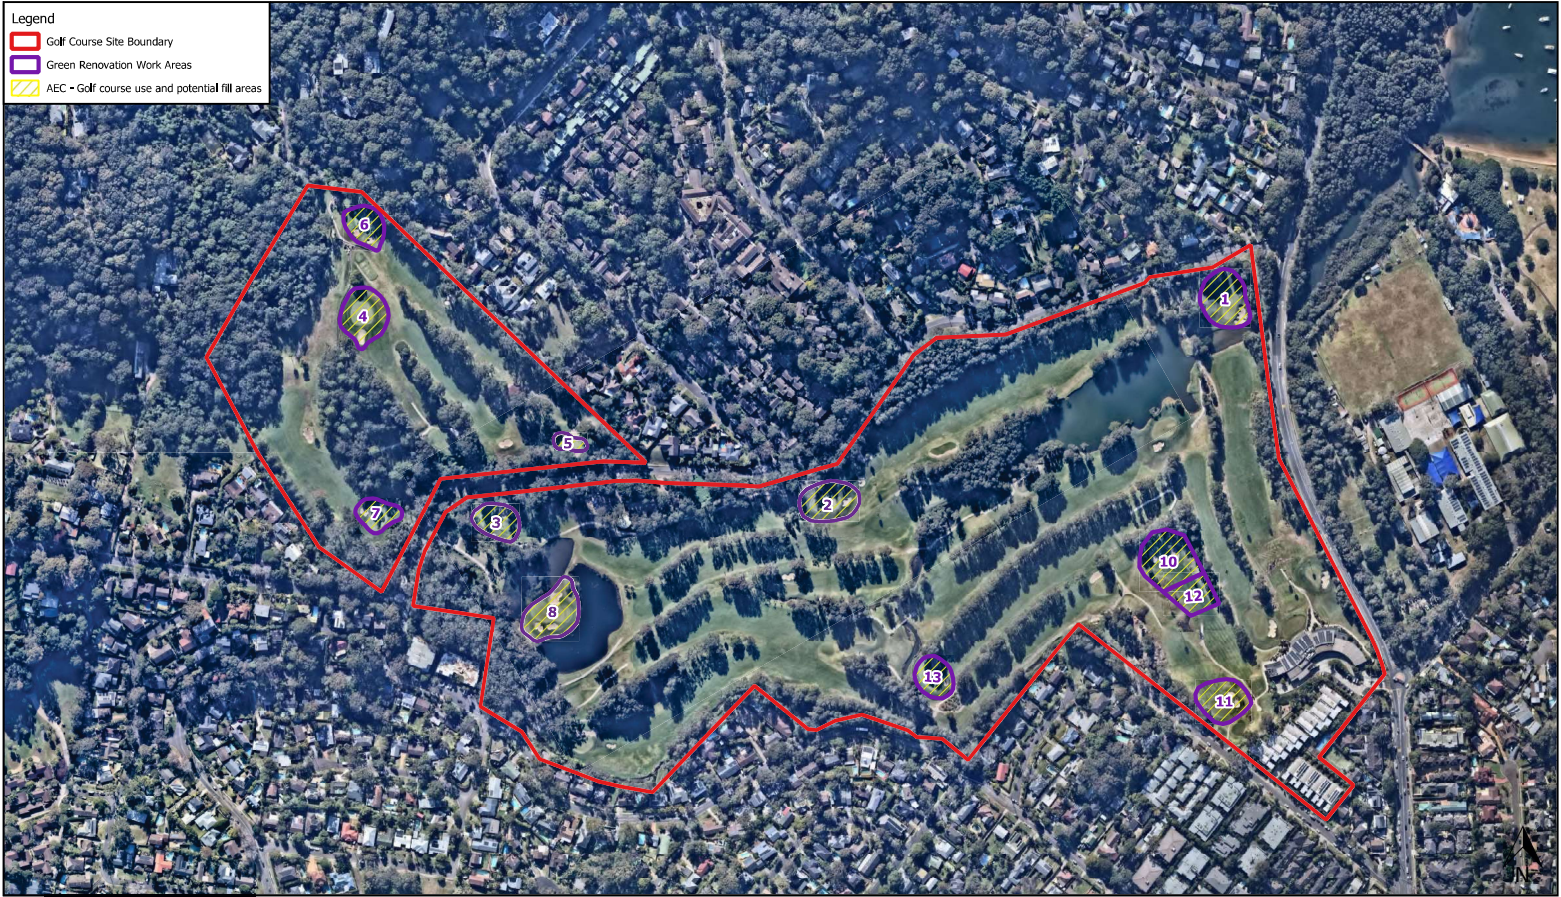
IA walkover did not identify any surficial forms (i.e. soil staining or odour) of contamination. Council records indicate that Bayview Golf Course underwent earthworks during the 90s which are considered potential sources of contamination.

Green Renovation Work Areas

AEC - Golf course use and potential fill areas

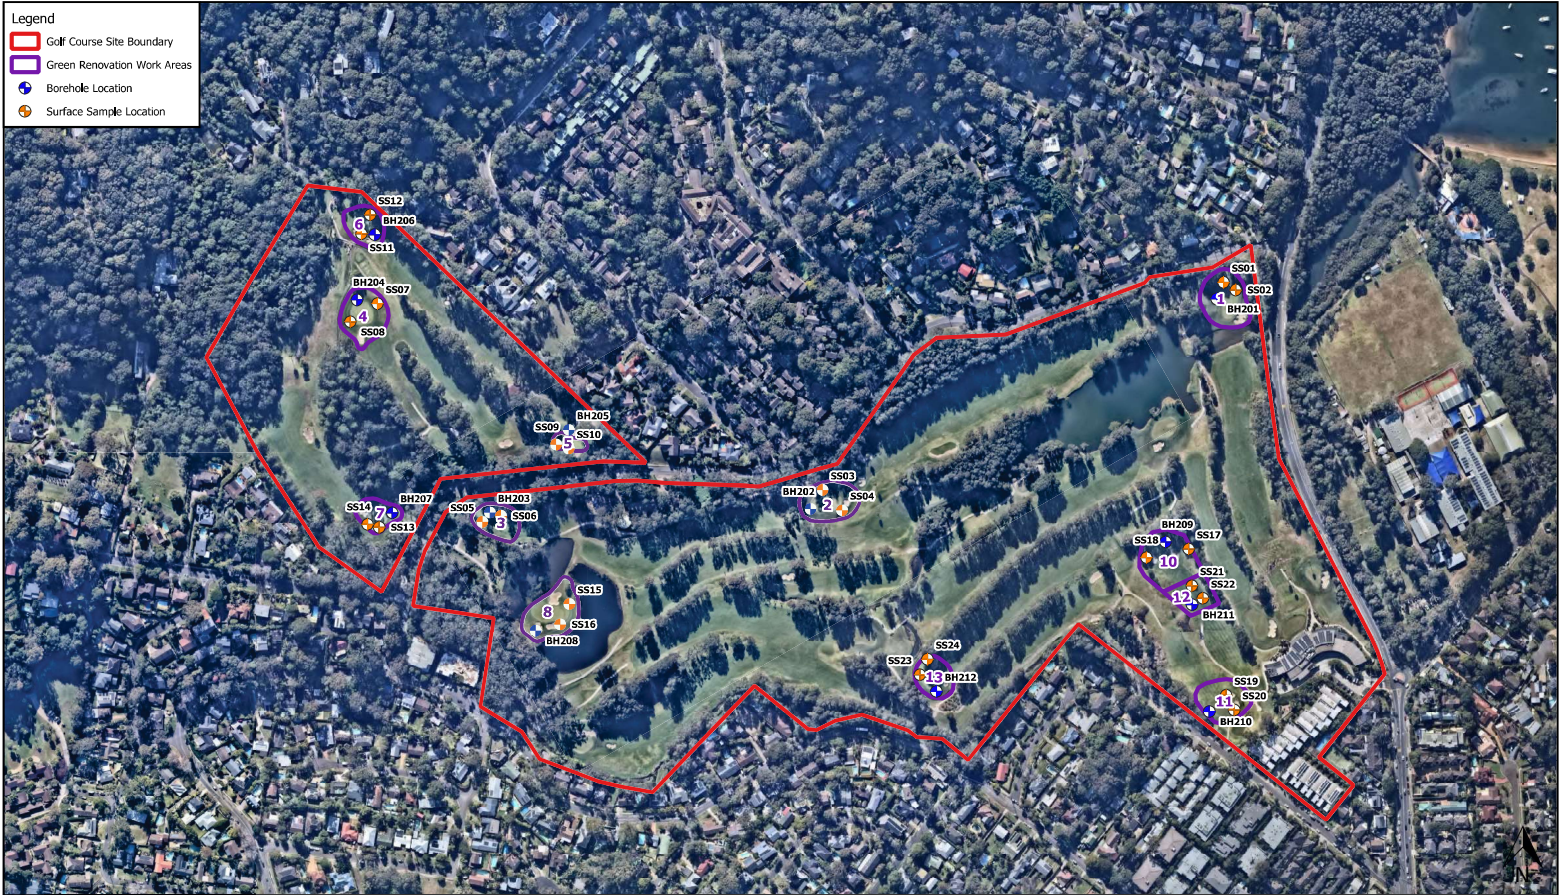
Borehole soil sampling was performed at each sampling location utilising an electric auger. Soils observations from each sampling location indicated that fill consisting of silty and / or clayey sand was observed up to 1.0 mbgl, with alluvium and / or residual soil consisting of sandy and / or silty clay underlying fill material to a maximum target depth of 1.2 mbgl.

- Golf Course Site Boundary
- Green Renovation Work Areas
- Borehole Location
- Surface Sample Location

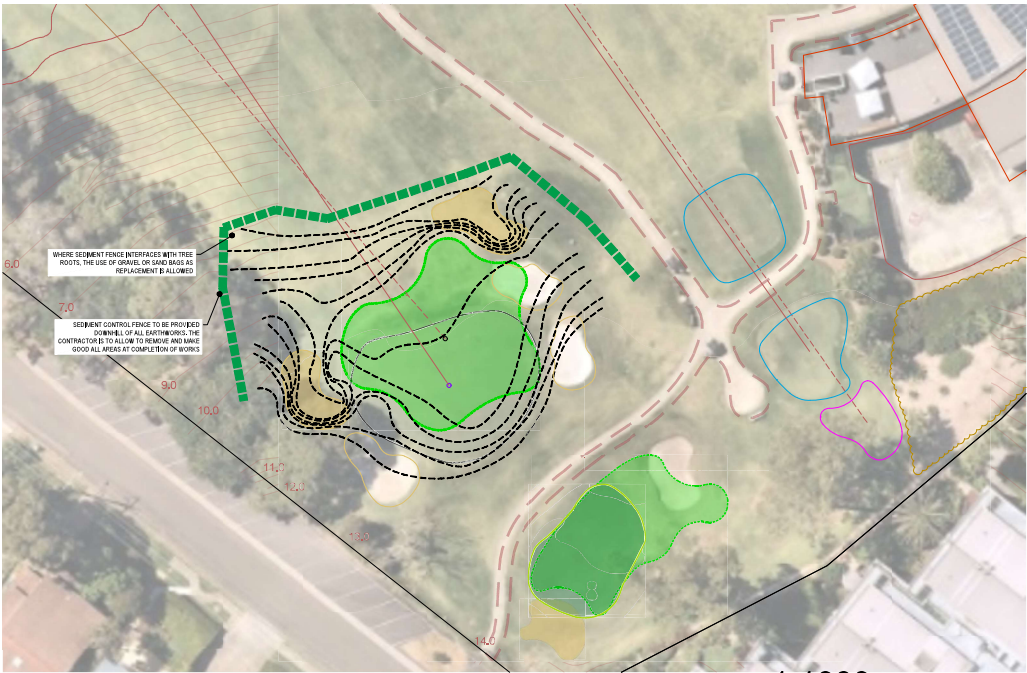
SEDIMENT AND EROSION CONTROL MANAGEMENT
CUSTOMER BAYVIEW GOLF CLUB
PROJECT 10 TH GREEN DETAIL PLAN
DATE FOR REVIEW 23/003
SCALE @ A1 1:250
SHEET No C119
REV A

CUT AND FILL VOLUMES

Assessment Surfaces	Volumes m3	Hole													TOTAL m3
		1st	2nd	3rd	4th	5th	6th	7th	8th	10th	11th	12th	13th		
Final Surface v	Cut	0	-10	-10	-426	-2	-454	-8	-17	0	-517	0	0	-1444	
	Fill	291	72	87	0	105	0	87	21	233	3	290	188	1377	
Existing Surface	Balance	291	62	77	-426	103	-454	79	4	233	-514	290	188	-57

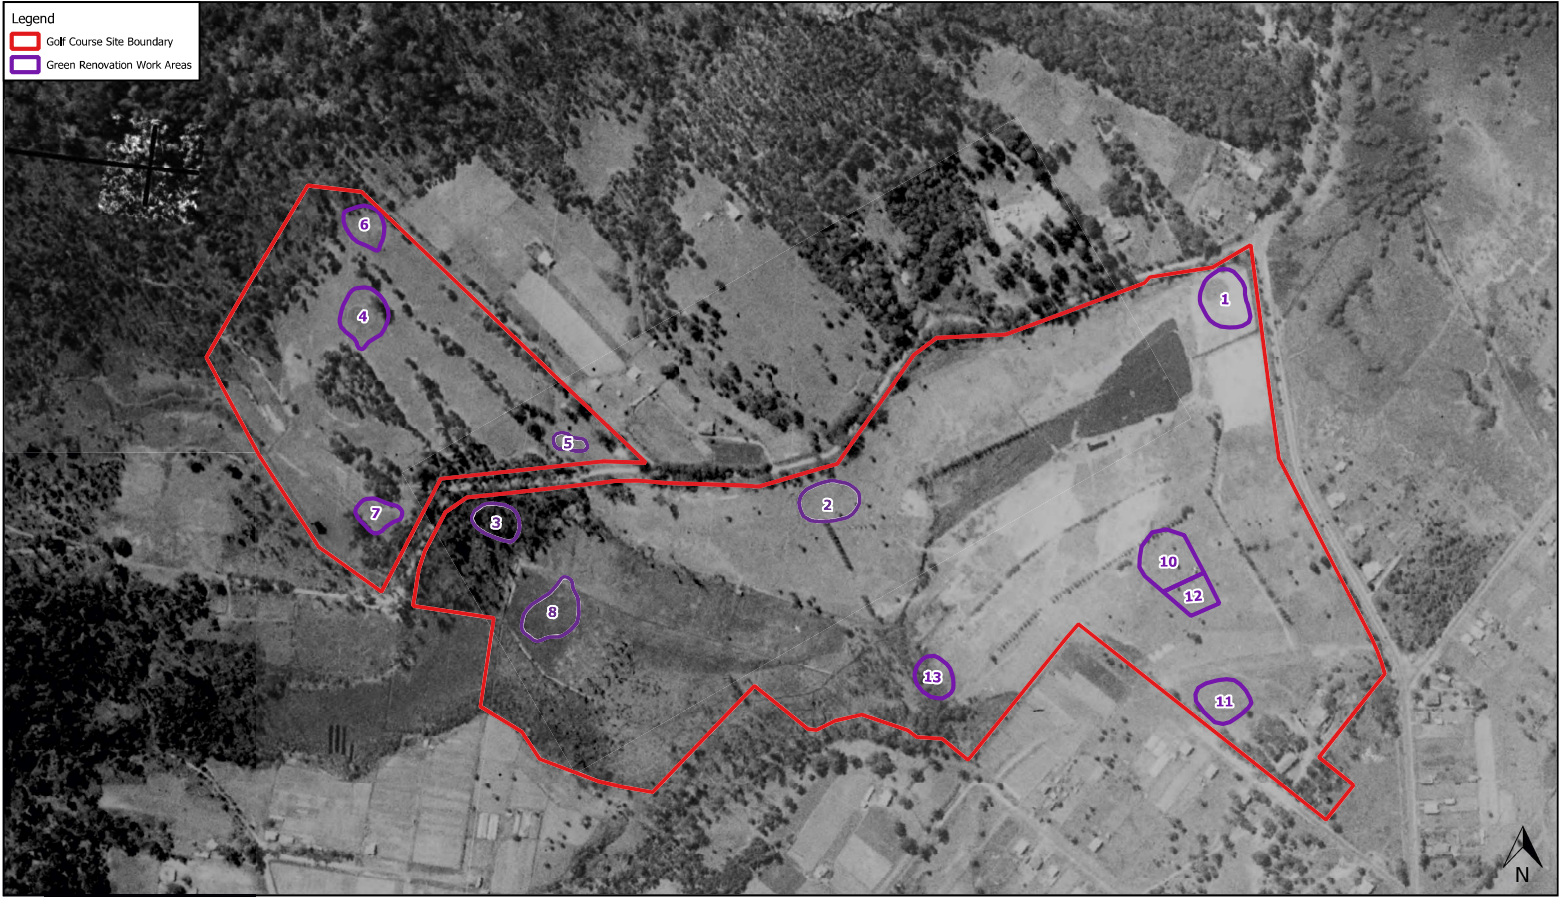
Year	Golf Course and IA Observations	Observation on Surrounding Land
1940 ¹	Much of the golf course land is grassed area with line of trees dividing fairways for golf course use. Existing dam and former structures observed at the eastern and south eastern portion of the golf course, respectively.	Areas to the north and east remain vegetated and undeveloped. Much of the land to the south west is cultivated and occupied by orchards, with some horticultural activities. Low density residential dwellings in all directions except to the east.
1951 ¹	Some existing greens (1, 2, 4 and 13) were constructed within the IA.	Increased horticultural activities to the north and south west of the golf course. Increased residential structures to the south east.
1961 ¹	Some clearing and replanting of trees at the central portion for the construction of all of the remaining greens, apart for the 3 rd green, at central and western portion of the golf course.	Further increase in horticultural activities to the north, south west and south of the golf course. Further increase in residential structures to the south and south east.

1:4000 @ A3
 Viewport A
 Notes:
 - Aerial from Foundation Spatial Data - ICSM (1940)
