ARBORICULTURAL IMPACT ASSESSMENT

50 CONDOVER ST, NORTH BALGOWLAH 2093

28/09/2019

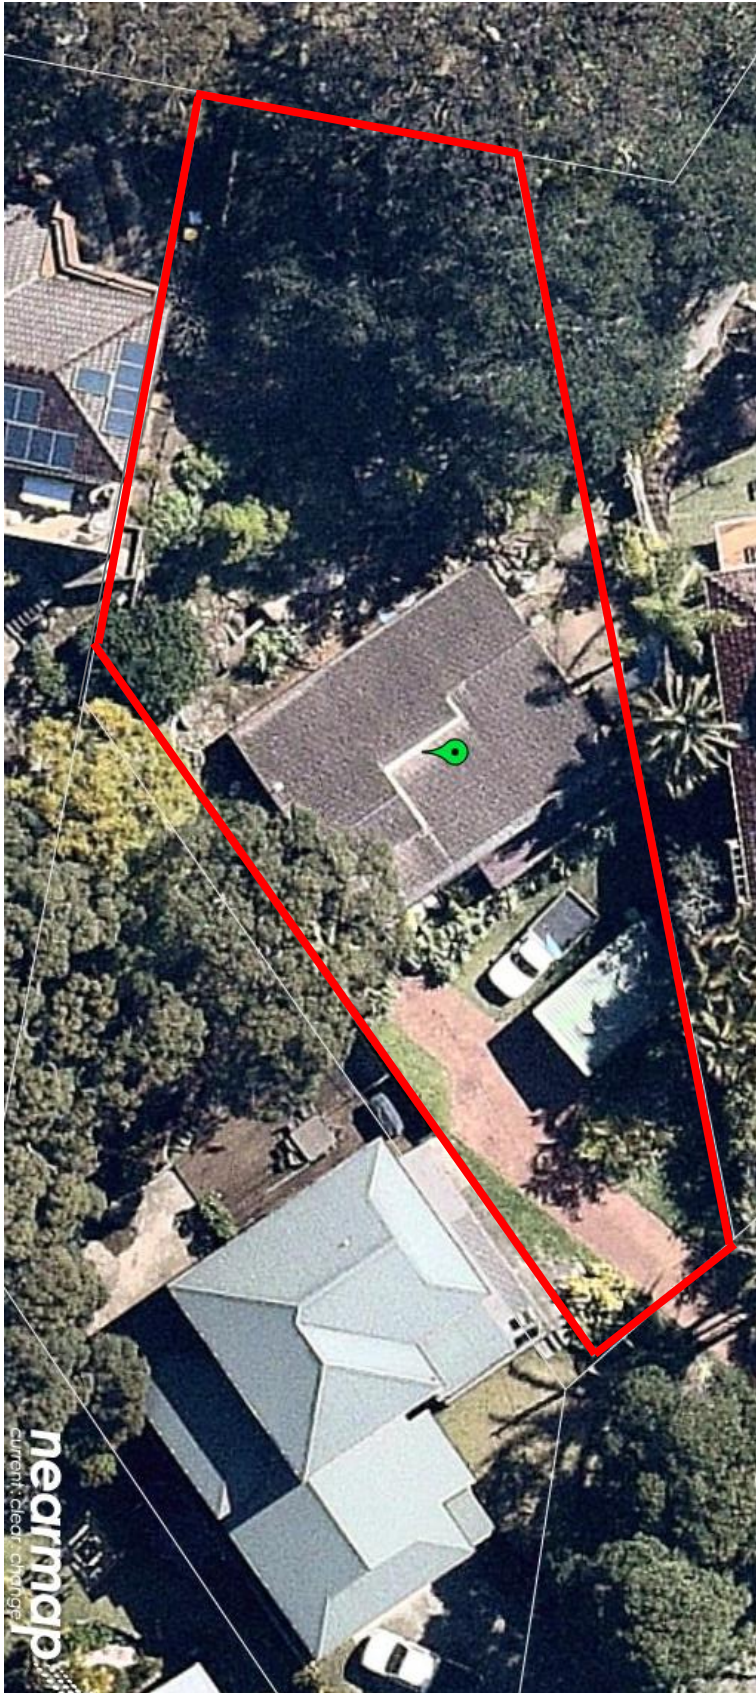
Figure 1: The subject site outlined in red (*nearmap 2019*).
