Aquatic Ecology Report

Boat House, Palm Beach

59916081 – Private and Confidential

30 August 2021

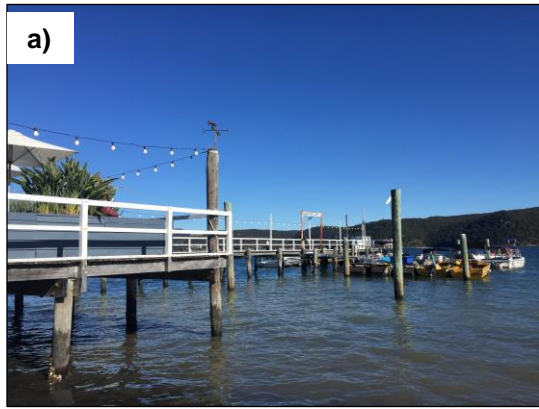
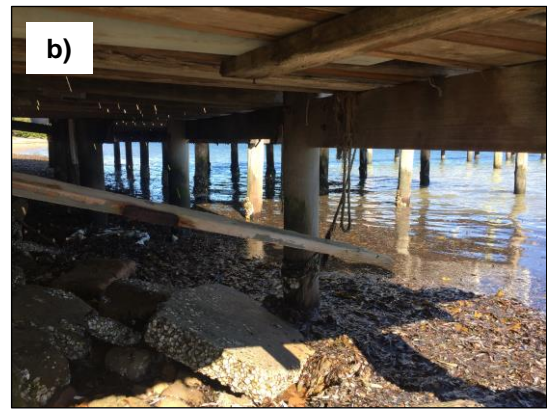
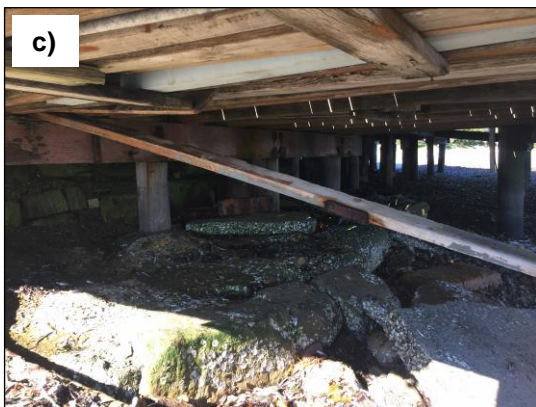
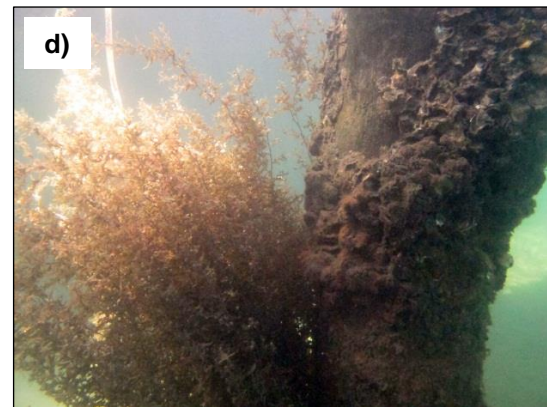
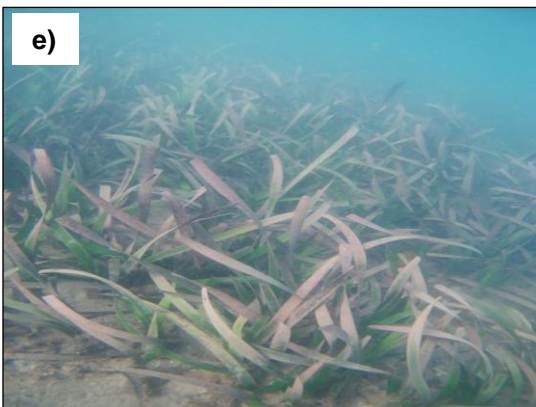
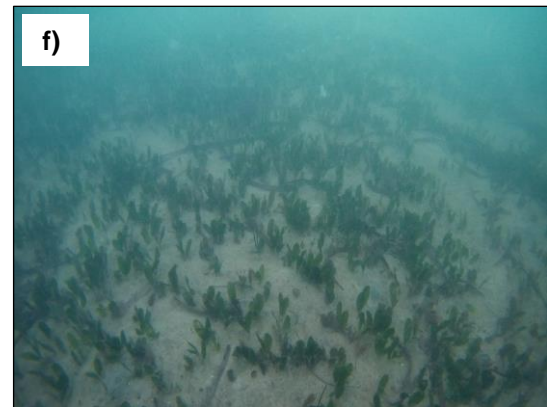
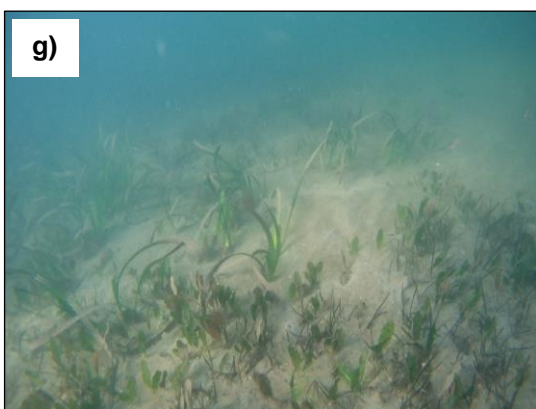
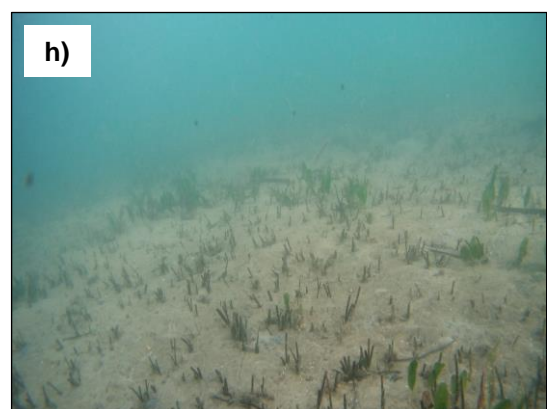
At the time of the survey, the intertidal habitat at the Property consisted primarily of bare sand, which was present below and adjacent to the boathouse and decking areas (**Plate 1a**). A concrete boat ramp was present to the north of the boathouse and decking. The wooden piles and boulders below the decking were colonised by oysters (*Saccostrea* spp.), anemones (Order: Actiniaria) and limpets / chitons (Class: Polyplacophora) (**Plate 1b/c**). Piles within the subtidal areas were colonised by brown algae including Neptune's necklace (*Hormosira banksia*) and *Sargassum* sp. and ascidians (Class: Ascidiacea) (**Plate 1d**).

Posidonia occurred dominantly in one high density patch to the south west (**Plate 1e**), medium density patches also occurred among/near medium density *Zostera* in the south and south west in proximity to the jetty and pontoons. A medium density patch also occurred in the north west among medium density *Zostera* and low density *Halophila* (**Plate 1g**). Small shoots of medium density *Zostera* were common west of the jetty, and also in areas of *Halophila* north and south of the jetty and pontoons. A small patch of medium density *Zostera* was recorded north of the jetty in the centre of the Study Area. Medium density *Halophila* was present south and north of the northward pontoon (**Plate 1f**), with a patch present to the north west extent of the northern pontoon/berthing area. *Halophila* was also common amongst medium density *Zostera* at the southern/northern extent and west of the berthing area.

Plate 1a) Adjacent to the boathouse and decking, submerged bare sediment habitat b) Sydney rock oyster attached to the decking piles and c) attached to boulders below the decking, d) brown algae on the subtidal piles below the jetty, e) high density *Posidonia*, f) medium density *Halophila*, g) medium density *Posidonia*, *Zostera*, *Halophila* and h) medium density *Zostera* and low density *Halophila*.

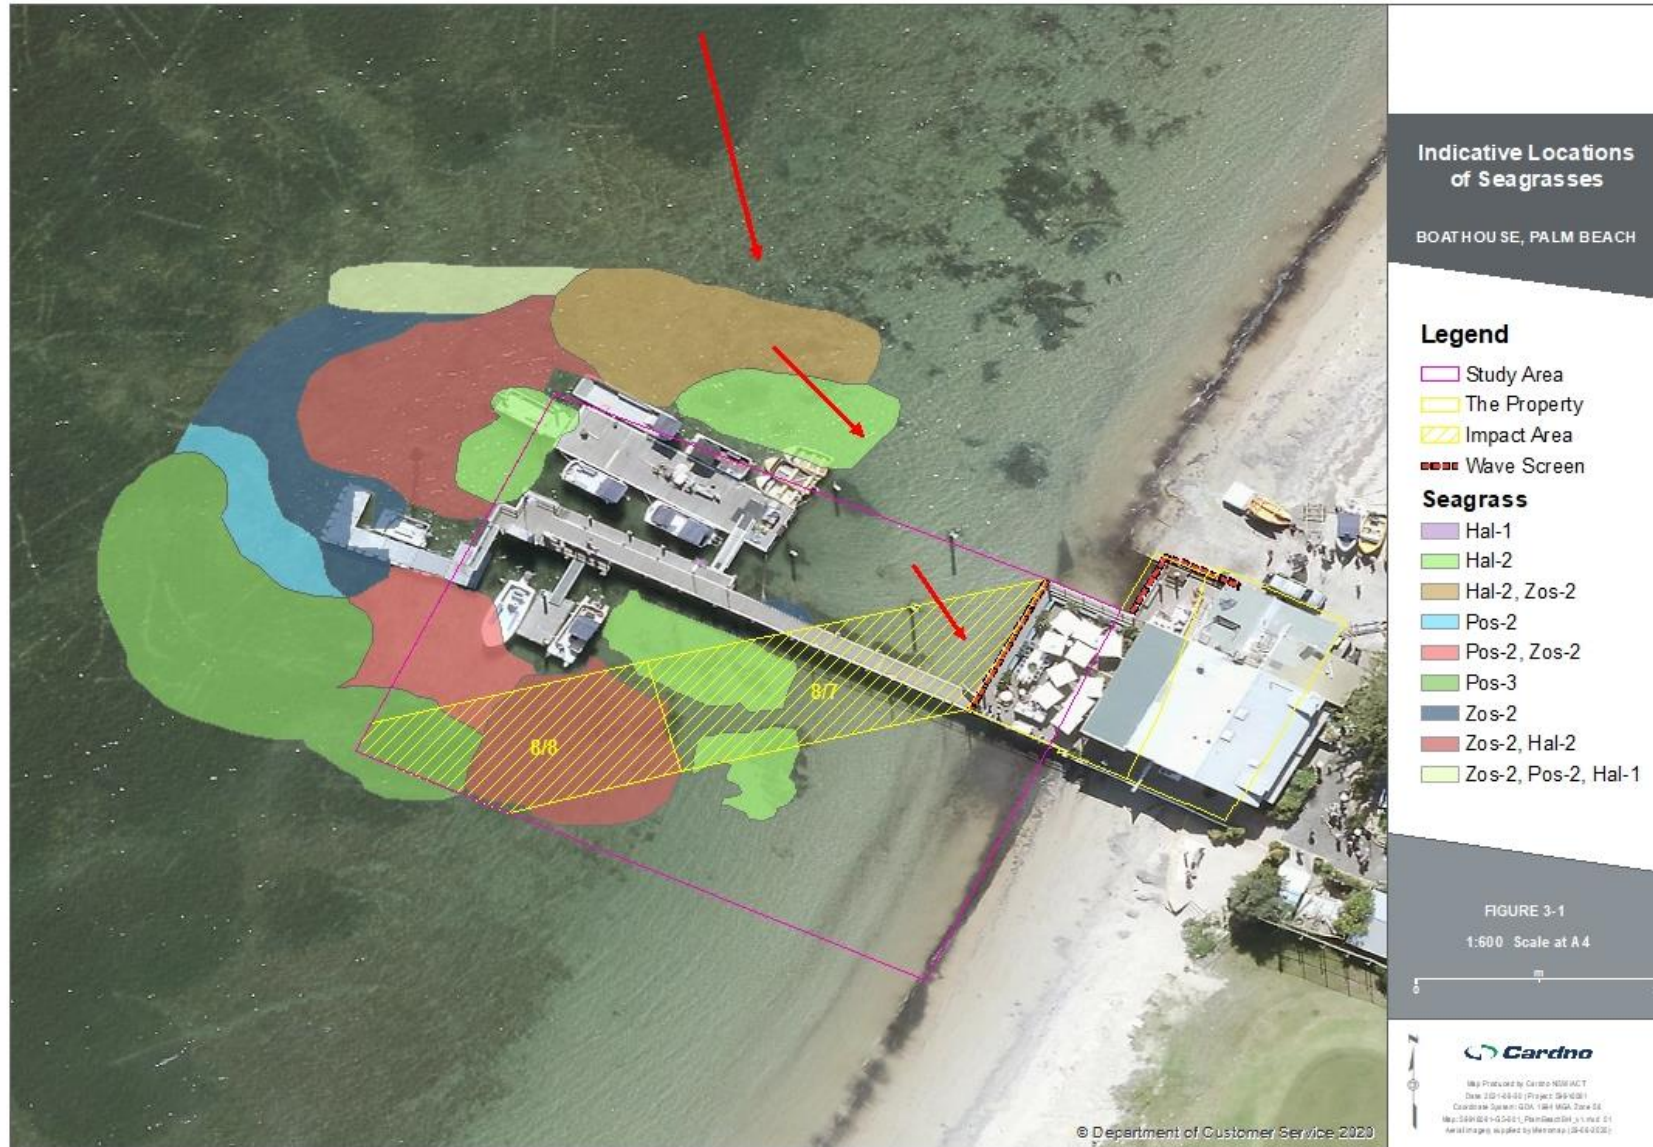
At the time of the survey, *Posidonia*, *Zostera* and *Halophila* seagrass was present within the Study Area (see mapping of type and extent in **Figure 3-1**).

No seagrass was present under, and immediately adjacent to (within 5 m) of the boathouse decking areas and where the alterations to piling would take place. The closest seagrass in proximity to the piling work zone are medium density patch of *Zostera* adjacent to jetty and medium density *Halophila*, approximately 15 m from the deck. No *Posidonia* was present within approximately 25 m of the area of proposed pile placement.

Figure 3-1 Aerial figure of the Property with the indicative location of seagrasses present within the Study Area at the time of the survey. Wave screen impact 8/8 and 8/7 zones highlighted in yellow. The red arrows indicate the recommended path for the barge movements to avoid areas of *Posidonia*.

- > Piling via barge is only to be completed on high tide and in suitable weather conditions. The barge (un-propelled, draft approx. 0.5 m) will be only moved into position upon a high tide of 1.6-1.7 m allowing sufficient water above the shallower areas adjacent to the northern pontoon. The barge will be moved via a large tinny (draft approx. 0.3 m) with an out-board motor that can be tilted to suit water depth to avoid prop scouring (recommended barge path represented by red arrow in **Figure 3-1**). The boundaries of mapped areas of *Posidonia* (**Figure 3-1**) would be marked clearly at the water's surface (i.e. Exclusion Zones) so that all vessels would avoid these areas during the barge escort. A minimum of 0.5 m above the seabed in any area is required as a precaution to avoid damage to the seabed or any marine flora or fauna occurring at the time of mobilisation. Once into proximity (near the four existing berthing piles) the barge can then be manoeuvred into position during the high tide by ropes. Once in position the barge can be securely tied off and remain over the bare sediment while the works progress (approx. three days). On completion of the works, the barge must only be moved out on a similar tide as mentioned above.

- > The construction of the wave screen will have some effect on wave heights and directions at the shoreline. There is likely to be tendency for minor sand accumulation at the shoreline beneath the Boat House because of a localised change in near shore wave direction. It is estimated that the area highlighted in **Figure 3-1** has potential to be affected by reflected waves from the front screen. Based on previous investigations in Botany Bay, Kurnell seagrass patches experience a near bottom wave particle speed of approx. 1 m/s (equal to roughly a shear stress of 1 N/m²) which will tear up seagrass from a sandy seabed. At this site, a near bottom wave particle speed of 1 m/s or an Hs=0.8 (swell height) is needed to damage seagrass. Based on Lawson and Treloar's Pittwater Estuary Processes Study, a Hs=0.8 occurs roughly every 8 years (8/8 zone, **Figure 3-1**) in this area. The effects of wave reflection and radial reduction from the proposed outer wave screen, however, would see a Hs of 0.8 occur roughly every 7 years, increasing the frequency of damage to seagrass in this area (8/7 zone, **Figure 3-1**). Therefore, as indicated on 8/7 zone in **Figure 3-1**, the patches of medium density *Halophila* (and a small portion of *Zostera*) to the south may be affected from the wave screen installation.

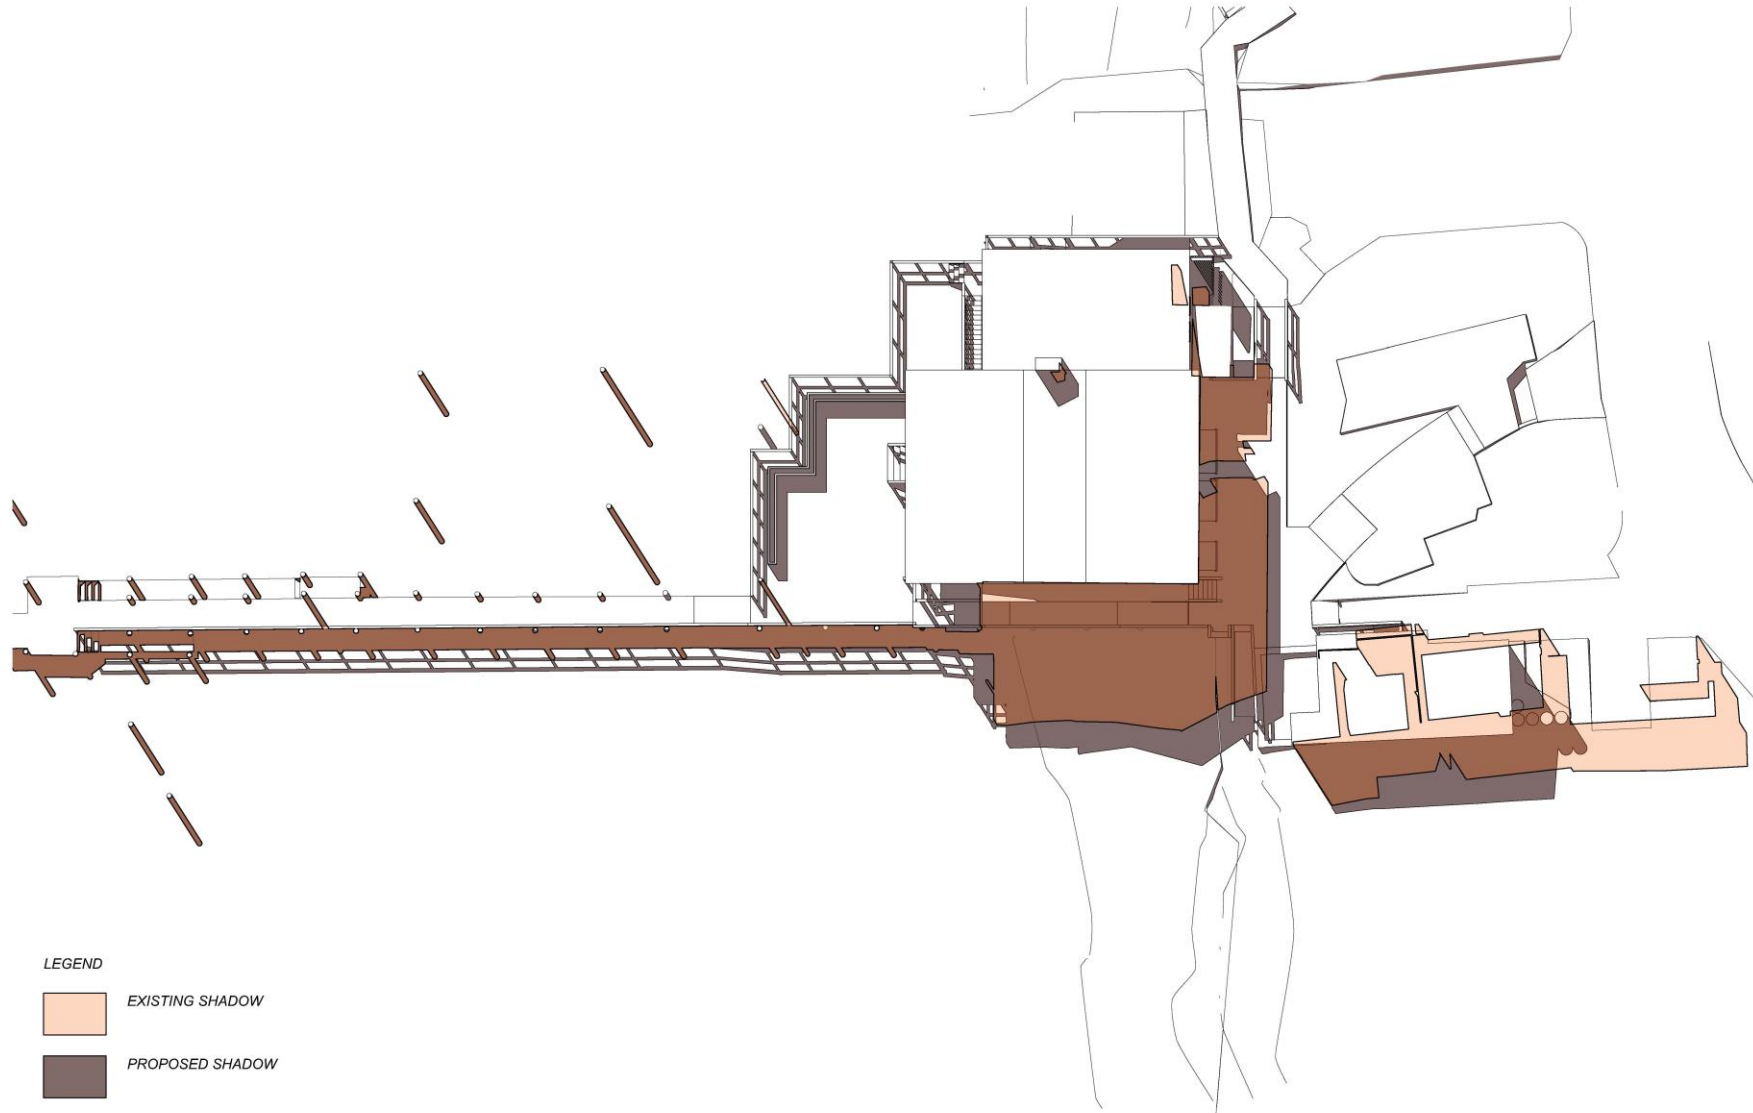
Layout ID
DA16
30/01/2021 DEVELOPMENT APPLICATION

Drawing Name
WINTER SOLSTICE 12 PM

- > The proposed building is expected to be 1.7 m higher than the existing building. The architectural shading drawings DA15-17, dated 1 March 2021 (see **Appendix B**) illustrate the existing shadow vs. the proposed shadow. The increase in the shading footprint falls on bare sediment in the shallow areas below the Highest Astronomical Tide (HAT), south of the Property. Based on this, there is no anticipated increase in shading of seagrass.

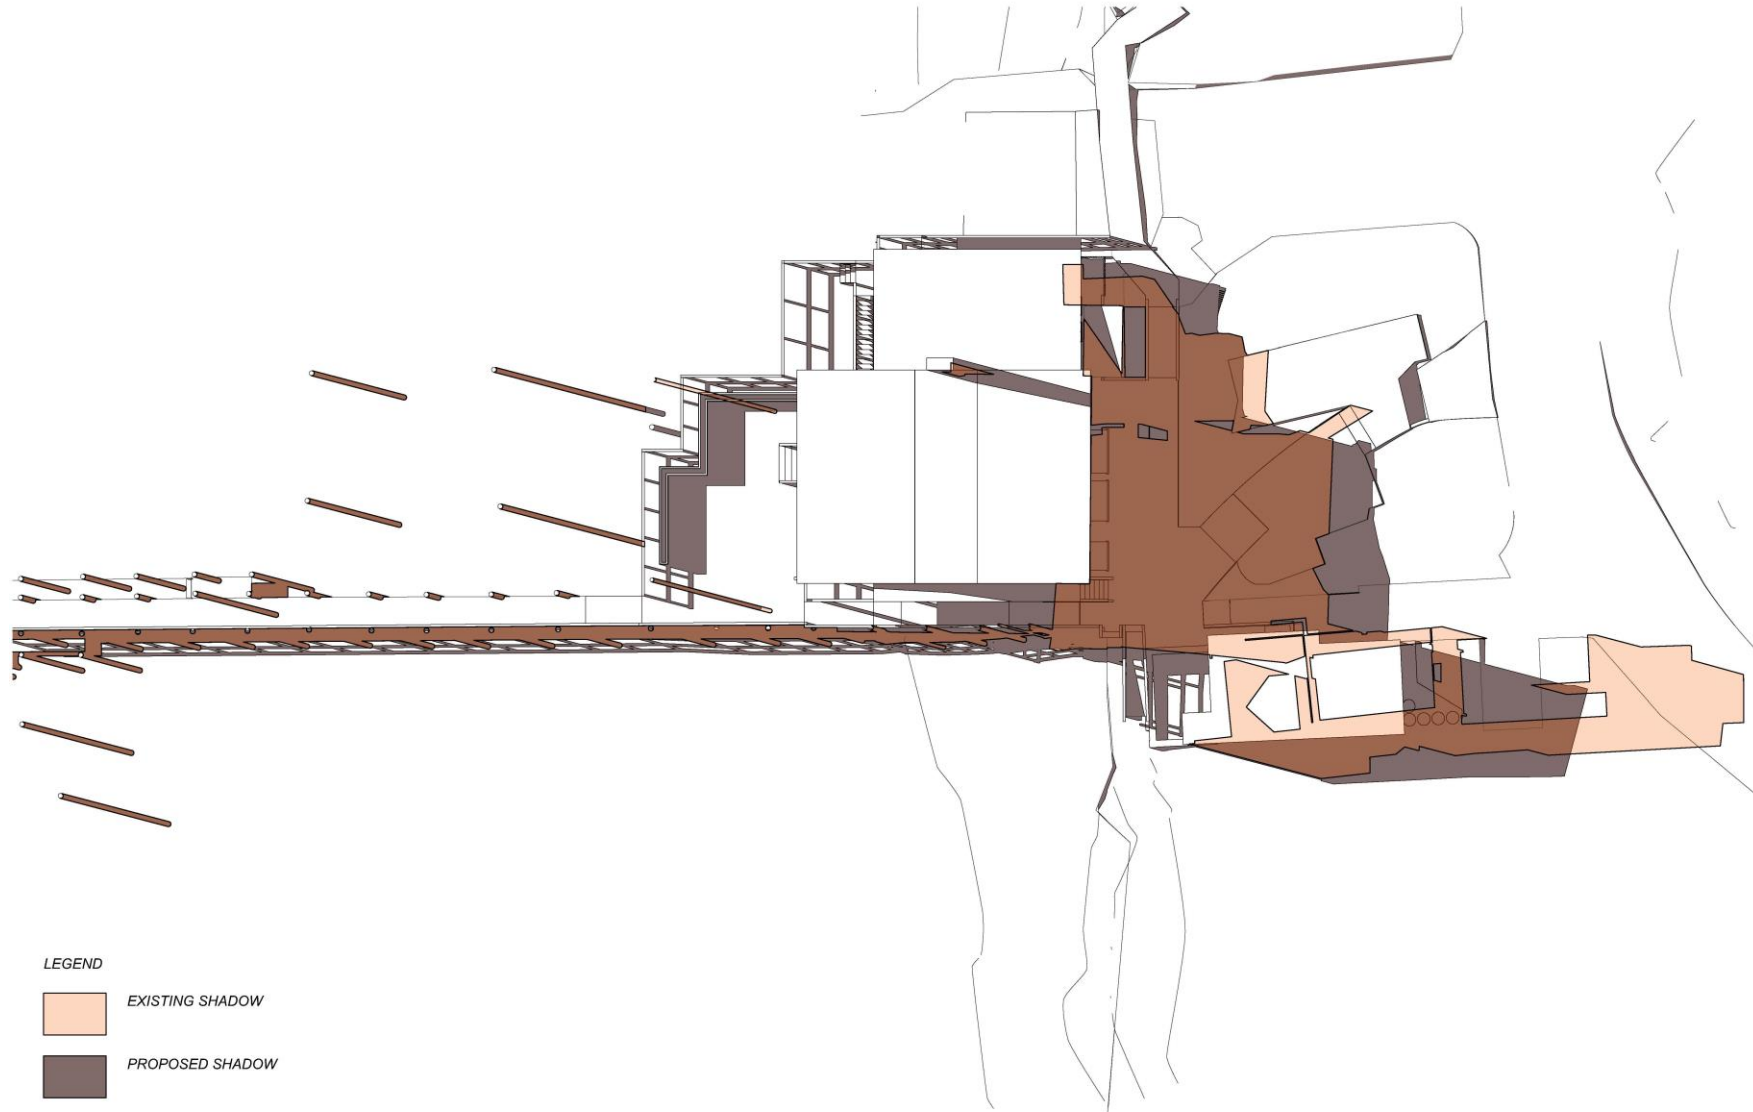
Layout ID
DA17
30/01/2021 DEVELOPMENT APPLICATION

Drawing Name
WINTER SOLSTICE 3 PM
