Report Title: Geotechnical Report 1 Narrabeen Park Parade, North Narrabeen  
Report Date: 6/11/24

## **GEOTECHNICAL INVESTIGATION:**

New House at **1 Narrabeen Park Parade, North Narrabeen**

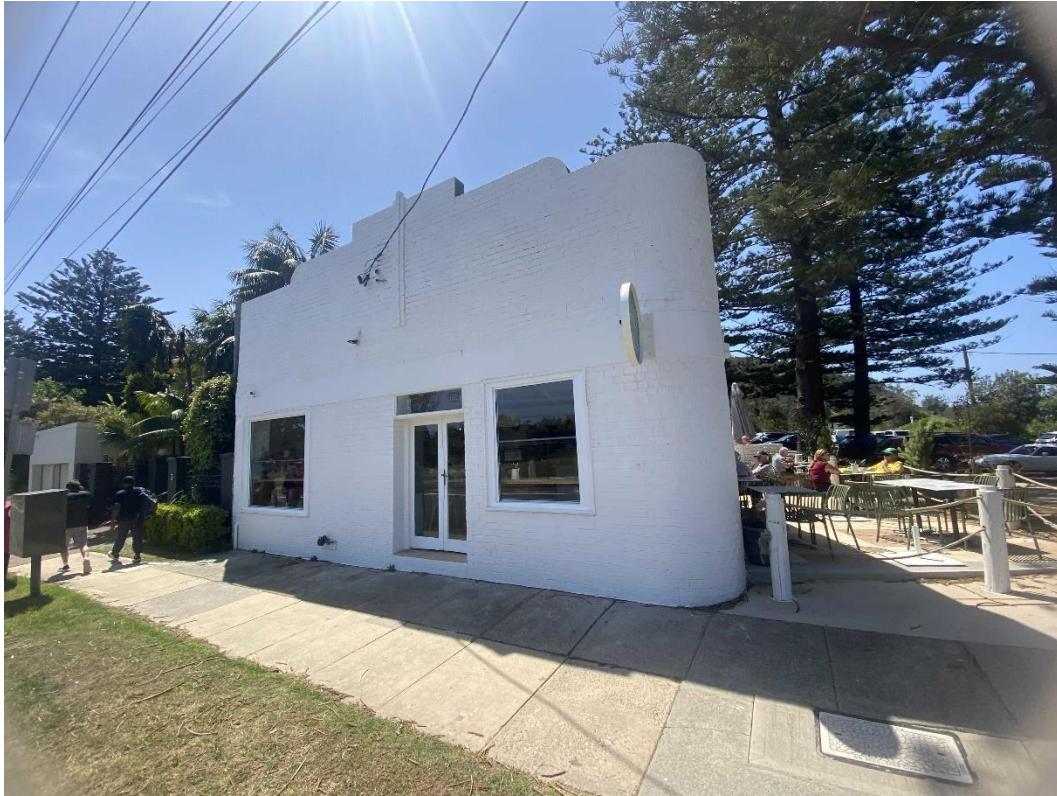
Photo 1

- 2.1** The site was inspected on the 30<sup>th</sup> October, 2024.
- 2.2** This mixed-use property is on the E side of Narrabeen Park Parade and to the N of a council carpark. The property is on near level ground to the NW of Narrabeen Beach. The land begins to slope upwards at gentle to moderate angles near the E boundary.
- 2.3** A brick building lines the road frontage to Narrabeen Park Parade and encompasses the width of the property (Photo 1). The building appears to be in good condition. A concrete driveway runs from the council carpark to a parking area and brick garage on the E side of the property (Photo 2). The garage is partially cut into the slope (Photo 3). The visible brick walls of the garage show no significant signs of movement.

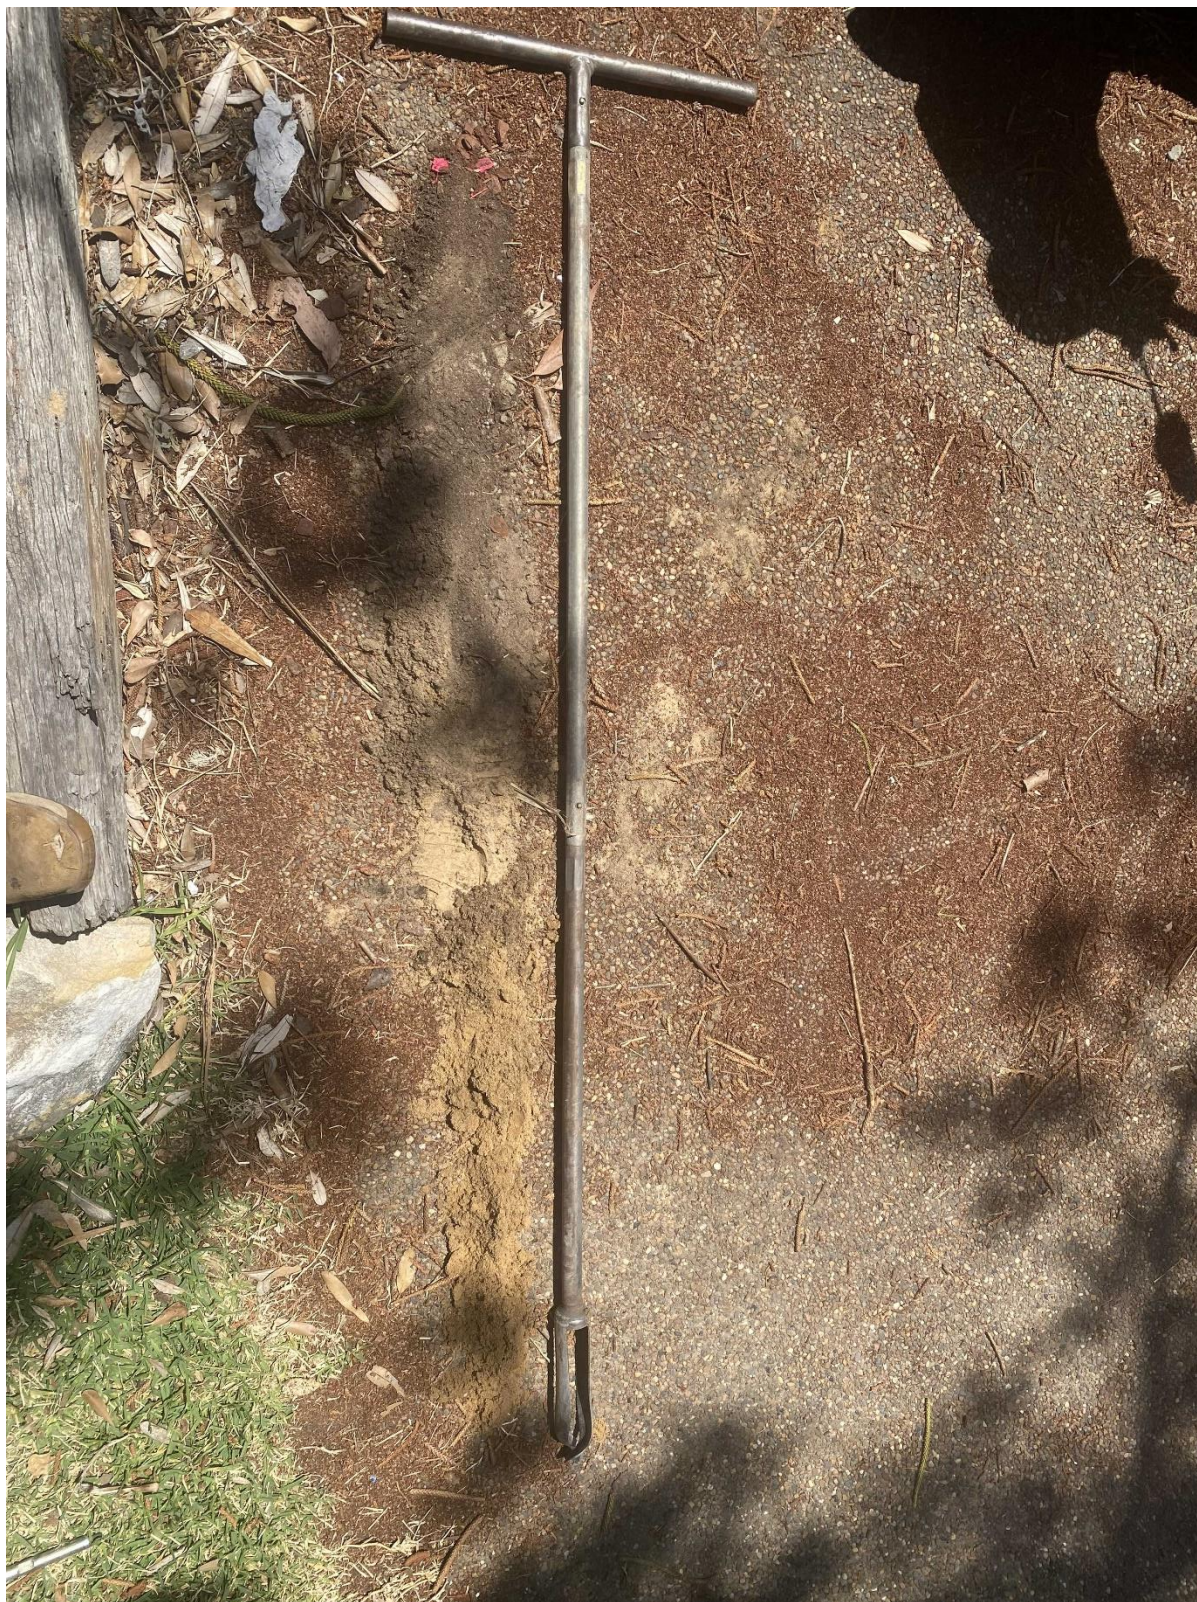
Photo 4 - top to bottom

### AUGER HOLE 1 (~RL4.6) – AH1 (Photo 4)

Depth (m)	Material Encountered
0.0 to 0.5	<b>SAND</b> , dark brown, medium grained, dense, dry.
0.5 to 1.0	<b>SAND</b> , grey, medium grained, dense, dry.
1.0 to 1.8	<b>SAND</b> , orange, coarse grained, dense, dry.

End of hole @ 1.8m in dry sand. The water table was not encountered to the extent of testing.

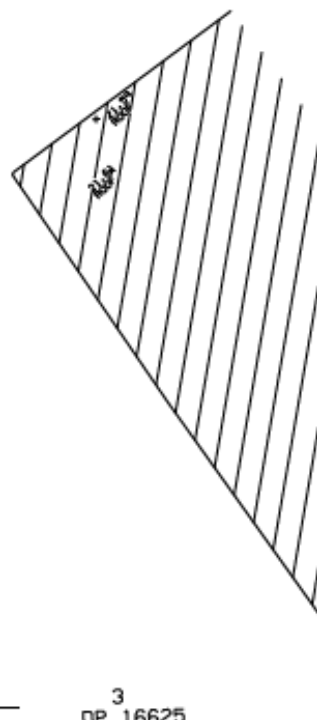
DRAWING TITLE		
PARKING LEVEL / SITE PLAN.		
DWG No.	2.3119	DA101 <sup>B</sup>
SCALE	1:100	
DATE	09.24	
DRAWN	MRB	
CHECKED	MRR

One hand Auger Hole (AH) was put down to identify the soil materials. Three Dynamic Cone Penetrometer (DCP) tests were put down to determine the relative densities of the sands through the profile. The locations of the tests are shown on the site plan attached. It should be noted that a level of caution should be applied when interpreting DCP test results. The test will not pass through hard buried objects so in some instances it can be difficult to determine whether refusal has occurred on an obstruction in the profile or on the natural rock surface. This is not expected to be an issue for the testing on this site. However, excavation and foundation budgets should always allow for the possibility that the interpreted ground conditions in this report vary from those encountered during excavations. See the appended "Important information about your report" for a more comprehensive explanation. The results are as follows:
