**REPORT ON GEOTECHNICAL SITE INVESTIGATION**

**PROPOSED GANGWAY TO BOAT MOORING PENS**

**THE NEWPORT, 1 KALINYA STREET, NEWPORT**

**Project No.: 2015-240.1**

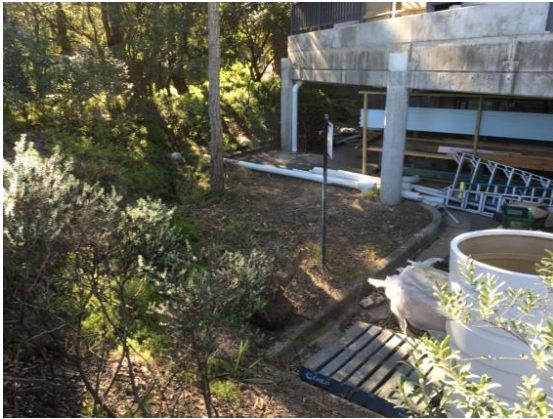
The majority of The Newport site is gently west sloping and modified from its natural condition with extensive built structures which have been recently modernised. On the western side of the property a raised concrete open entertainment area exists above a parking and loading area. The parking area appears excavated into the hill slope up to approximately 2.0m depth with a vegetated steep (25°) slope extending up from the carpark pavements gutter to a low ridge line which extends along the western boundary, see Photo: 1.

Photo: 1 - Carpark and gutter along west side of down The Newport site

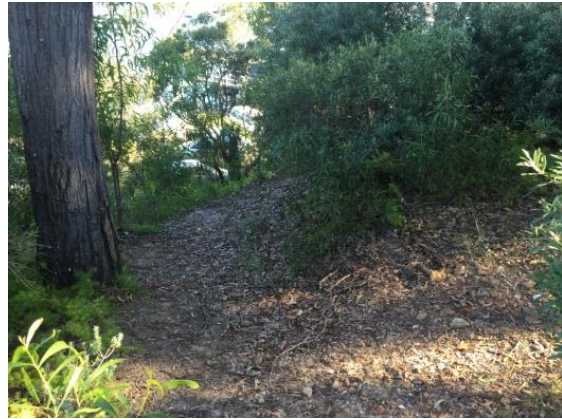
Photo: 2 - Steep natural vegetated slope extending towards foreshore

The western side of the ridge is formed as a steep (average 22°) vegetated slope (Photo: 2) which extends down to the foreshore. For the northern half of the site, adjacent to the western end of Queens Parade, the base of the slope is formed as a low (<4.0m) cliff line down to a foreshore rock platform. The cliff is formed at very steep (40°) to vertical slopes which have resulted from erosion of the claystone/laminite bedrock exposed along the foreshore. At the base of the cliff is an iron rich shale/siltstone horizon up to 1.0m in height with a sandstone rock platform extending from its base towards the west, see Photo: 3.

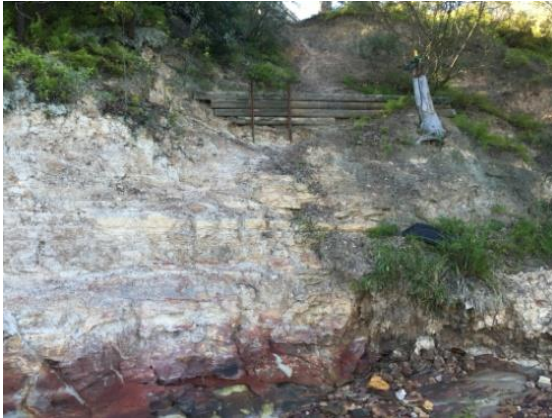
Photo: 3 ó Cliff line at foreshore showing exposed weathered bedrock and erosion along informal pedestrian pathways

The cliff contains extensive outcrops of extremely low to very low strength claystone/siltstone which are exposed due to erosion with clayey soils and a thin topsoil formed above. In parts the erosion has created small scale overhangs and areas of potential small scale landslip instability within the weak rock and thin soil profile formed above. The slopes along the western side of the site show signs of pedestrian activity which has resulted in concentration of surface stormwater and subsequent shallow gully erosion.

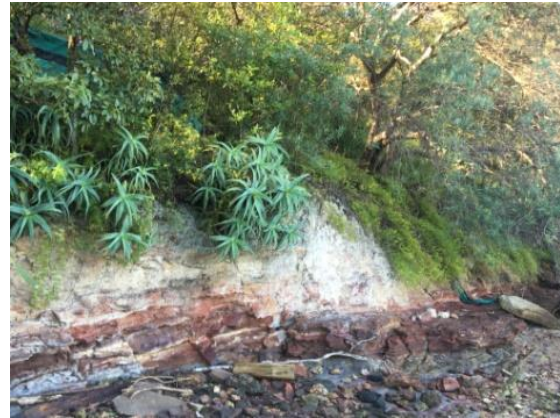
At the northern end of the site Queens Parade extends down below the foreshore line and is formed as a gently sloping bitumen car parking area which is surrounded by a low (<1.0m) dry stacked rock sea wall. Approximately 10m south of the rock walls the eroded cliff ends reduces in height, see Photo: 4.

Photo: 4 ó Area of reduced coastal erosion away from road extension and sea wall at the western end of Queens Parade.
