Report Title: RISK ANALYSIS & MANAGEMENT FOR PROPOSED ADDITIONS AND ALTERATIONS AND LANDSCAPING AT 54 ATTUNGA ROAD, NEWPORT
Report Date: 17/03/2016

**RISK ANALYSIS & MANAGEMENT
FOR
PROPOSED ADDITIONS AND ALTERATIONS
AND LANDSCAPING
AT
54 ATTUNGA ROAD, NEWPORT**

MR 30425

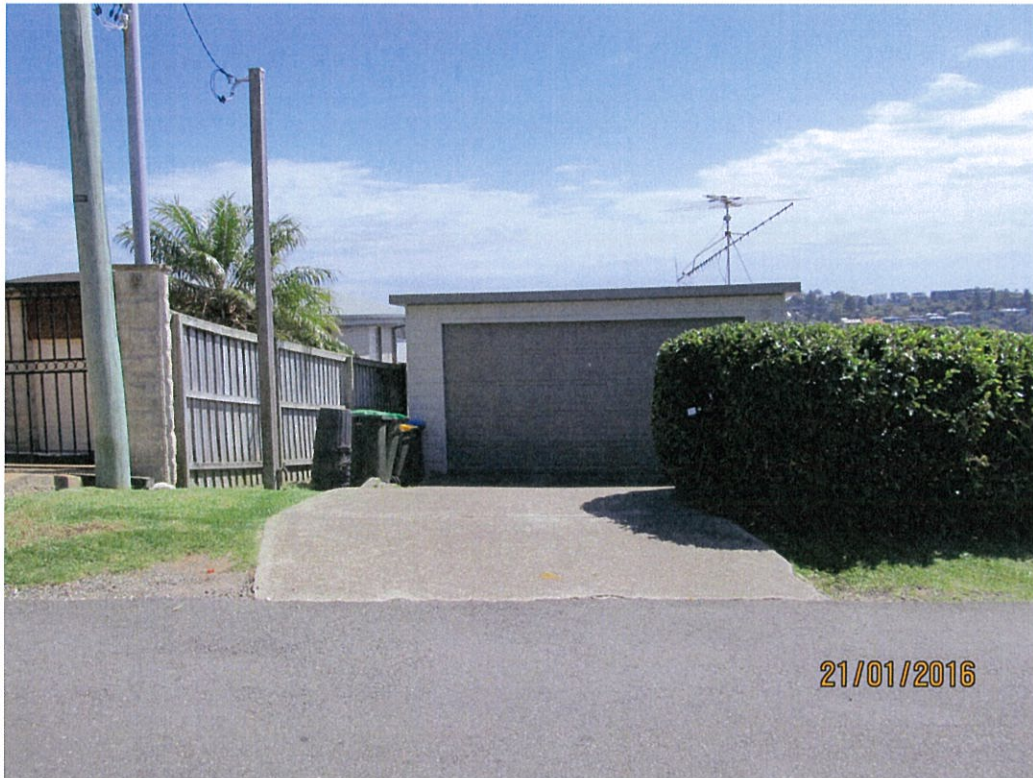
Photo 1

3.3 From the road frontage a short concrete driveway provides access to a double garage detached from the main residence (Photo 1). A series of timber stairs and terraced paved lawn areas are situated in the south-eastern portion of the property. The stairs provide access to a timber deck entry area situated on the south-eastern corner of the residence (Photo 2). The cut for residence is supported by a timber soldier pile wall in the south-western portion of the property with pile support for the garage above spaced evenly along the wall (Photo 3). Access to the north-eastern portion of the block is via a concrete path and stairs that extends along the eastern boundary of the property (Photo 4). Access is also possible via sandstone stack stairs that extends along the western boundary (Photo 5). A paved ground floor balcony extends along the north-eastern side of the residence. A moderately sloping lawn area extends from the balcony to the lower north-eastern boundary with spaced medium sized trees lining the timber fences (Photo 6).
