REMEDIATION ACTION PLAN (REVISED 2020)

STATE TRANSIT BUS DEPOT, 58 DARLEY
STREET MONA VALE, NEW SOUTH WALES

Remediation Action Plan (Revised 2020)

PS109544-CLM-REP-001 RevE

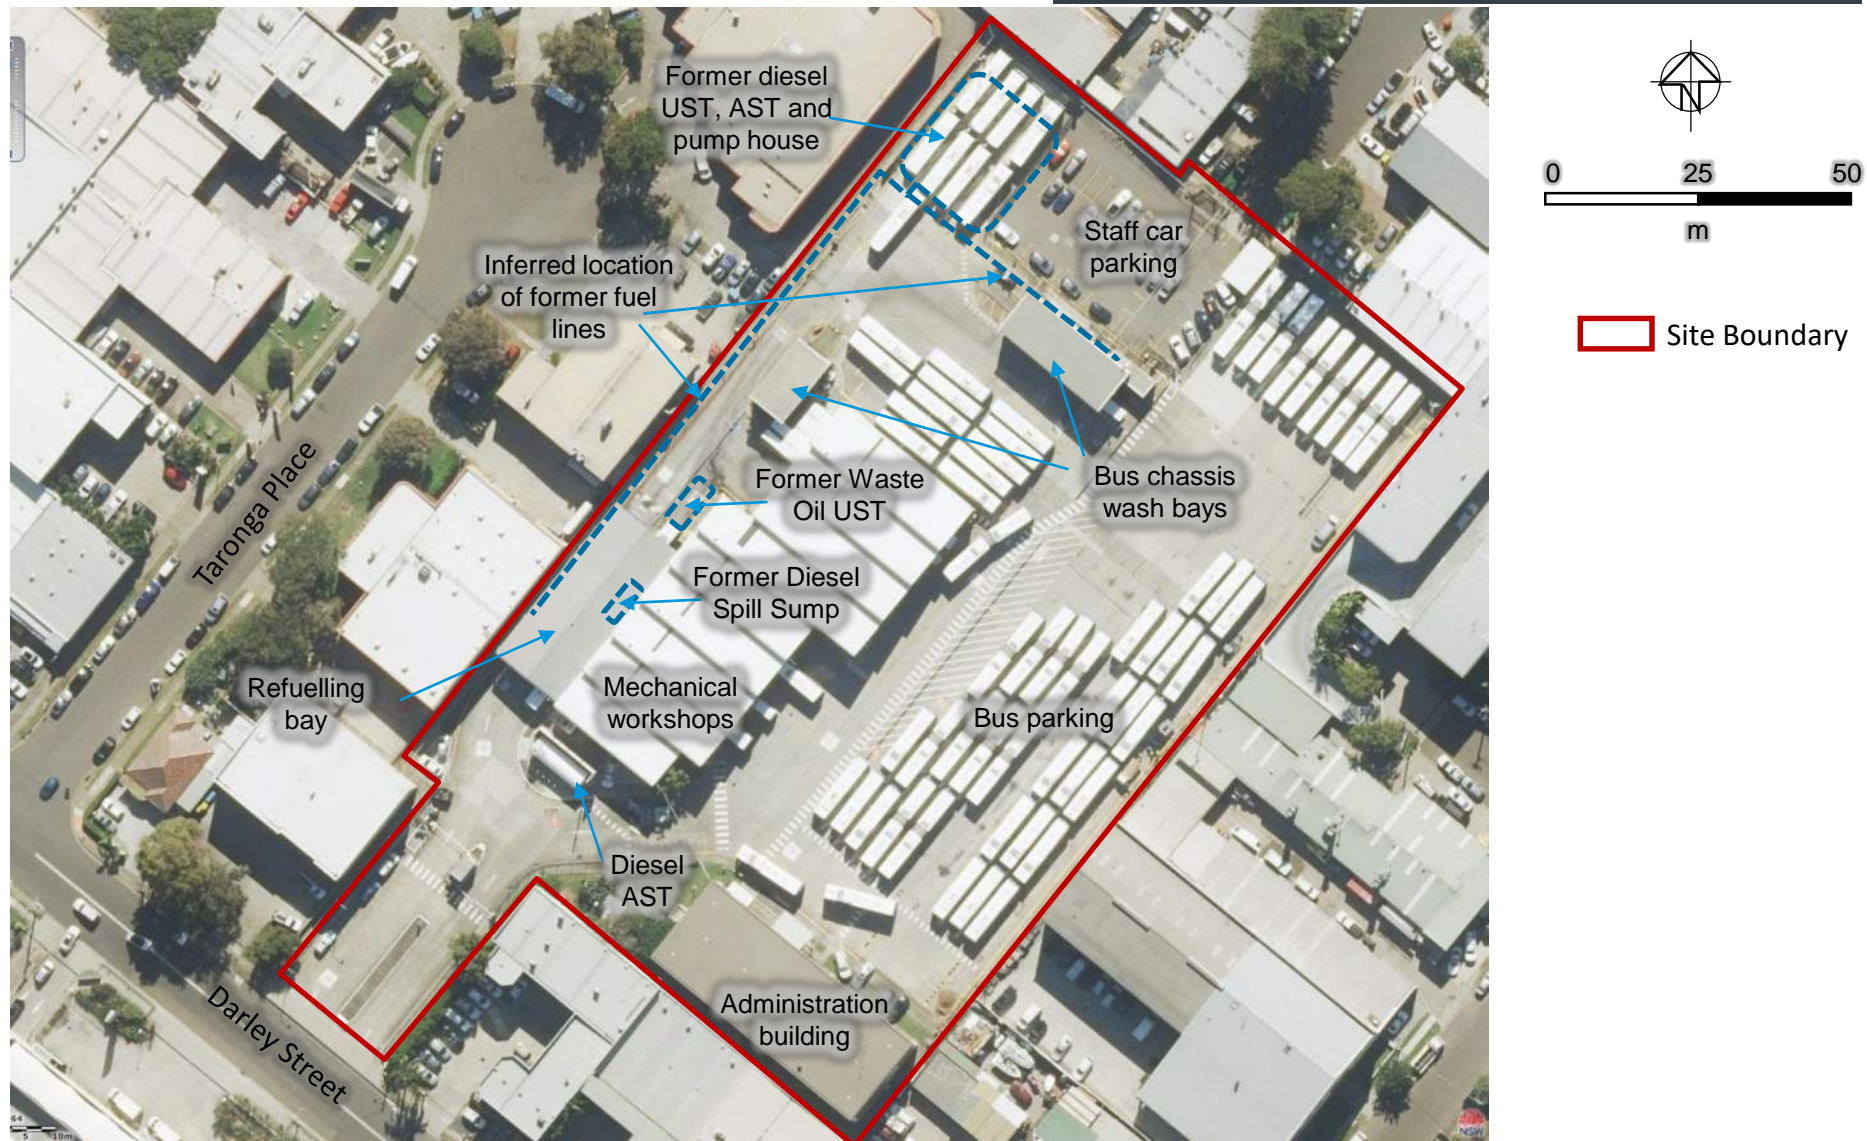
Figure 3 Site Current and Historical Features

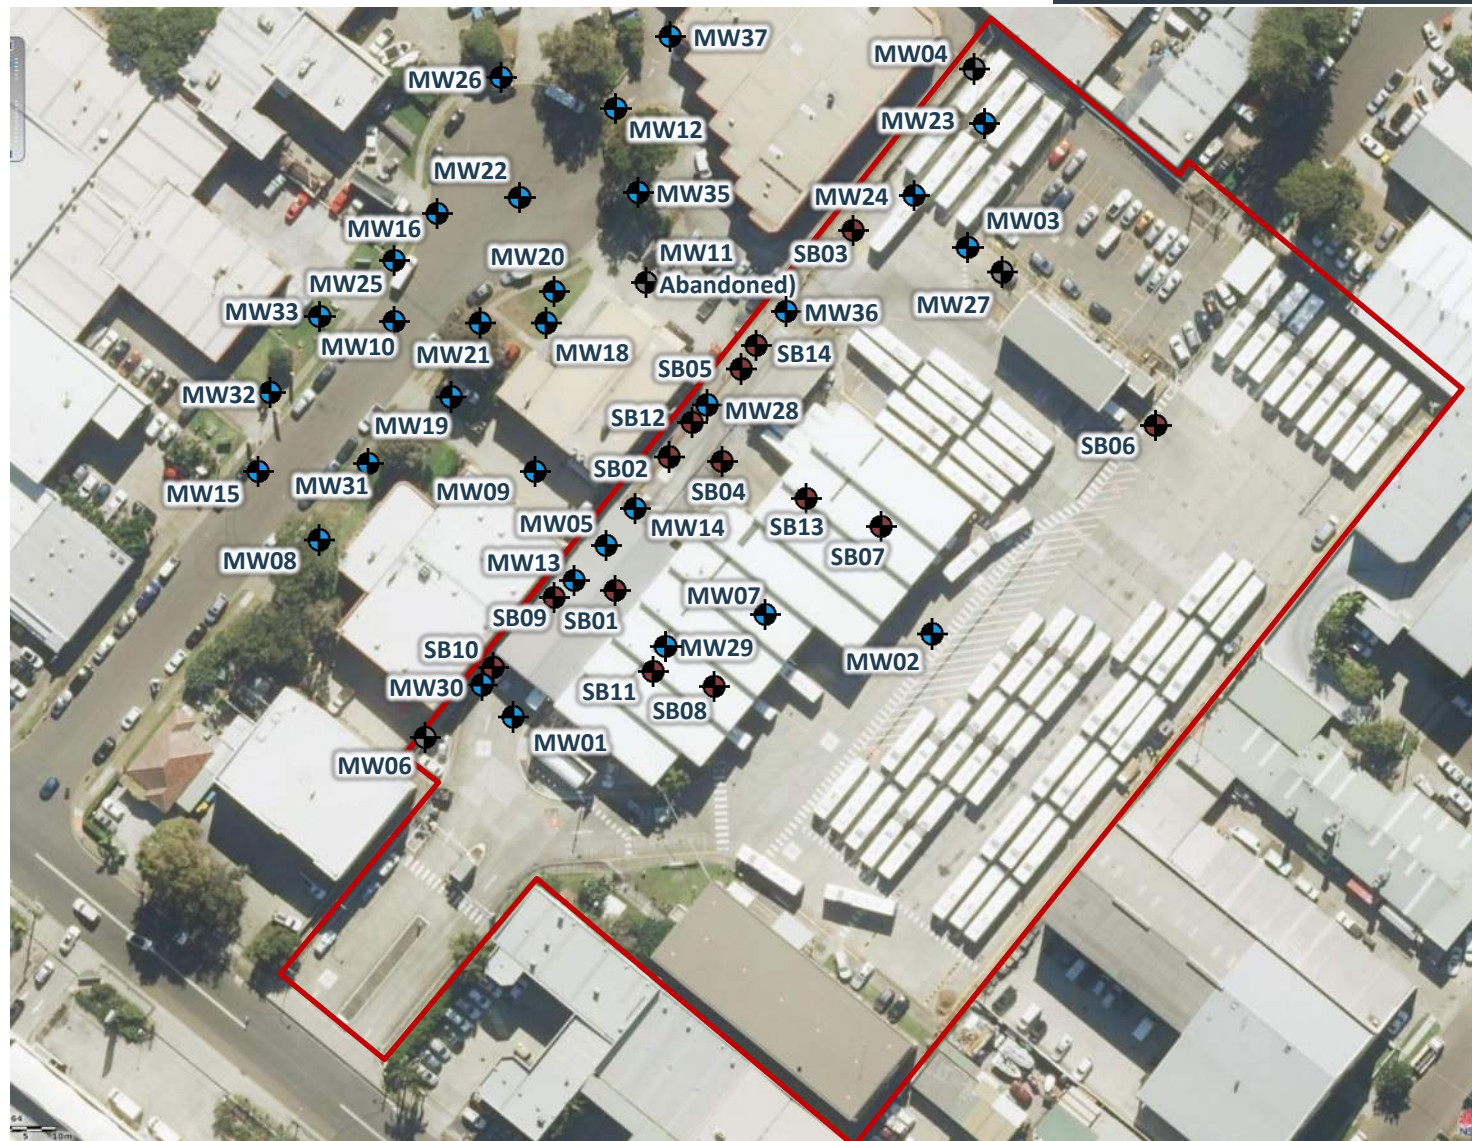
Figure 4 Soil Boreholes and Groundwater Wells

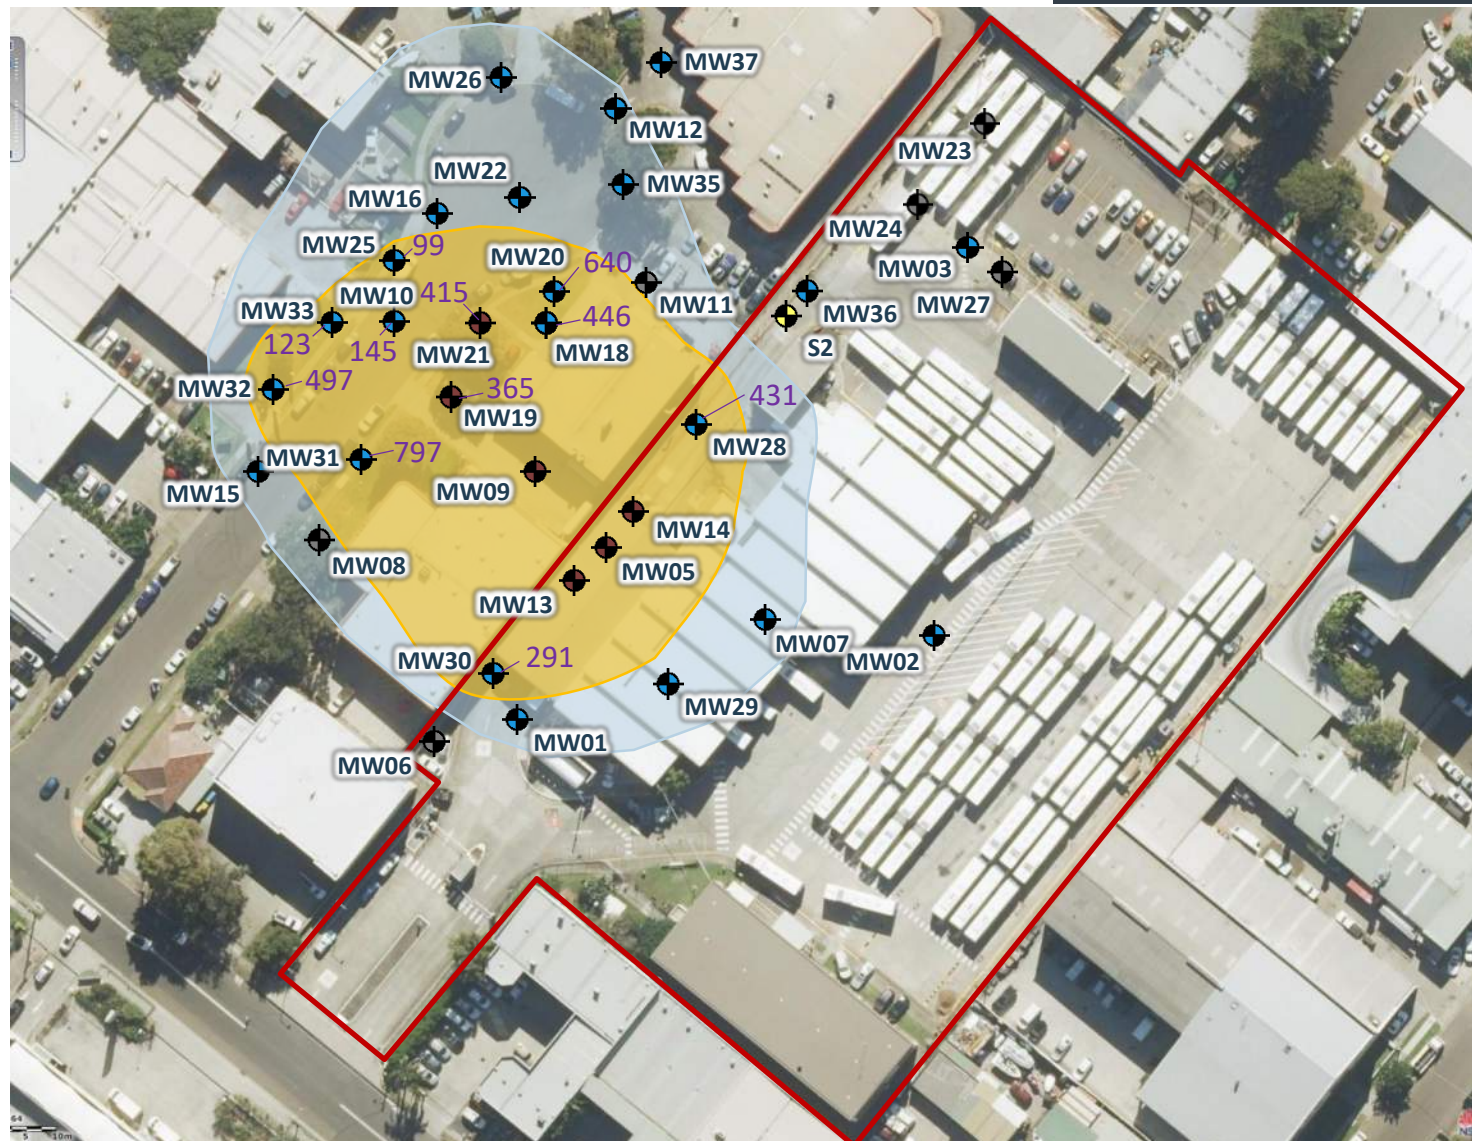
Figure 6 Hydrocarbon Results
PS111744 GME – Oct 2019 & Feb 2020
STA Bus Depot, 58 Darley Street Mona Vale

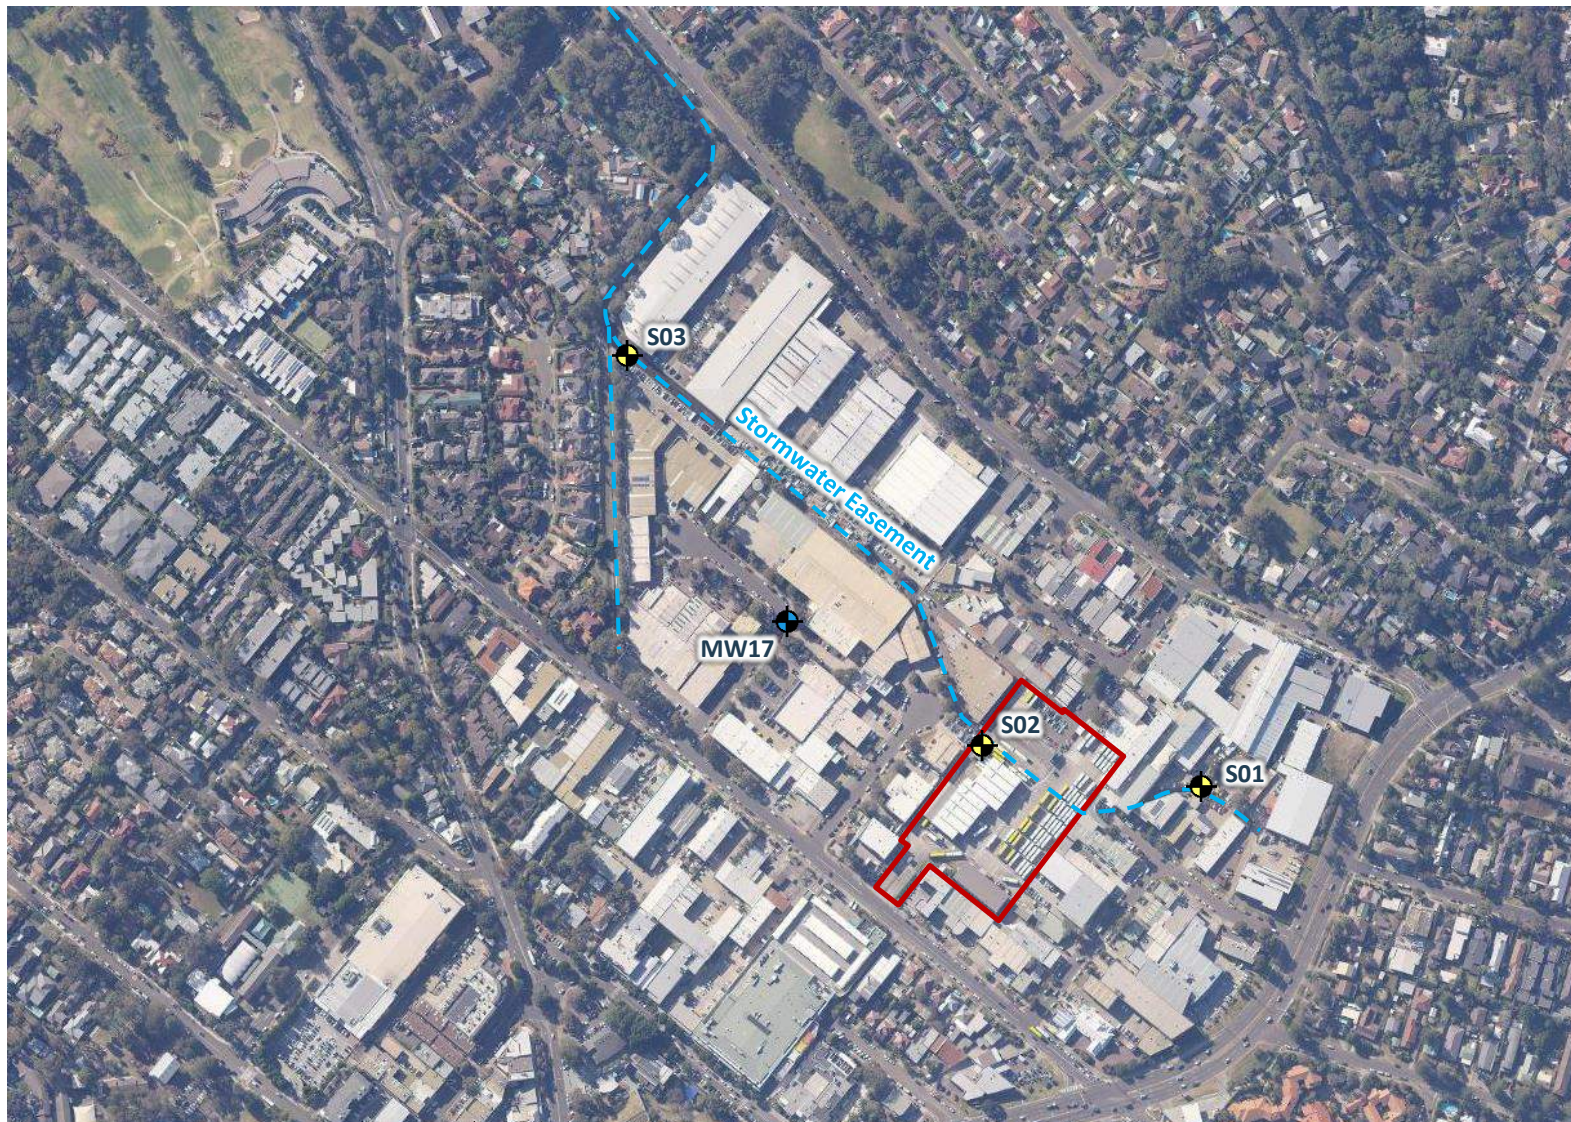
Figure 8 Surface Water Monitoring + Location of MW17

- In February 2020, WSP collected three surface water samples; one from upstream, at the site's downgradient boundary, and downstream of the site along the stormwater channel. The results indicated that no detectable hydrocarbons were present in the stormwater drain upstream, at the site boundary or downstream of the site. This provides a line of evidence that despite the proximity of the PSH to the stormwater easement, it is unlikely that the contamination is leaking into the system putting the ecology of the creek or downstream receptors at risk. Surface water testing is now included in the bi-annual monitoring program.
