CONSERVATION MANAGEMENT PLAN

Newport SLSC
394 Barrenjoey Road
Newport

June 2022

Job No: 9546

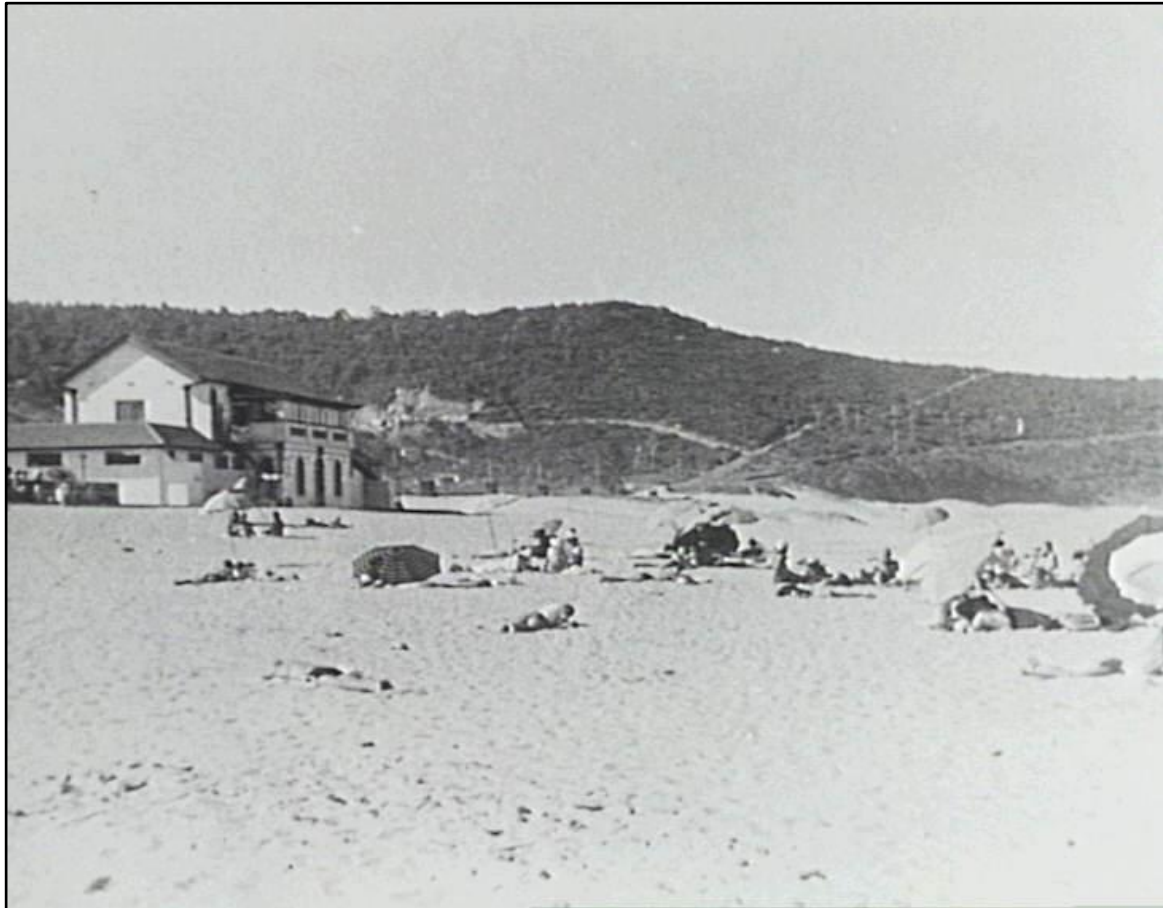
Figure 31. 'Newport Beach Surf Club House', c. 1937.⁷⁸

By 1937, additions had been made to the original 1933 Clubhouse. These included an external staircase introduced to the northern wing of the Clubhouse, on the eastern façade, providing direct access to the beach.

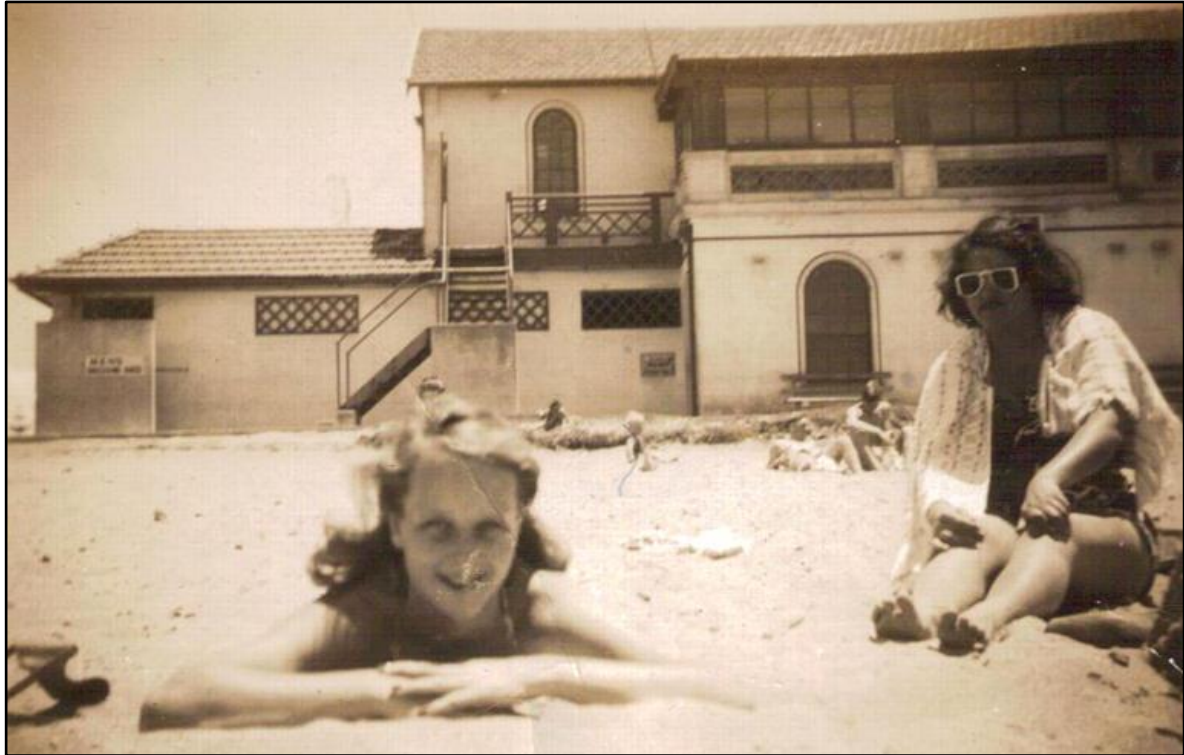
Figure 33. Image of eastern façade of the Newport Clubhouse, c. 1948. The photo shows the removal of a portion of the balustrade for the addition of emergency stairs. 'Ann Kristensen on sand at Newport Beach'.⁸³

By 1948, further modifications had been made to the Clubhouse building. Photographic evidence demonstrates that part of the balustrade to the eastern façade had been removed in order to construct emergency stairs adjacent to the southern wing, providing access to the beach.

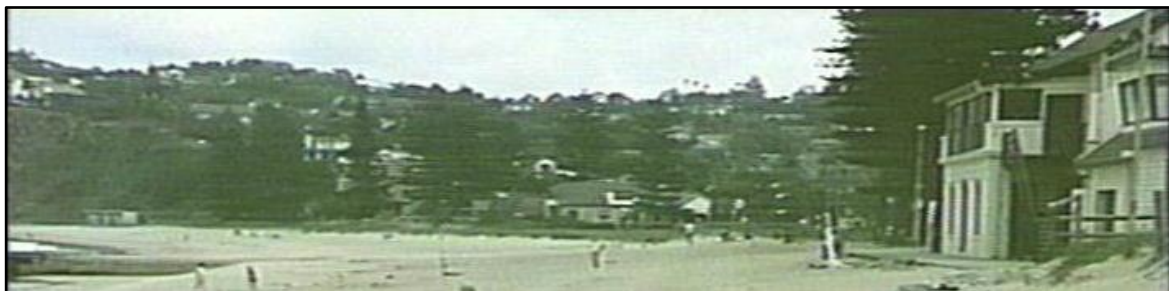
Figure 39. 'Newport Beach and Surf Club, 1986'¹⁰⁰.

By 1986, further additions and modifications had been made to the Clubhouse. The pitched roof of the northern wing had been removed and replaced by a flat roof. Additionally, a tower with glazing had been added on top of the flat room, in order to provide views of the beach from the Clubhouse.

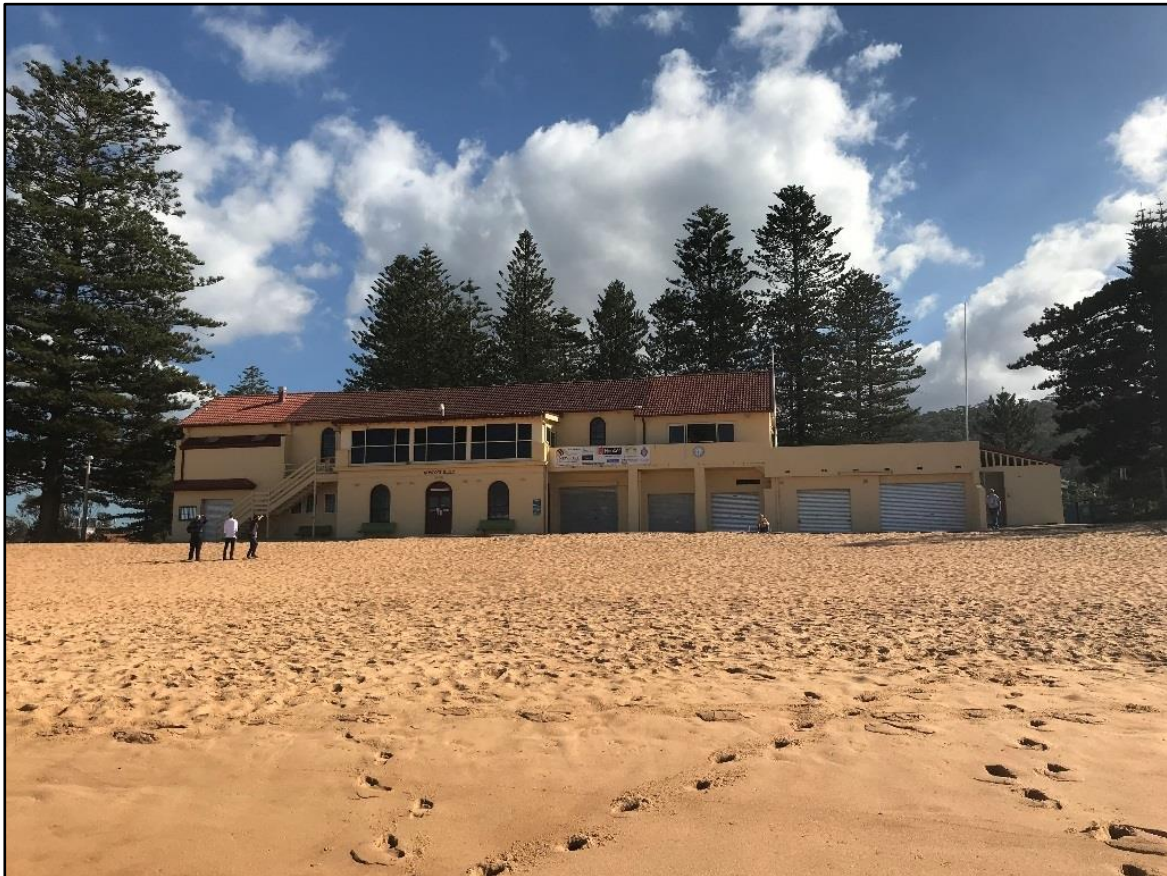
Figure 46. Eastern elevation of the Clubhouse. (Source: Photo taken by Heritage 21, 23.05.18)

The eastern façade facing the Tasman Sea and Newport beach presents itself as a two-storey single building with an extended entrance podium and a single storey extension at the northern end. Fenestrations along the extended podium on ground floor have been retained while the veranda on first floor has been enclosed with aluminium windows. Two doors on either side of the podium have been left in original condition. An access staircase in timber leads to the beach along the southern end of the building. The extension along the southern end presents itself as a three-tiered structure, with the ground floor tier punctured by a large roll-up door and a small aluminium framed window; the second tier comprises the kitchen with skylights inserted in a narrow skillion roof that has been added at a later stage; the third tier matches the roofline of the original building. The single storey extension at the northern end comprises of a high parapet wall indicating that the entire first-floor of the extension is used as an outdoor seating area while the ground floor is penetrated with five inconsistently sized garage roll-up doors that house the club's larger sized equipment. A small lean-to with a skillion roof is further added on as a secondary extension along the northern end containing the public female washrooms.

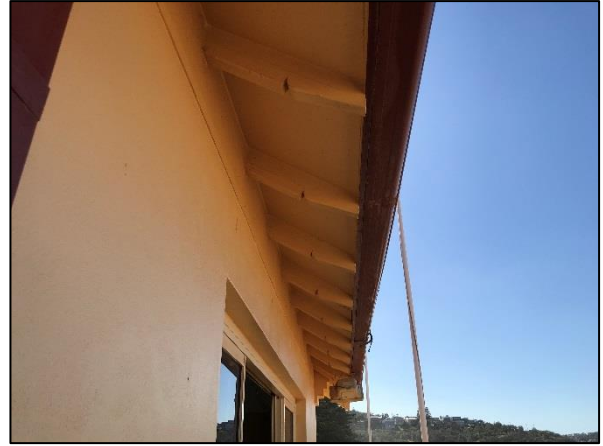
Figure 105. Note timber batons along roof line of original building in the centre. (Source: Heritage 21, 23.05.18)

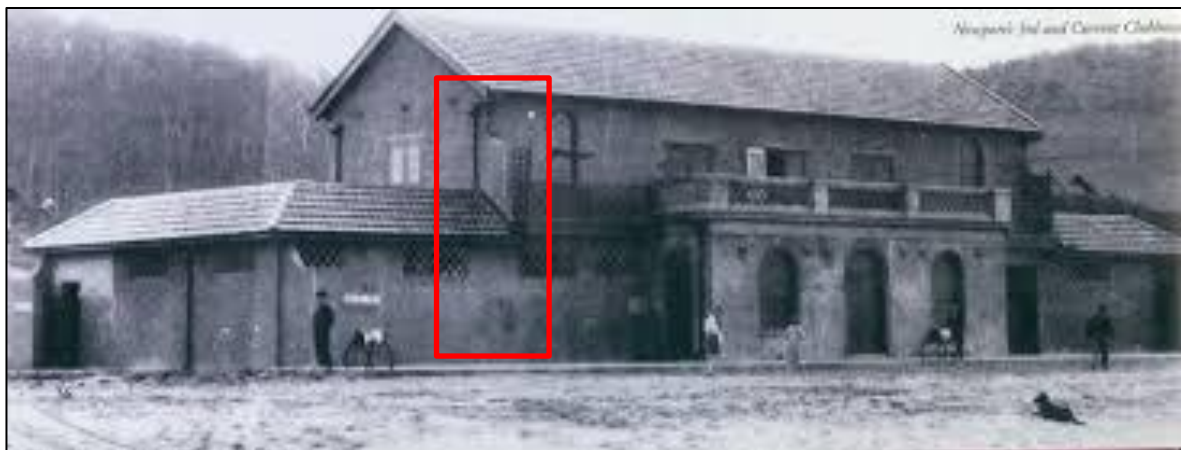
Figure 107. Photograph indicating original single storey wing alignment with two-storey section walls

The exterior of the building, built in the Mediterranean Clubhouse style, is in a fair condition. However, considerable alterations have been undertaken over the years. The original building footprint included a two-storey central section with an entrance portico along the western façade and an extended podium entrance along the east. Two single storey wings flanked the main building

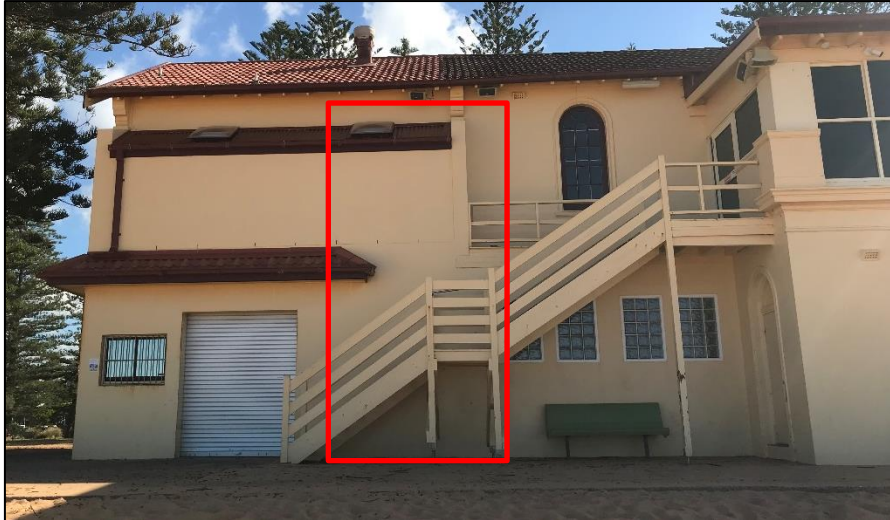
Figure 108. Current alignment of wing and central section walls.

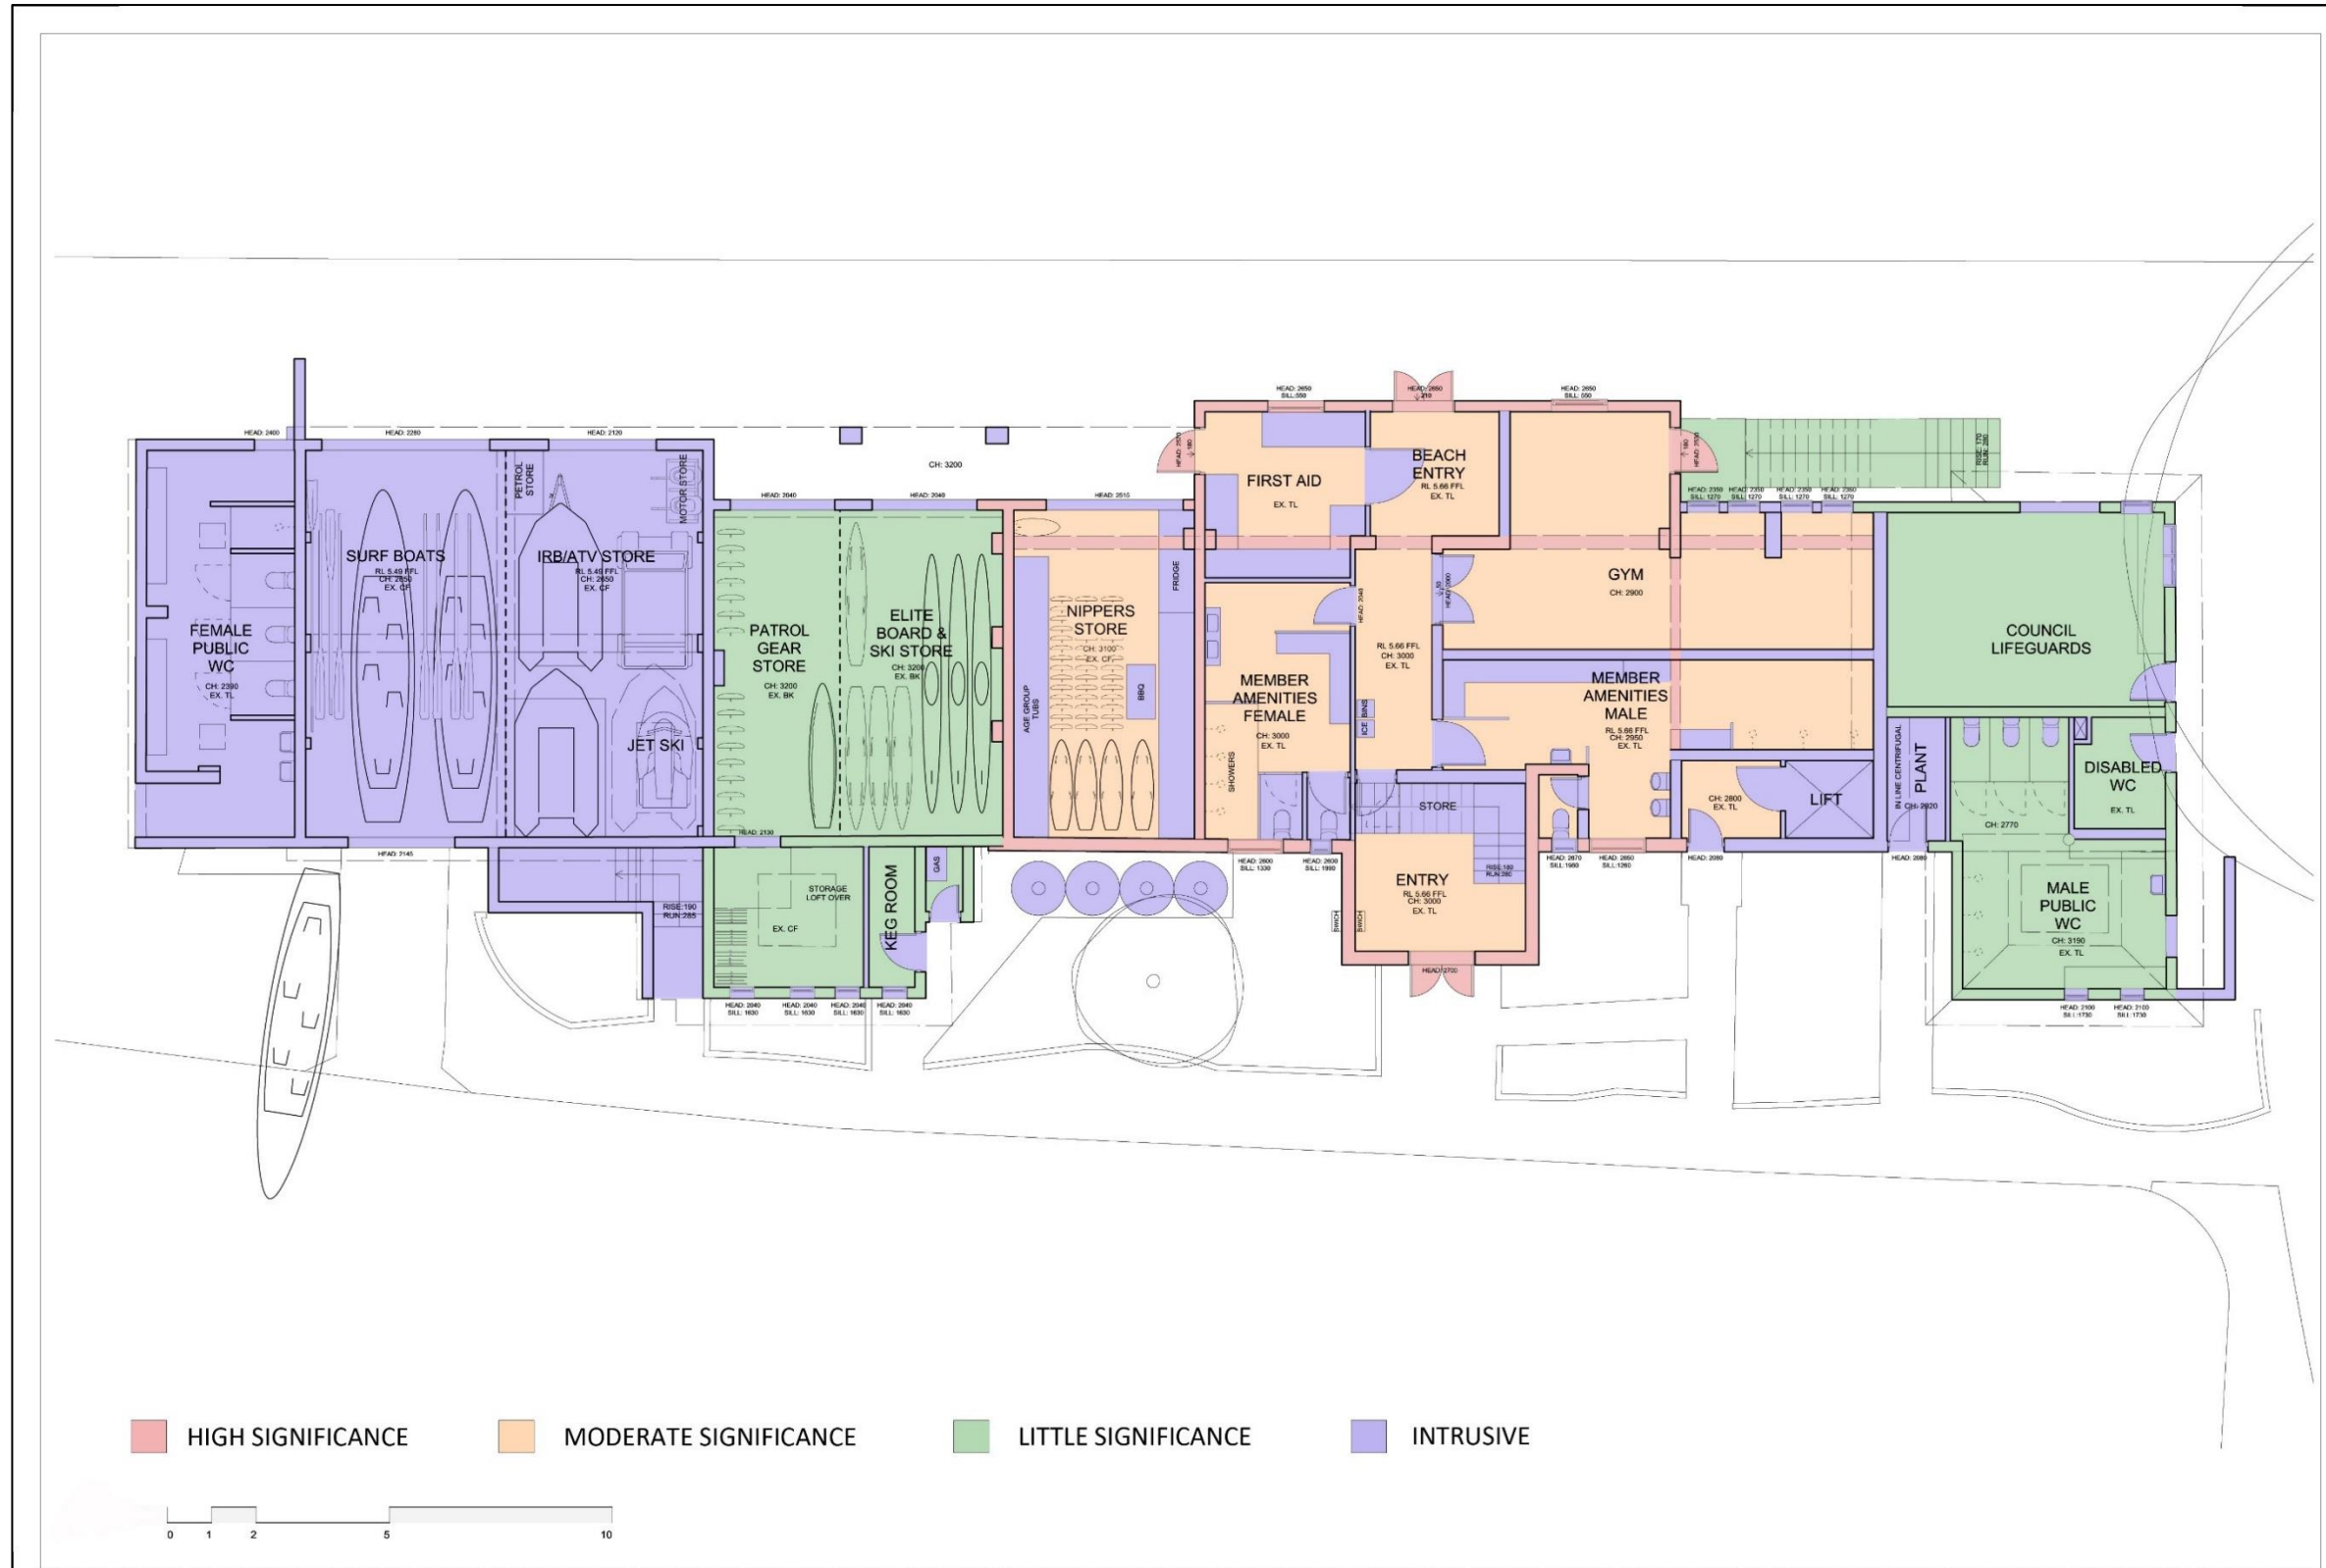
Figure 115. Levels of fabric significance on the ground floor of Newport SLSC.¹¹⁰

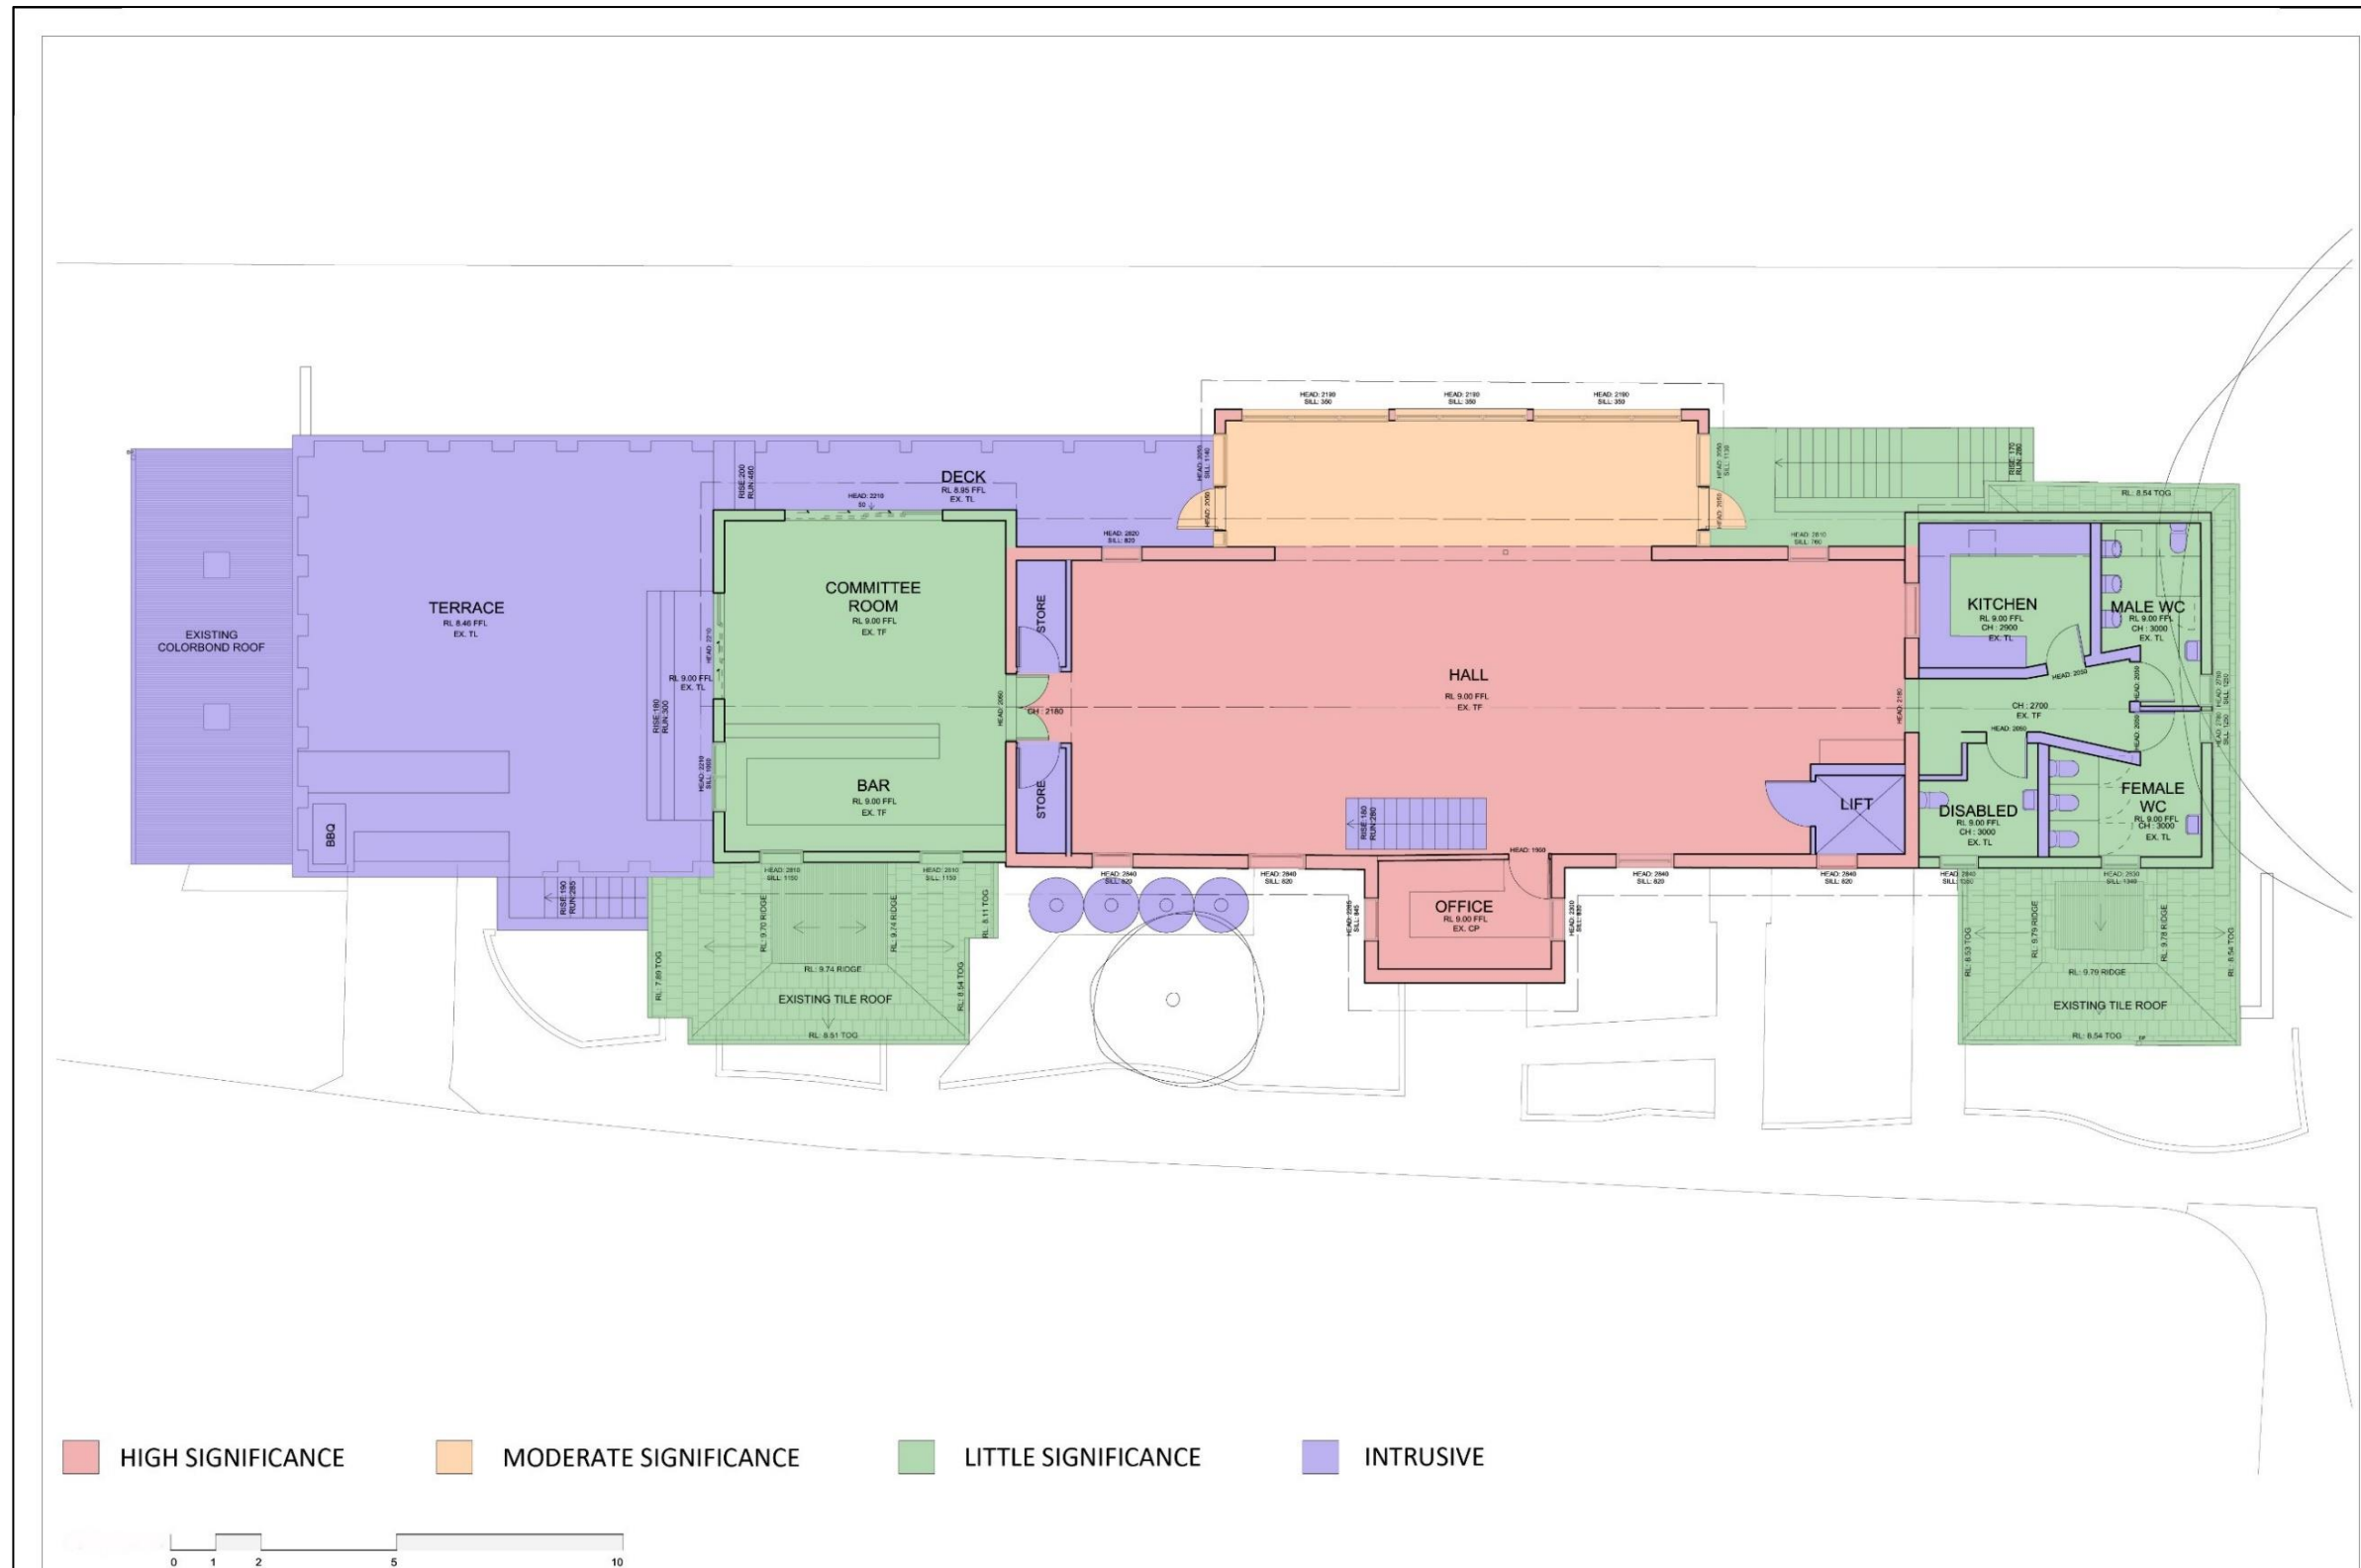
Figure 116. Levels of fabric significance on the first floor of Newport SLSC.¹¹¹

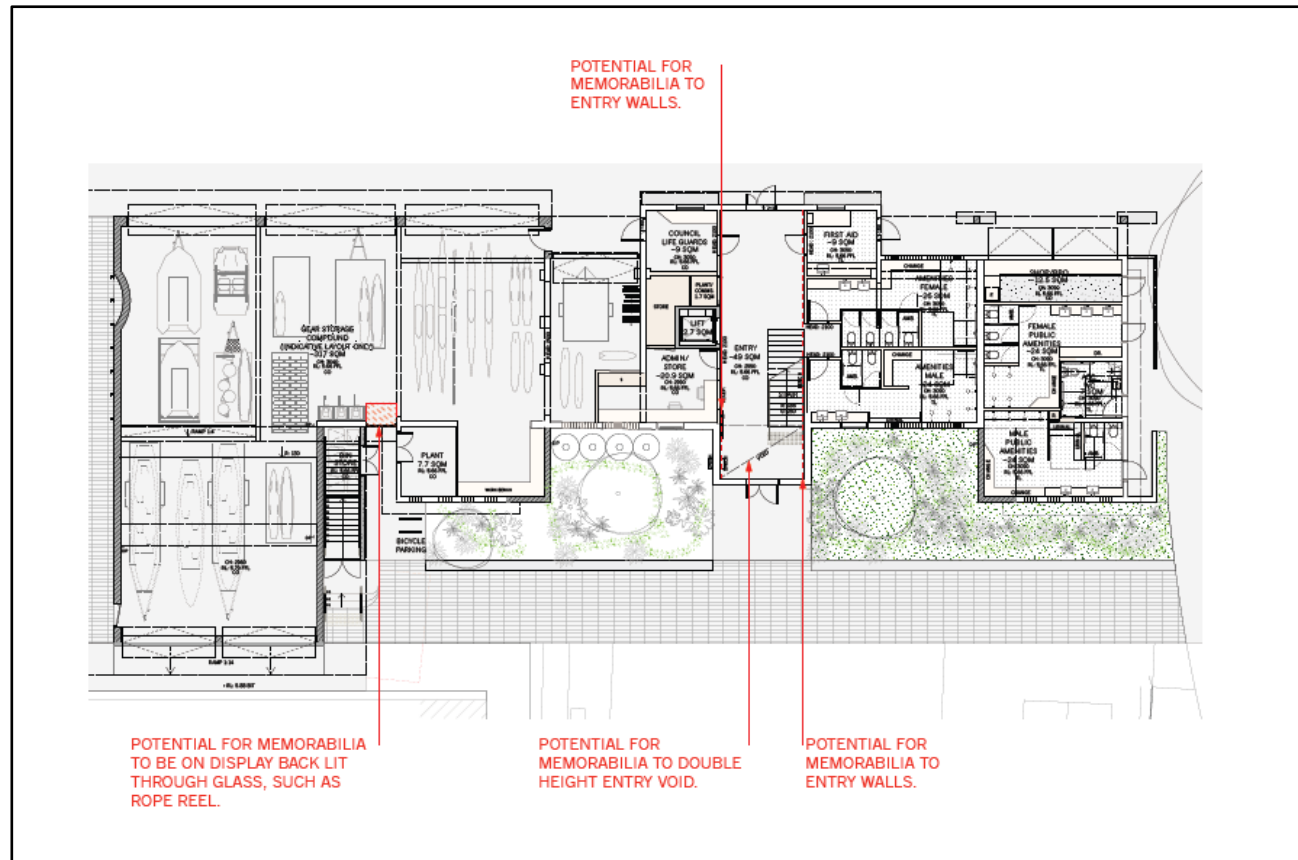
Figure 129. Proposed general locations for the display of moveable heritage – ground floor. (Source: Adriano Pupilli)

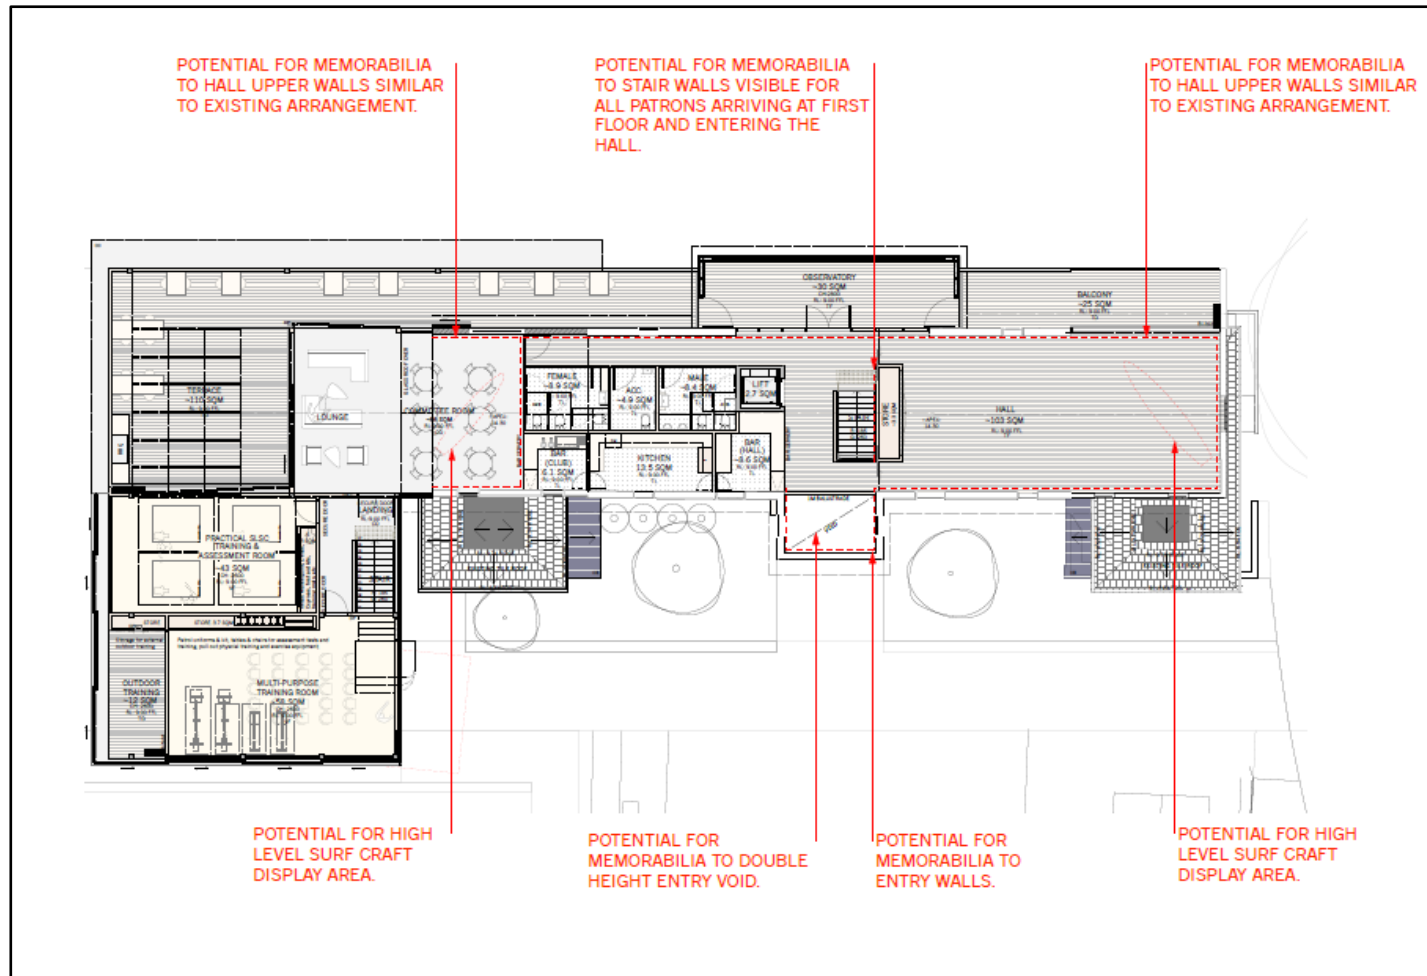
Figure 130. Proposed general locations for the display of moveable heritage – first floor. (Source: Adriano Pupilli)
