PRELIMINARY ENVIRONMENTAL SITE ASSESSMENT

1294-1300 Pittwater Road and 2-4 Albert Street,
Narrabeen NSW 2101

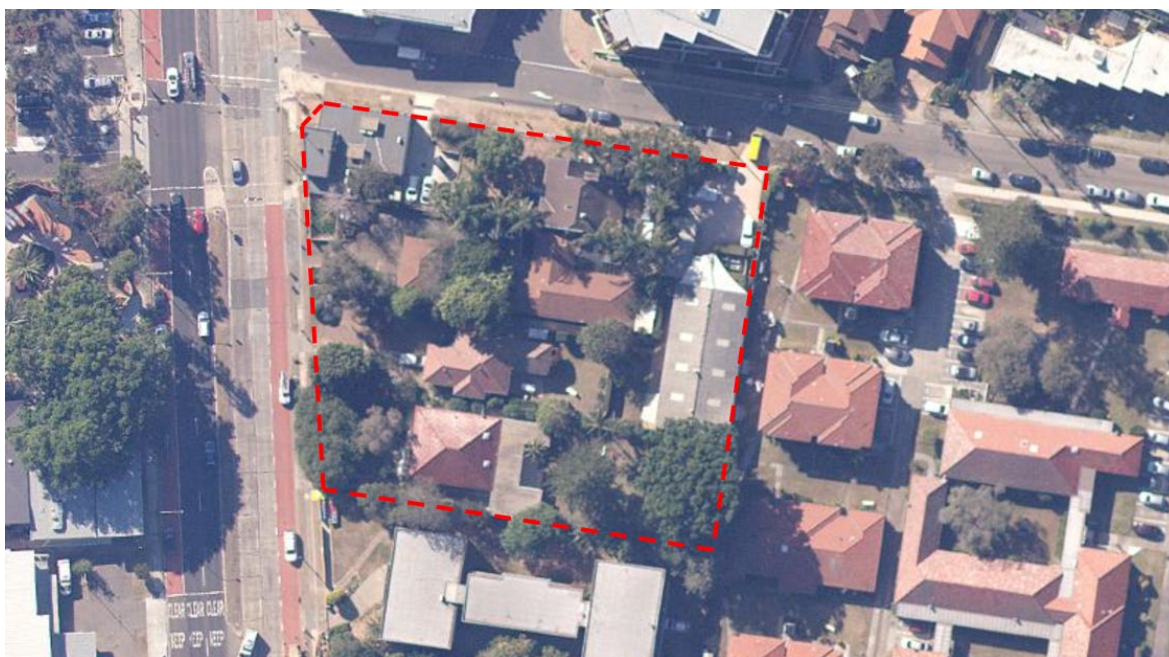
Figure 2.2 – Site Layout

The existing structures on the Site are shown on Figure 2.2 with the Site outlined in red.

The building at 4 Albert Street, the most eastern building, is a medical practice which consists of a single storey brick building with a paved driveway from Albert Street and carpark in the northern portion of the property that occupies approximately one third of this premises.

The building at 2 Albert Street is a single storey residential dwelling of roughcast render and weatherboard with a tiled roof.

The building at 1300 Pittwater Road is commercial offices of cement render with a concrete paved driveway from Albert Street and parking in the rear.

The buildings at 1298 Pittwater Road, 1296 Pittwater Road and 1294 Pittwater Road are residential premises. The buildings at 1298 Pittwater Road and 1296 Pittwater Road consists of brick buildings and tiled roofing and 1294 Pittwater Road consists of cement render and tiled roofing.

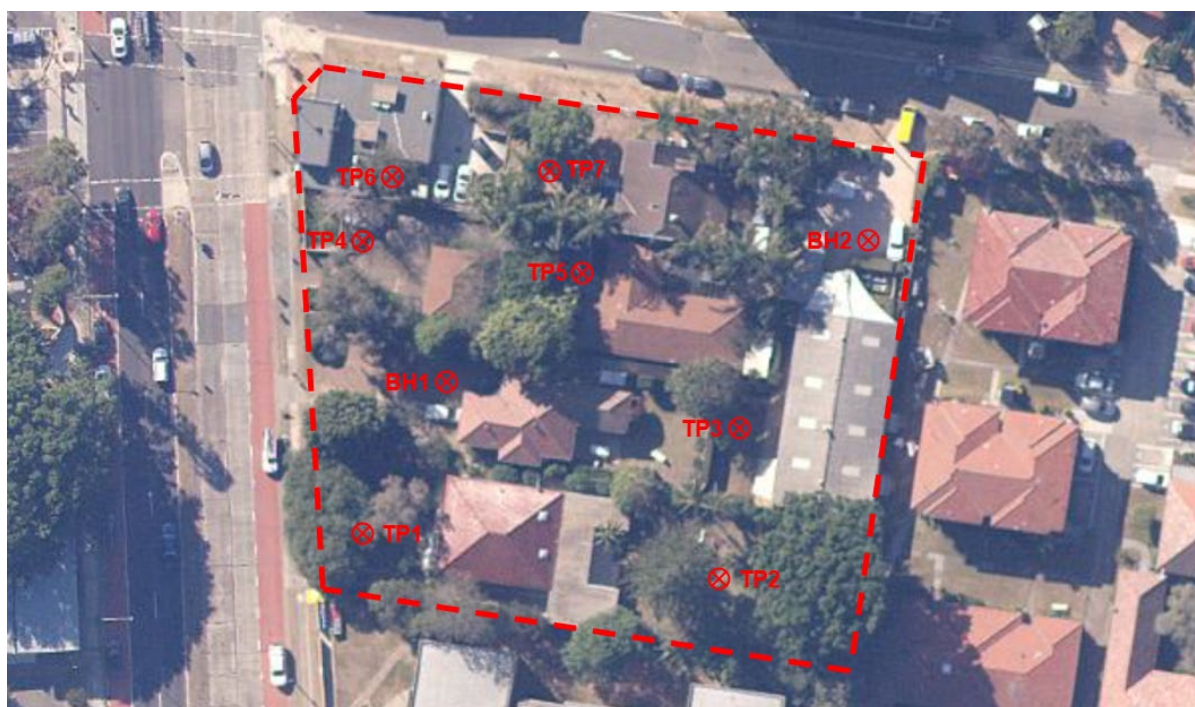
Figure 8.1 – Sample Location Plan

The locations of the test pits and boreholes are presented on Figure 8.1 – Sample Location Plan. The subsurface conditions encountered at each location are summarised in Table 8.1 – Subsurface Conditions.
