## INTEGRATED WATER CYCLE MANAGEMENT REPORT

### **RESIDENTIAL DEVELOPMENT**

3 CENTRAL ROAD, AVALON

Ref. No.: 19279\_C\_RPT\_IWCM Report

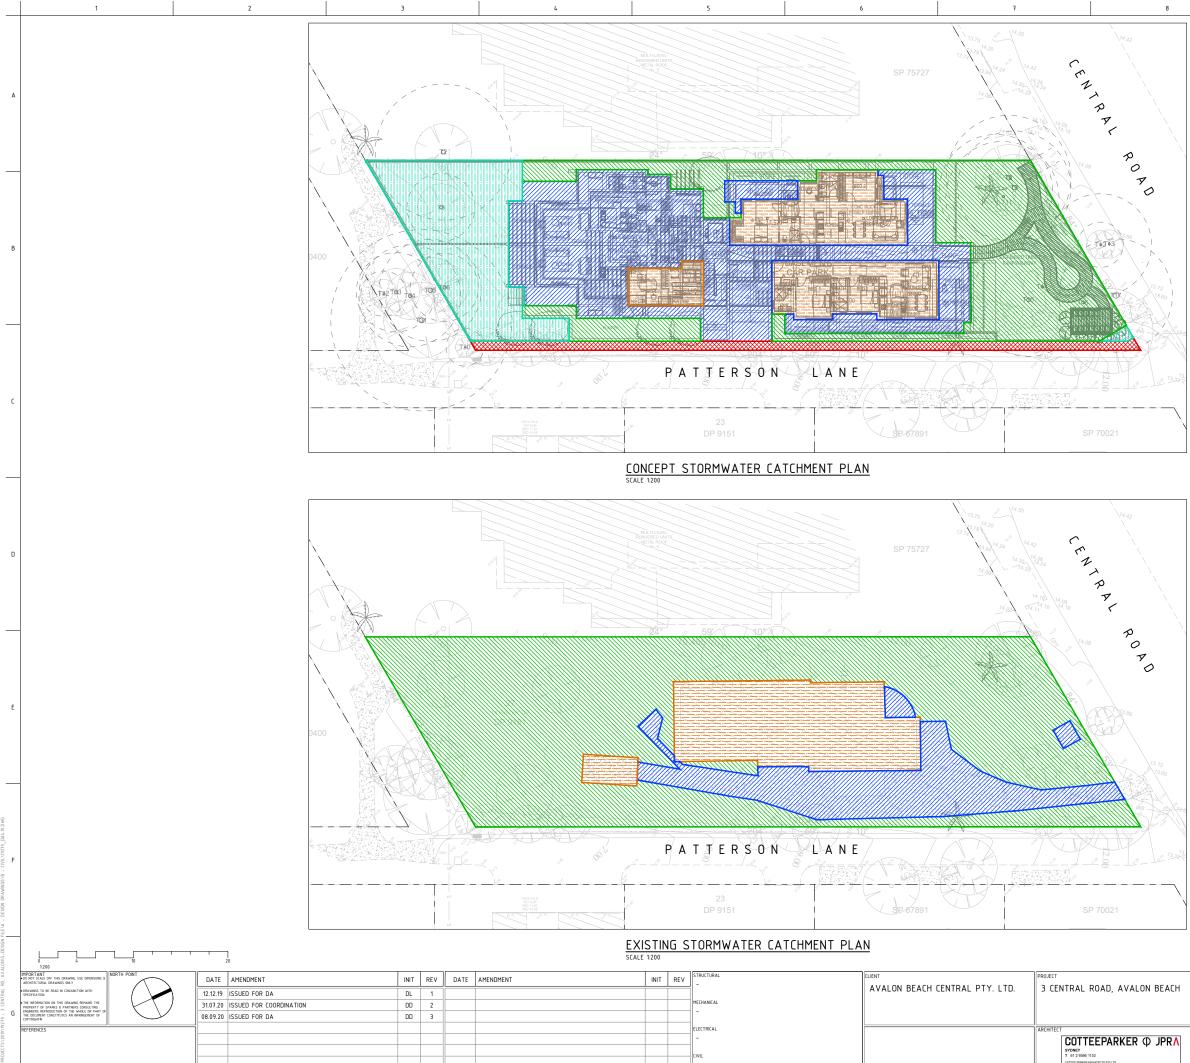
CIVIL DESIGN CONCEPT STORMWATER CATCHMENT PLAN

9		10	
LEGE	<u>END</u>	IMPERVIOUS CATCHMENT AREA TO	0.050 =		
		476m <sup>2</sup> PERVIOUS CATCHMENT AREA TO ( 404m <sup>2</sup>	DSD =		
		NON TRAFFICABLE ROOF CATCHME TO RWT = 256m <sup>2</sup> IMPERVIOUS BYPASS CATCHMENT			A
		67m <sup>2</sup> PERVIOUS BYPASS CATCHMENT A 214m <sup>2</sup>	REA =		
		TOTAL AREA = 1,417m <sup>2</sup>

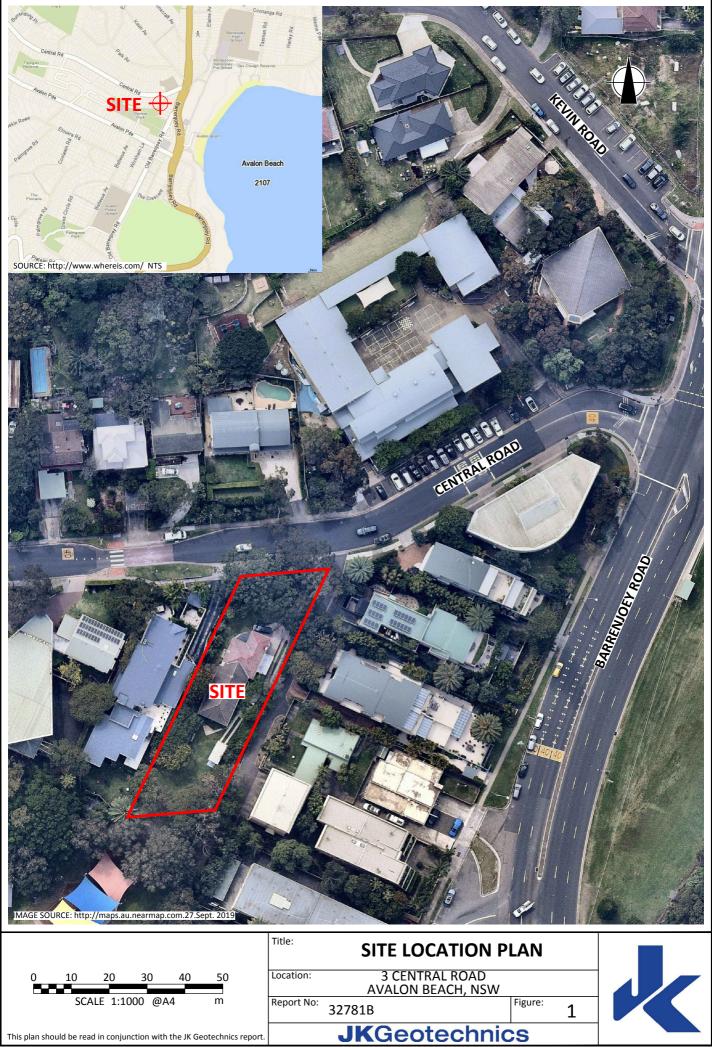
Client:		ON CEN							
Project:		PROPOSED INDEPENDENT LIVING UNITS							
Location:	: 3 CEN	NTRAL F	ROA	D, AV	ALON BEACH, NSW				
Job No.:	32781B			Meth	od: SPIRAL AUGER		R	.L. Surfa	ace: ≈ 12.7m
Date: 30/	/10/19						D	atum: A	\HD
Plant Typ	<b>e:</b> JK205			Logg	jed/Checked by: A.C.K./T.C.				
Groundwater Record ES U50 SAMPLES	DS Field Tests		Graphic Log	Unified Classification	DESCRIPTION	Moisture Condition/ Weathering	Strength/ Rel. Density	Hand Penetrometer Readings (kPa.)	Remarks
DRY ON DMPLET-		0	$\bigotimes$		FILL: silty sand, fine to medium $\neg$ grained, dark grey brown, trace of root	М			GRASS COVER
ION		-		SP	SAND: fine to medium grained, light	М	(L)	F	ALLUVIAL
	N = 10 3,3,7	1-		CI-CH	\grey brown, trace of silt. Silty CLAY: medium to high plasticity, light brown, with fine to medium grained sand.	w <pl< td=""><td>Hd</td><td>455 405 510</td><td>RESIDUAL</td></pl<>	Hd	455 405 510	RESIDUAL

СН	Silty CLAY: high plasticity, light grey and red brown, with fine to medium grained sand.				
	N = 17 5,7,10	2-						>600 >600 >600	-
	N > 30 13,17/	3			as above, but with medium grained ironstone gravel and fine to medium grained sand.			- - - - - - - - - - - - - - - - - - -	
	REFUSAL	4 -		-	Extremely Weathered siltstone: silty CLAY, medium to high plasticity, light grey, with iron indurated bands.	XW	Hd	<u>&gt;600</u>	NEWPORT FORMATION
					as above, but with high strength sandstone bands.			-	VERY LOW 'TC' F RESISTANCE WI HIGH BANDS GROUNDWATER MONITORING W INSTALLED TO 6 HAND SLOTTED 50mm DIA. PVC STANDPIPE 4m 6m. CASING 0m 4m. 2mm SAND
					END OF BOREHOLE AT 6.0m				FILTER PACK 3m FILTER PACK 3m 6m. BENTONITE SEA 0m TO 3m. BACKFILLED WI SAND TO SURFA COMPLETED WI CONCRETED GA COVER

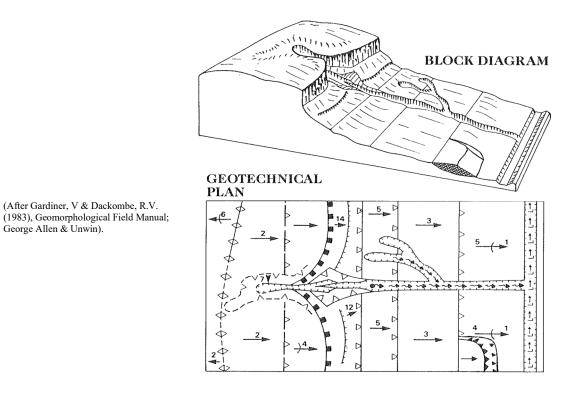
#### EXAMPLE OF USE OF TOPOGRAPHIC SYMBOLS:

# **GEOTECHNICAL MAPPING SYMBOLS**

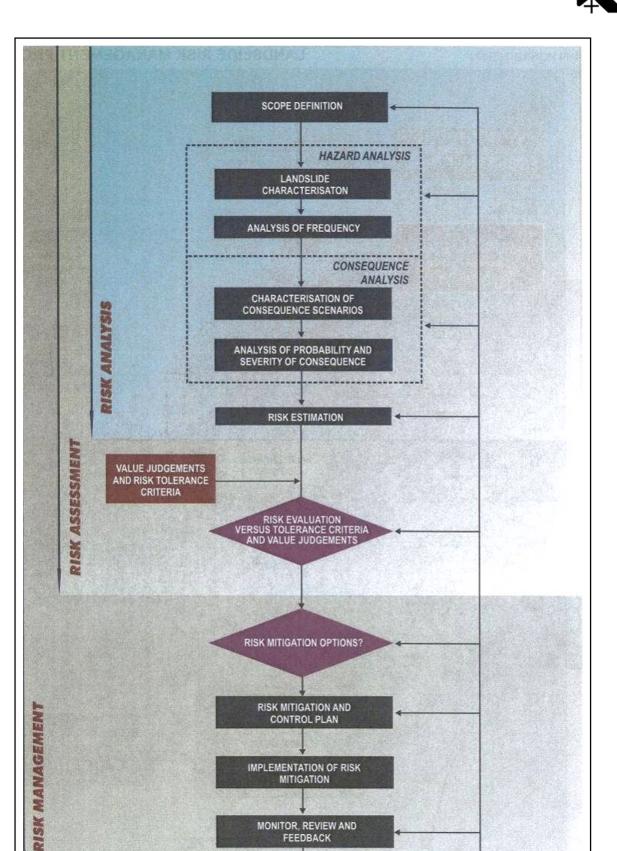
FIGURE A1: Flowchart for Landslide Risk Management.

This figure is an extract from GUIDELINE FOR LANDSLIDE SUSCEPTIBILITY, HAZARD AND RISK ZONING FOR LAND USE PLANNING, as presented in Australian Geomechanics Vol 42, No 1, March 2007, which discusses the matter more fully.

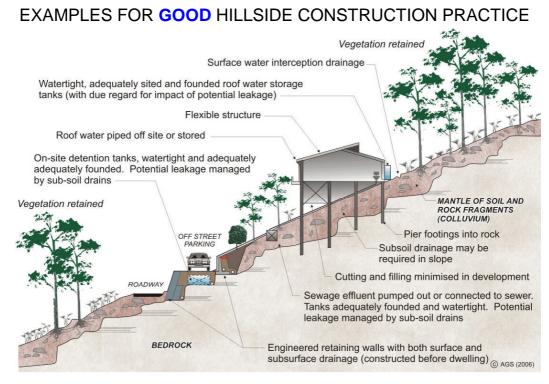
Sensible development practices are required when building on hillsides, particularly if the hillside has more than a low risk of instability (GeoGuide LR7). Only building techniques intended to maintain, or reduce, the overall level of landslide risk should be considered. Examples of good hillside construction practice are illustrated below.

#### WHY ARE THESE PRACTICES GOOD?

**Roadways and parking areas -** are paved and incorporate kerbs which prevent water discharging straight into the hillside (GeoGuide LR5).

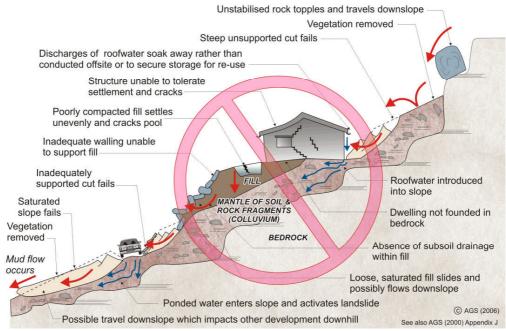
# EXAMPLES FOR **POOR** HILLSIDE CONSTRUCTION PRACTICE

#### WHY ARE THESE PRACTICES POOR?

Roadways and parking areas - are unsurfaced and lack proper table drains (gutters) causing surface water to pond and soaks into the ground.
