PRELIMINARY GEOTECHNICAL INVESTIGATION AND LANDSLIDE RISK ASSESSMENT

**173 SEAFORTH CRESCENT, SEAFORTH NSW
2092**

REF-18-6460-A

17th August 2018

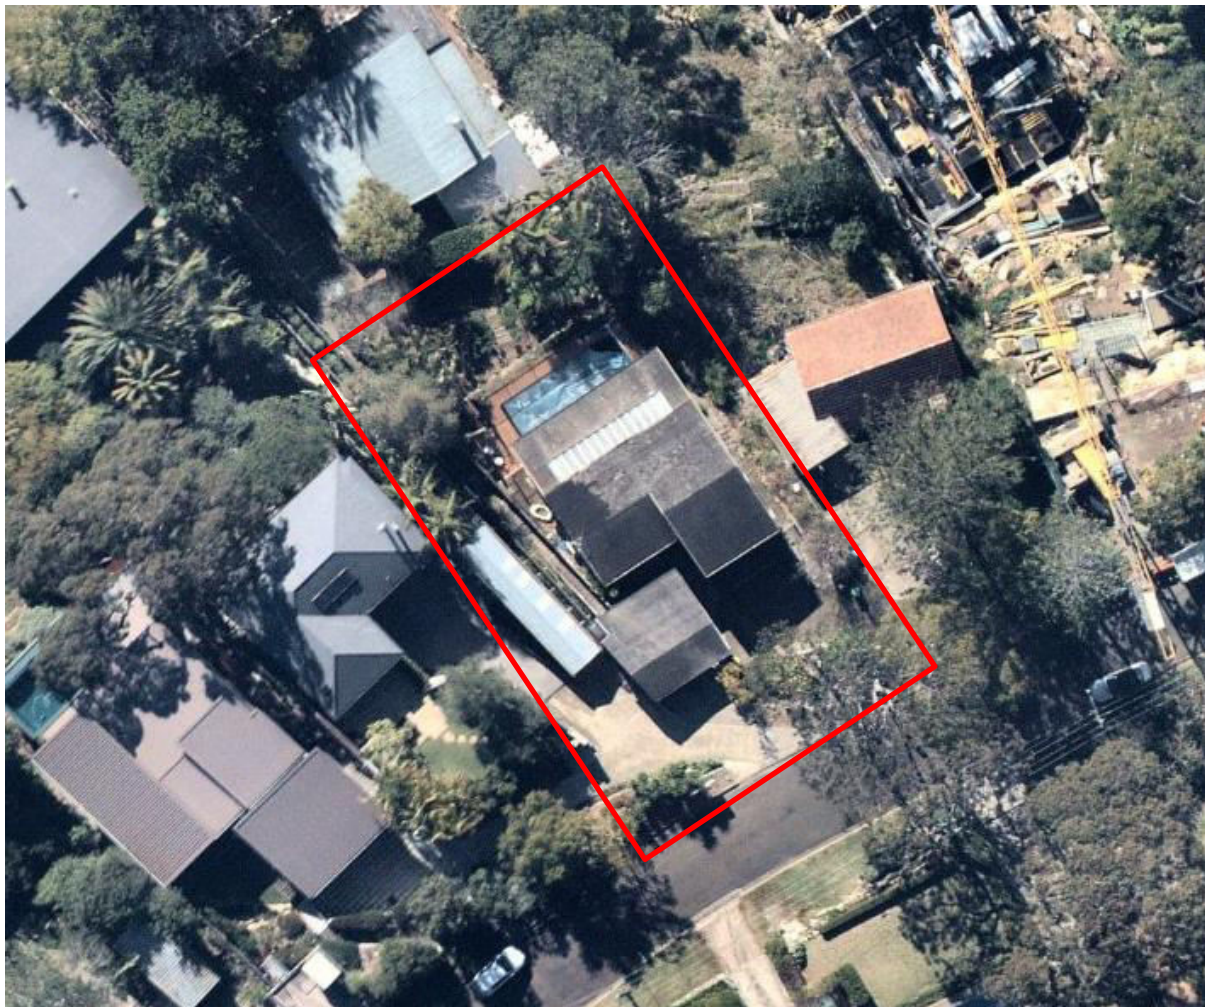
Figure 2 Site Location

The site was located at 173 Seaforth Crescent, Seaforth NSW. The site was situated on a moderately steep sloping block (Figure 2). At the time of the site inspection displayed existing dual level residential property with a moderate to steep sloping concrete driveway leading to a basement garage. A raised existing carport resides on the western boundary of the property. An inground swimming pool, terraced (retained) landscaped garden areas and paved courtyards are present at the rear of the property. An existing inclinometer featured along the western side of the property.

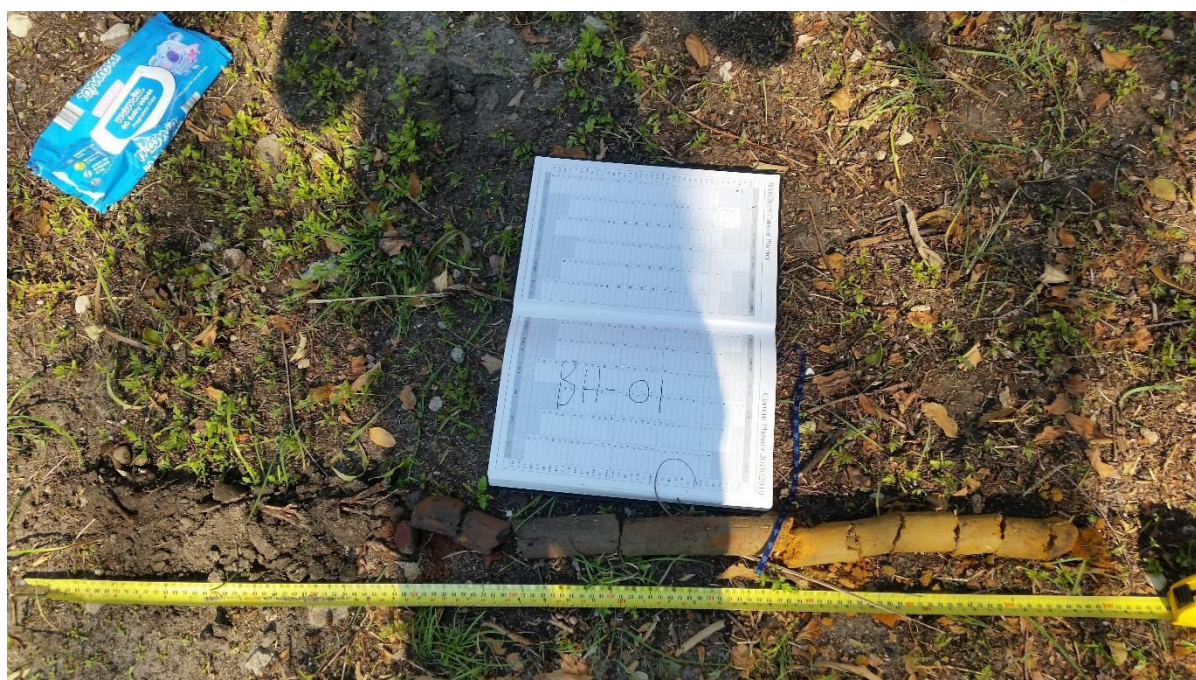
Figure 3 Undisturbed Borehole Sample (BH01)

Depth (m)	Material Description
0.00 – 0.40	FILL: TOPSOIL; Admixed sand and gravel, grey to dark-grey, organics (roots), fine to coarse sand and gravel, slightly moist
0.40 – 1.10 (LOI)	FILL: Clayey SAND; orange-brown becoming increasingly orange, low plasticity, organics (roots), fine to medium sands, slightly moist to moist, moisture content < plastic limit

The following figures present the undisturbed recovered material from the boreholes;

During the site investigation subsurface conditions (BH01 & BH02) presented evidence of uncontrolled sand fill greater than 0.8m in depth. In accordance with AS2870-2011 the site may be classified as “Class P”.

Local geology and site conditions generally feature shallow rock however the extent of investigation displayed uncontrolled fill greater than 1.10m. The borehole investigation was limited to the rear of the property where several levels of retained areas are present to manage the natural slope profile of the site. The recovered material from the boreholes is assumed backfill material for the retaining walls.

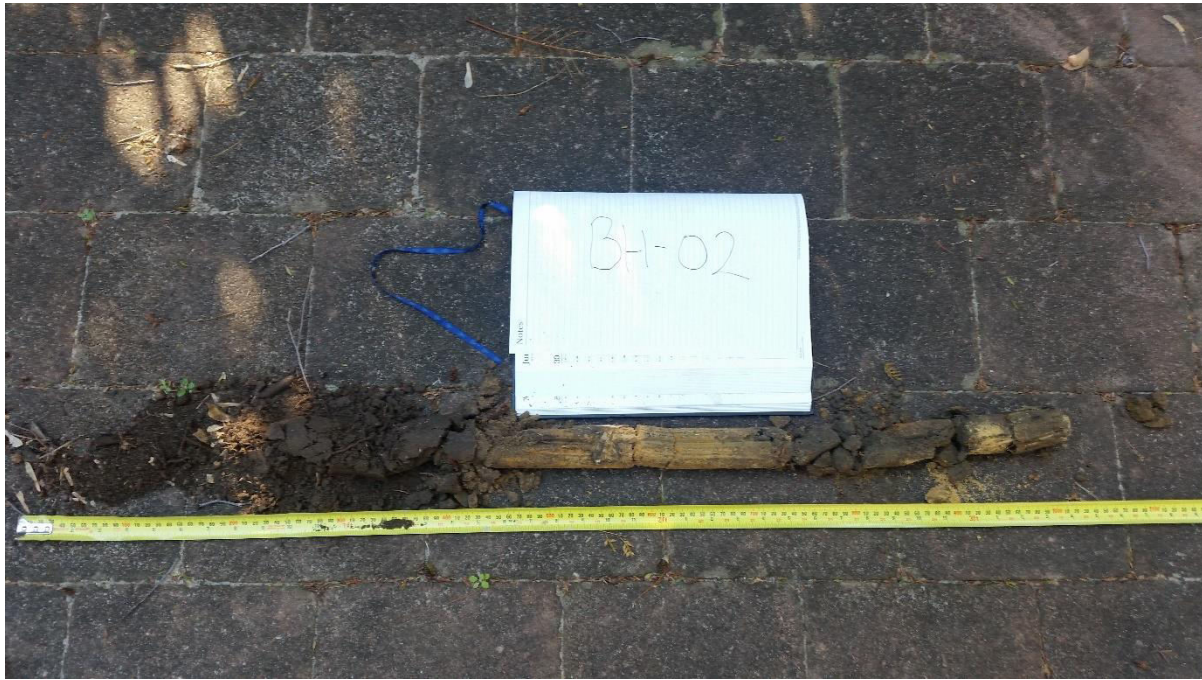
Figure 4 Undisturbed Borehole Sample (BH02)

Depth (m)	Material Description
0.00 – 0.40	FILL: TOPSOIL; Admixed sand and gravel, grey to dark-grey, organics (roots), fine to coarse sand and gravel, slightly moist
0.40 – 0.70	FILL: Clayey SAND; orange, low plasticity, organics (roots), fine to medium sands, slightly moist to moist, moisture content < plastic limit
0.70 – 1.10 (LOI)	FILL: SAND; brown, low plasticity, trace organics (roots), fine to medium sands, trace coarse gravels up to 20mm, slightly moist to moist, moisture content < plastic limit

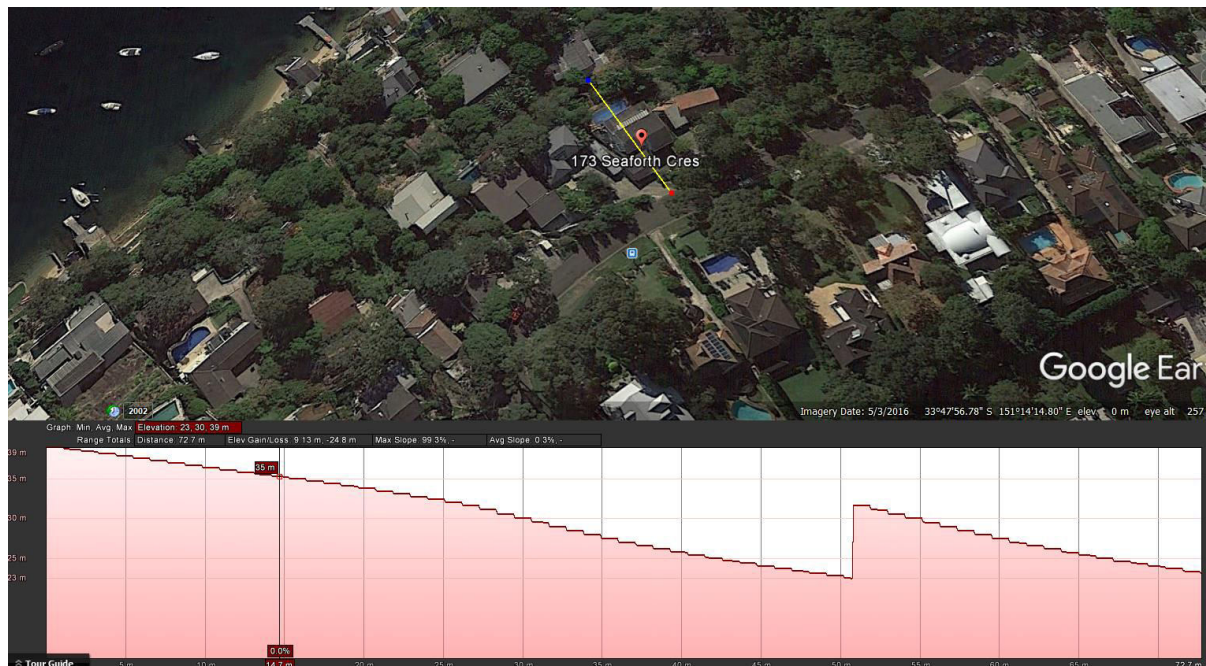
Figure 8 Site Cross Section Slope Elevation

Figure 8 below shows the cross-section elevation of the slope of the site.

The site was well landscaped with low to medium sized trees and shrubs bordering the property at the rear of the site. Low lying vegetation and shrubs occupied the retained areas of the property. No evidence of erosion was identified within the site. The retaining walls consisted of sandstone blocks and pre-cast concrete crib construction. Soil moisture was observed as slightly moist to moist although minimal soil movement (shrink-swell) is anticipated due to the sandy loam soils.

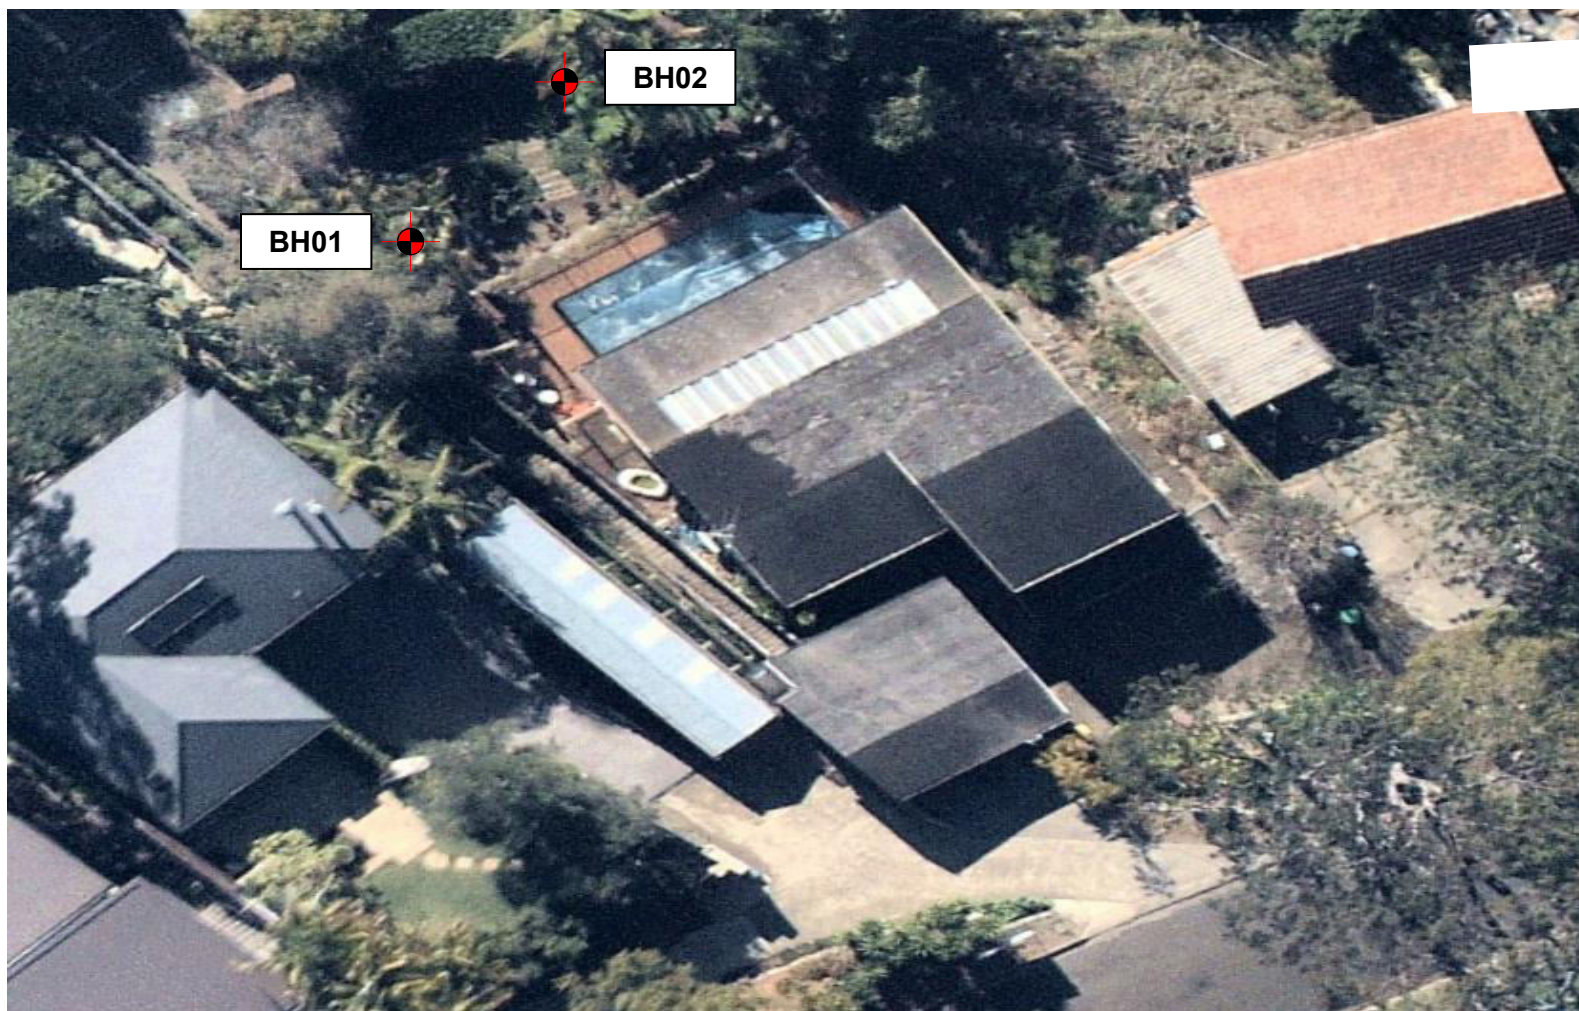
Borehole and DCP Test locations

Note: Borehole not to size. Borehole/test location approximate.
DCP undertaken in all locations.

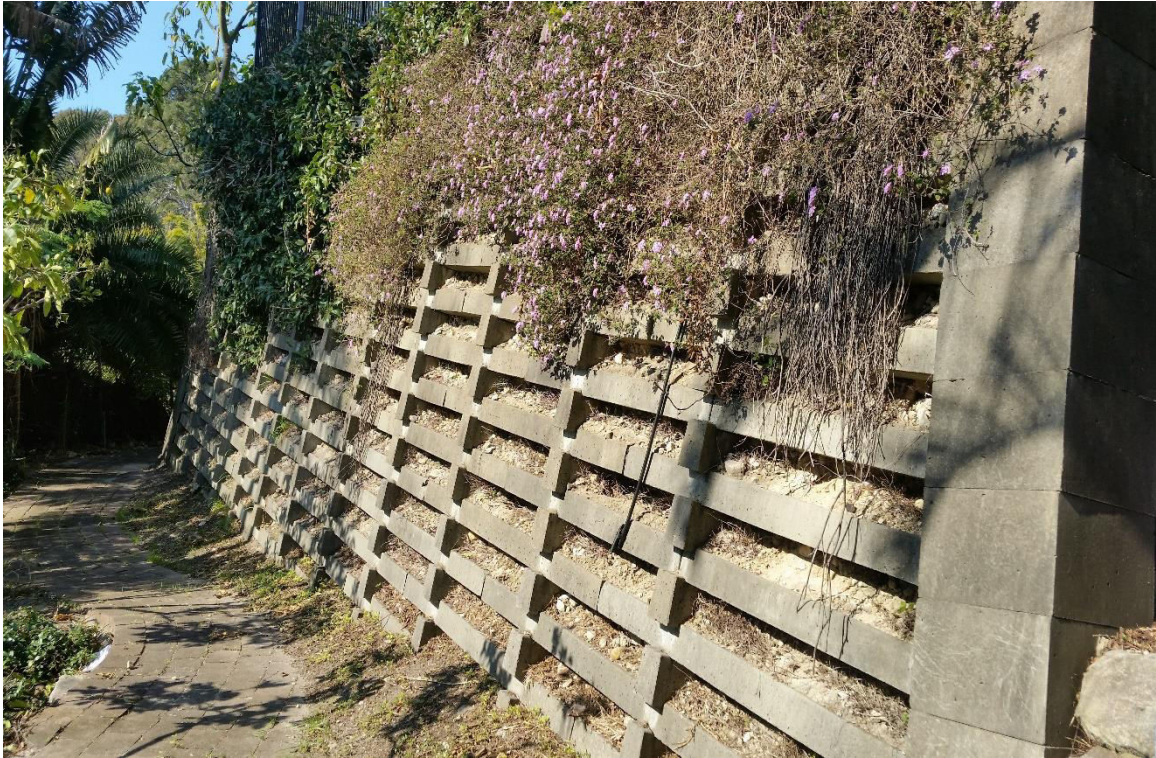
Pre-cast concrete crib retaining wall
