REPORT TO
SYESUN PTY LTD

ON
INTERIM ASBESTOS MANAGEMENT PLAN

FOR
FLOWER POWER GARDEN CENTRE

AT
277 MONA VALE ROAD, TERREY HILLS, NSW

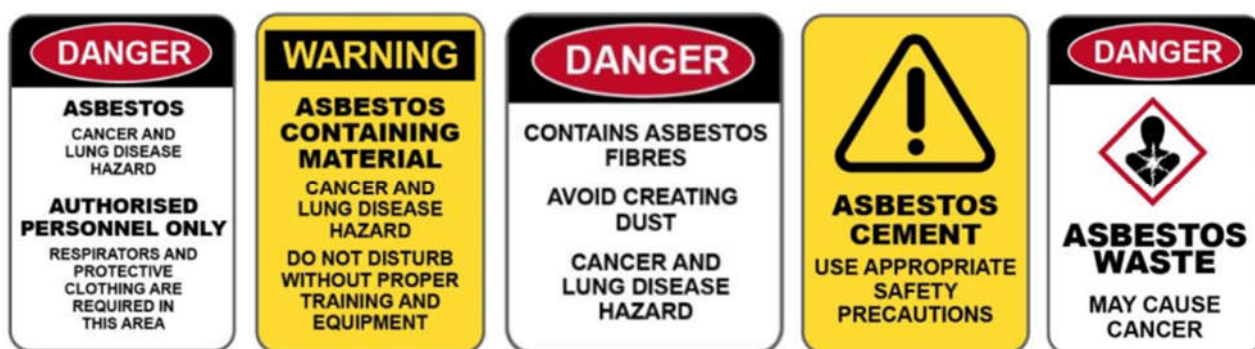
In-text Figure A: Example signage

The location, type and positioning of signs and labels must be decided, or authorised, by a competent person. Asbestos warning signs must comply with the requirement of AS1319-1994 Safety Signs for the Occupational Environment and the CoP How to Manage and Control Asbestos in the Workplace, for size, illumination, location and maintenance. Warning signs may include some of the following examples:
