J2765. 29th June, 2020. Page 1.

GEOTECHNICAL INVESTIGATION:

New Pool at 14 Bubalo St, Warriewood.

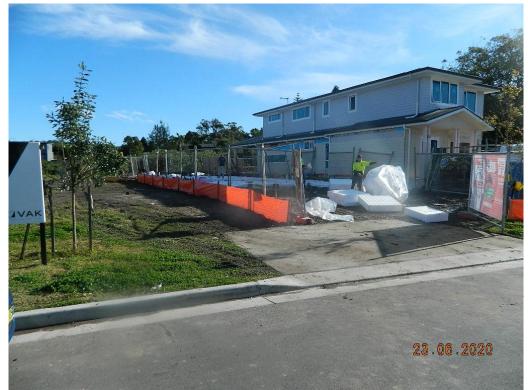
Photo 1

2.3 The property is a new development on a previously vacant lot on Bubalo Street. The new house being built is part of a separate development application. The property is accessed by a concrete driveway at the road frontage (Photo 1). Recently laid fill has been used to raise the property and neighbouring properties. The fill is supported by a stable ~1.8m high concrete retaining wall along the NW property boundary (Photo 2).

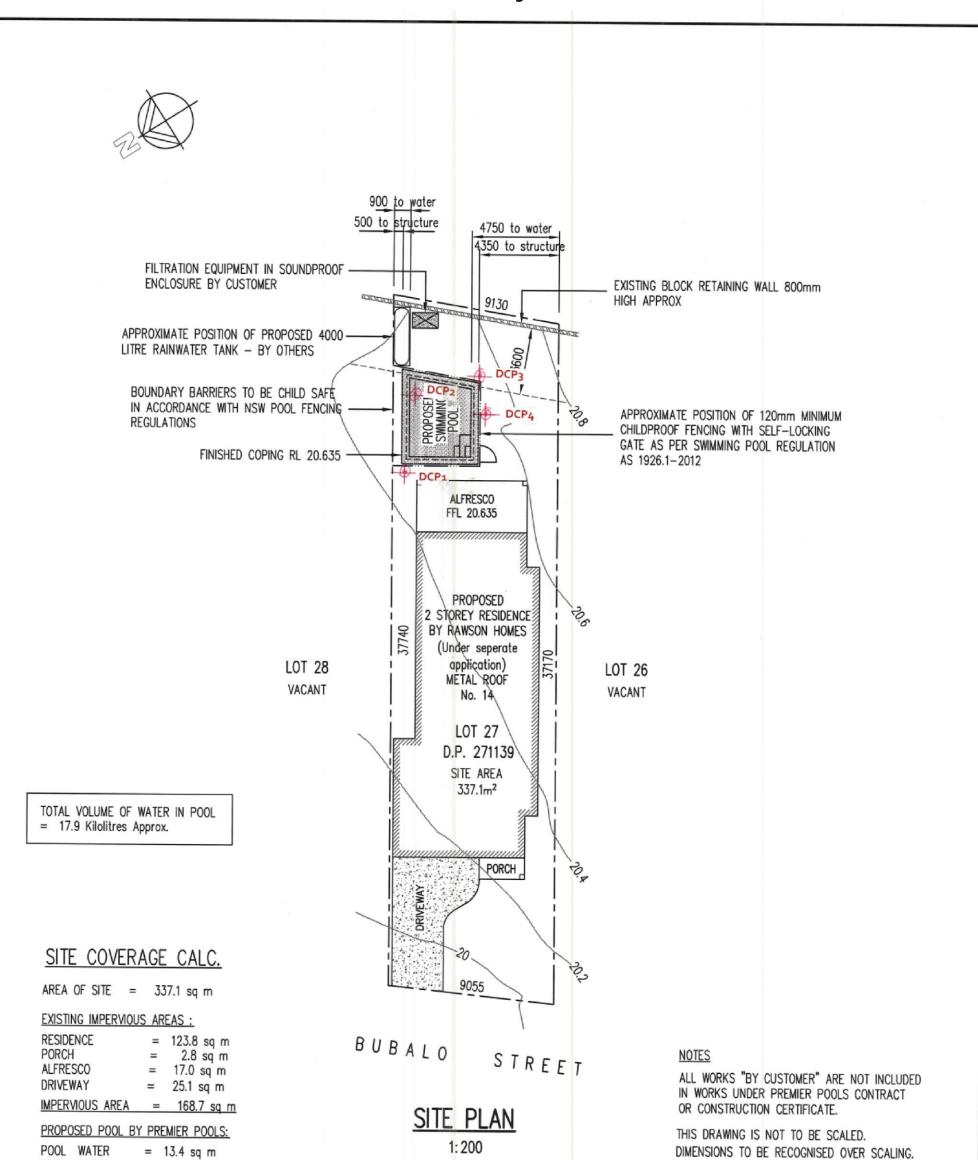
SITE PLAN – showing test locations

Four Dynamic Cone Penetrometer (DCP) tests were put down to determine the relative density of the overlying soil and the depth to weathered rock. The locations of the tests are shown on the site plan. It should be noted that a level of caution should be applied when interpreting DCP test results. The test will not pass through hard buried objects so in some instances it can be difficult to determine whether refusal has occurred on an obstruction in the profile or on the natural rock surface. It is expected DCP2 to DCP4 hit refusal on dense engineered fill, but DCP1 penetrated through this material. Although unlikely, due to the possibility that the actual ground conditions vary from our interpretation there should be allowances in the excavation and foundation budget to account for this. We refer to the appended "Important Information about Your Report" to further clarify. The results are as follows:
