**Proposed Mixed-Use Development
351-353 Barrenjoey Road, Newport NSW**

Preliminary Geotechnical Assessment

Our ref: 5622-G1
23 July 2019

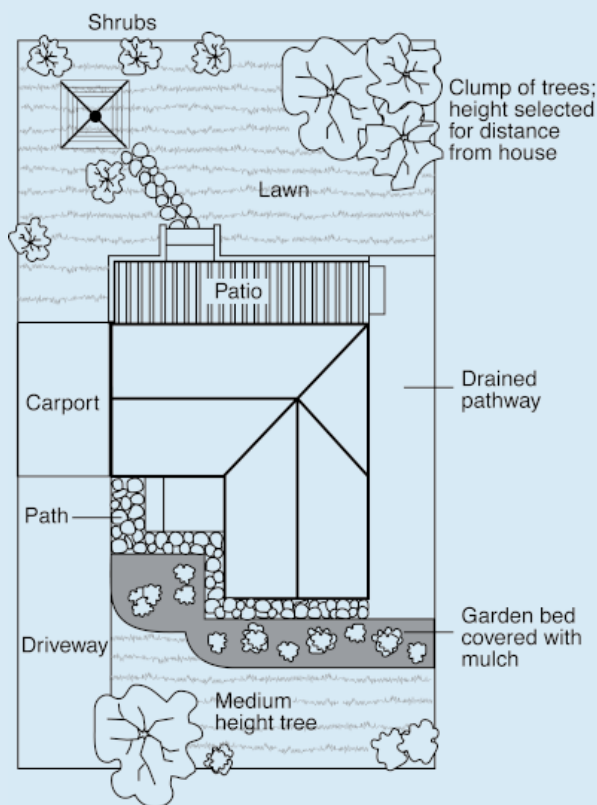
Gardens for a reactive site

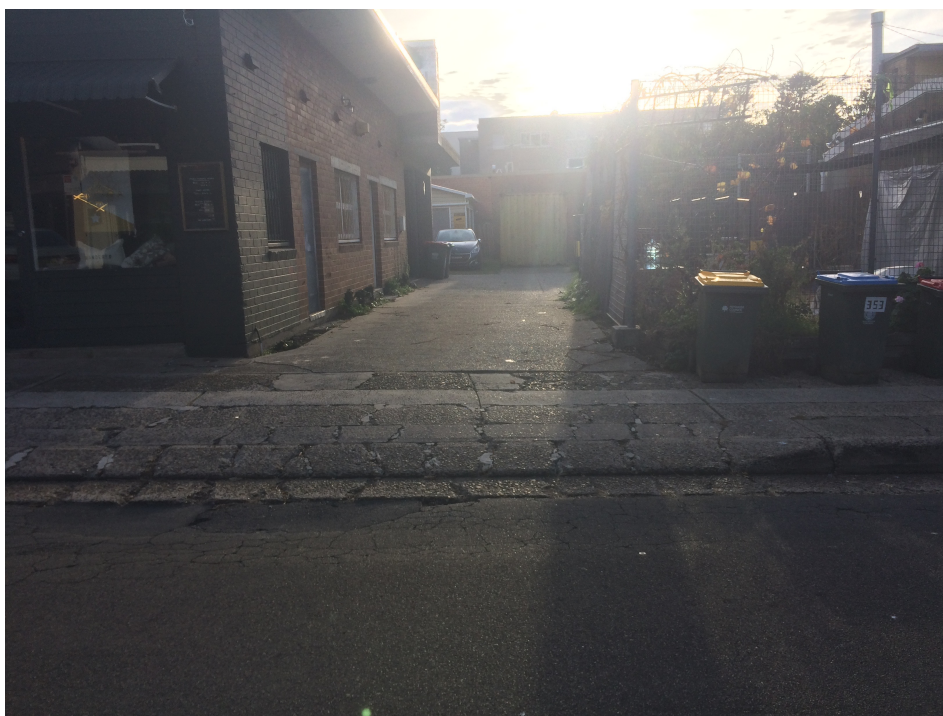
Photo 1

Driveway via Robertson
Road, cracks on
concrete pavement
