Remediation Action Plan

Proposed Upgrade of
Narrabeen North Public School
Narrabeen Education Precinct
Namona Street, Narrabeen

Prepared for
NSW Department of Education

Project 86973.04
August 2022

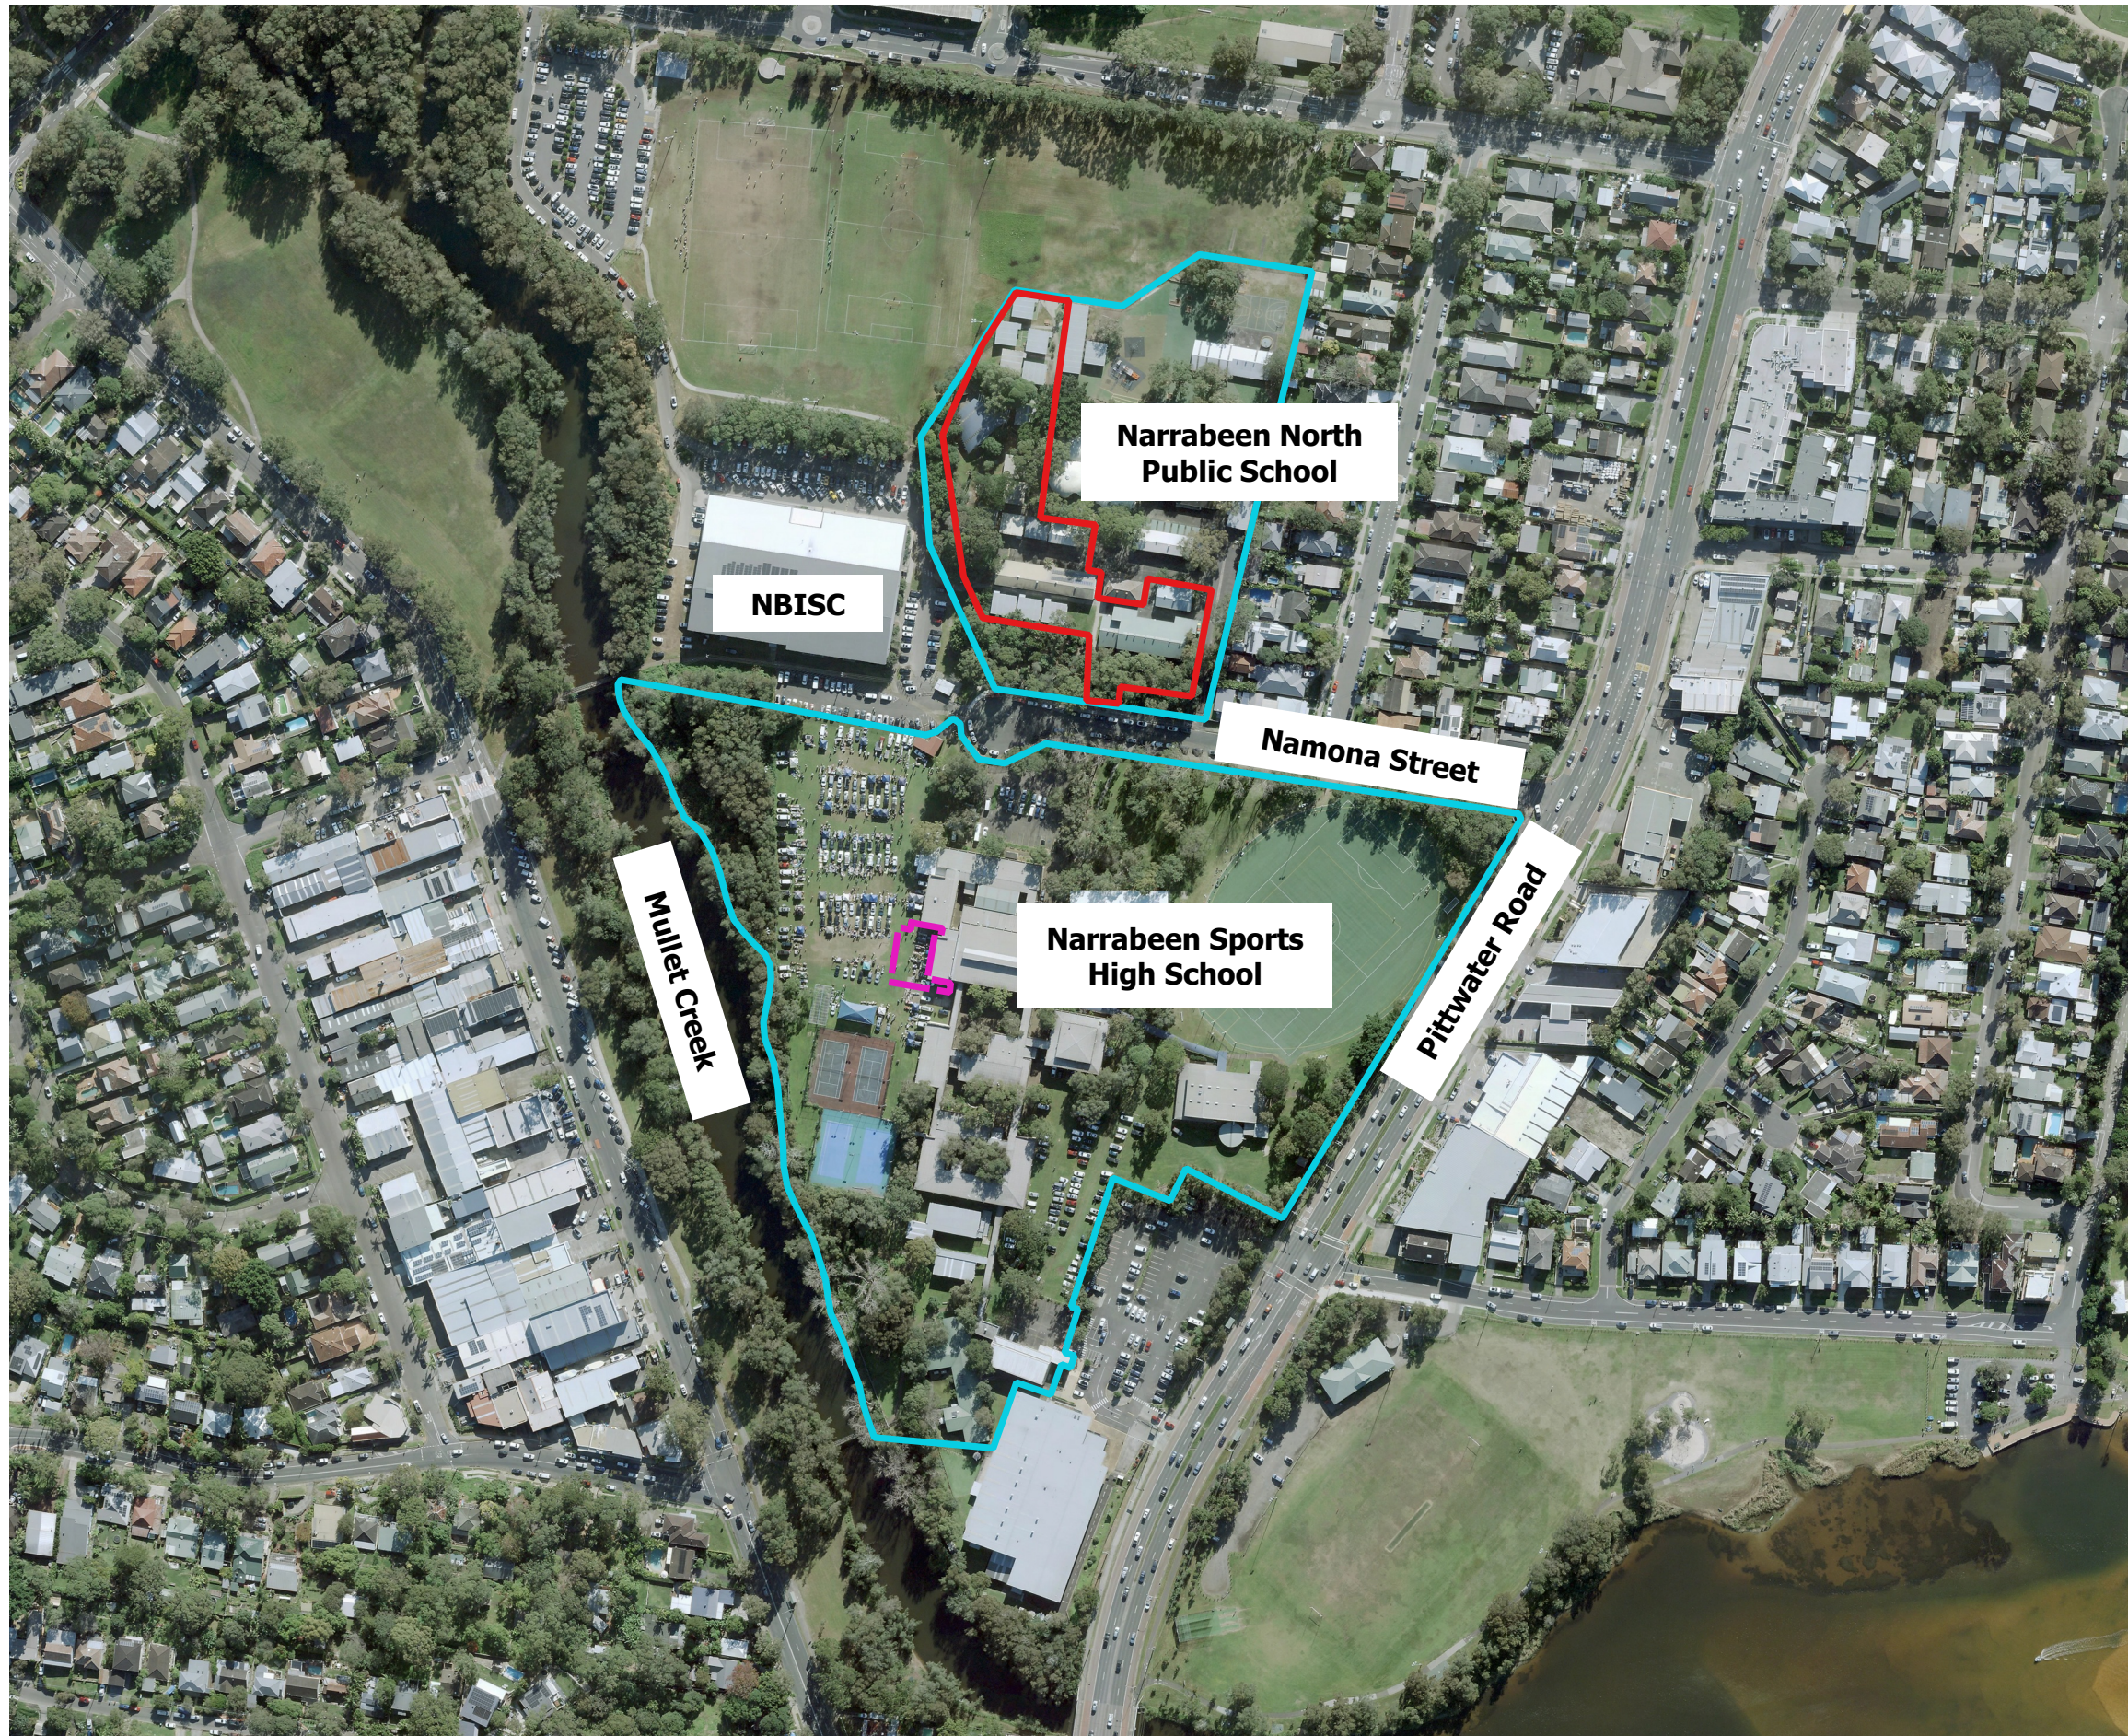
- Site Boundaries
- NNPS Proposed Work Area
- NSHS Proposed Work Area

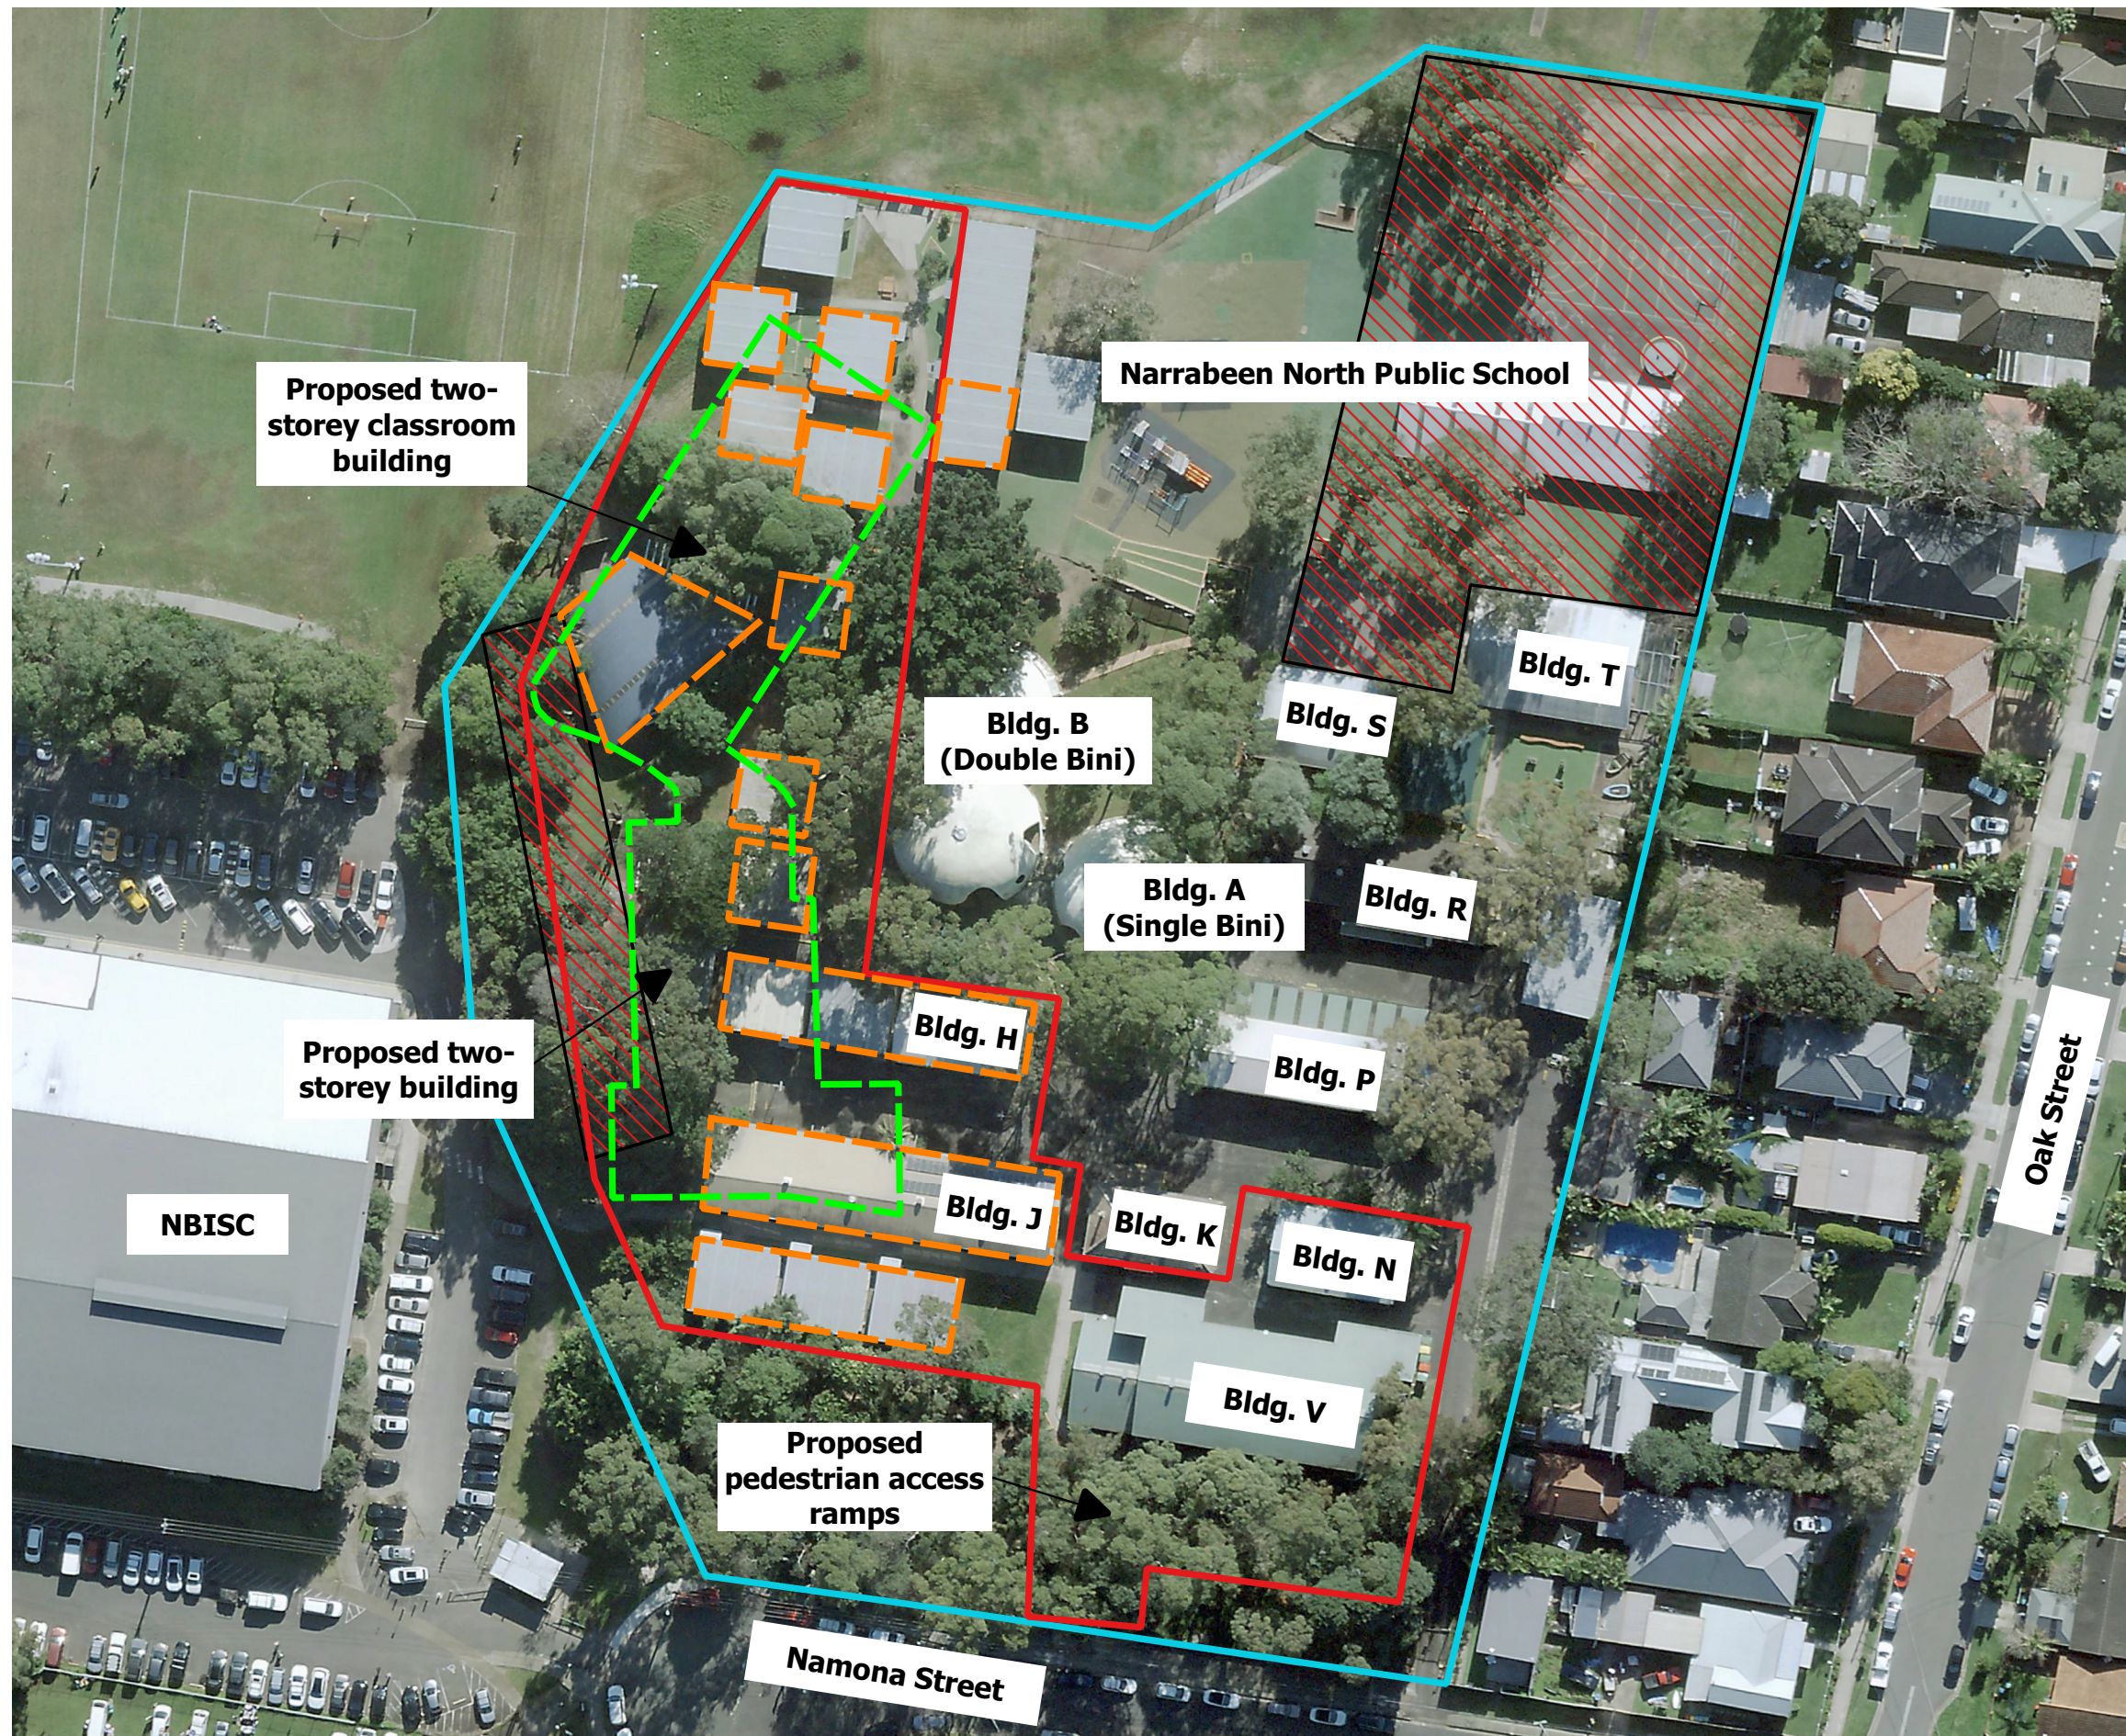
1. Basemap from metromap.com
2. Locality map from OSM Standard
3. Boundaries shown are approximate only
4. NNPS AMP Asbestos Zones were sourced from Figure 1 of the AMP and are approximate only

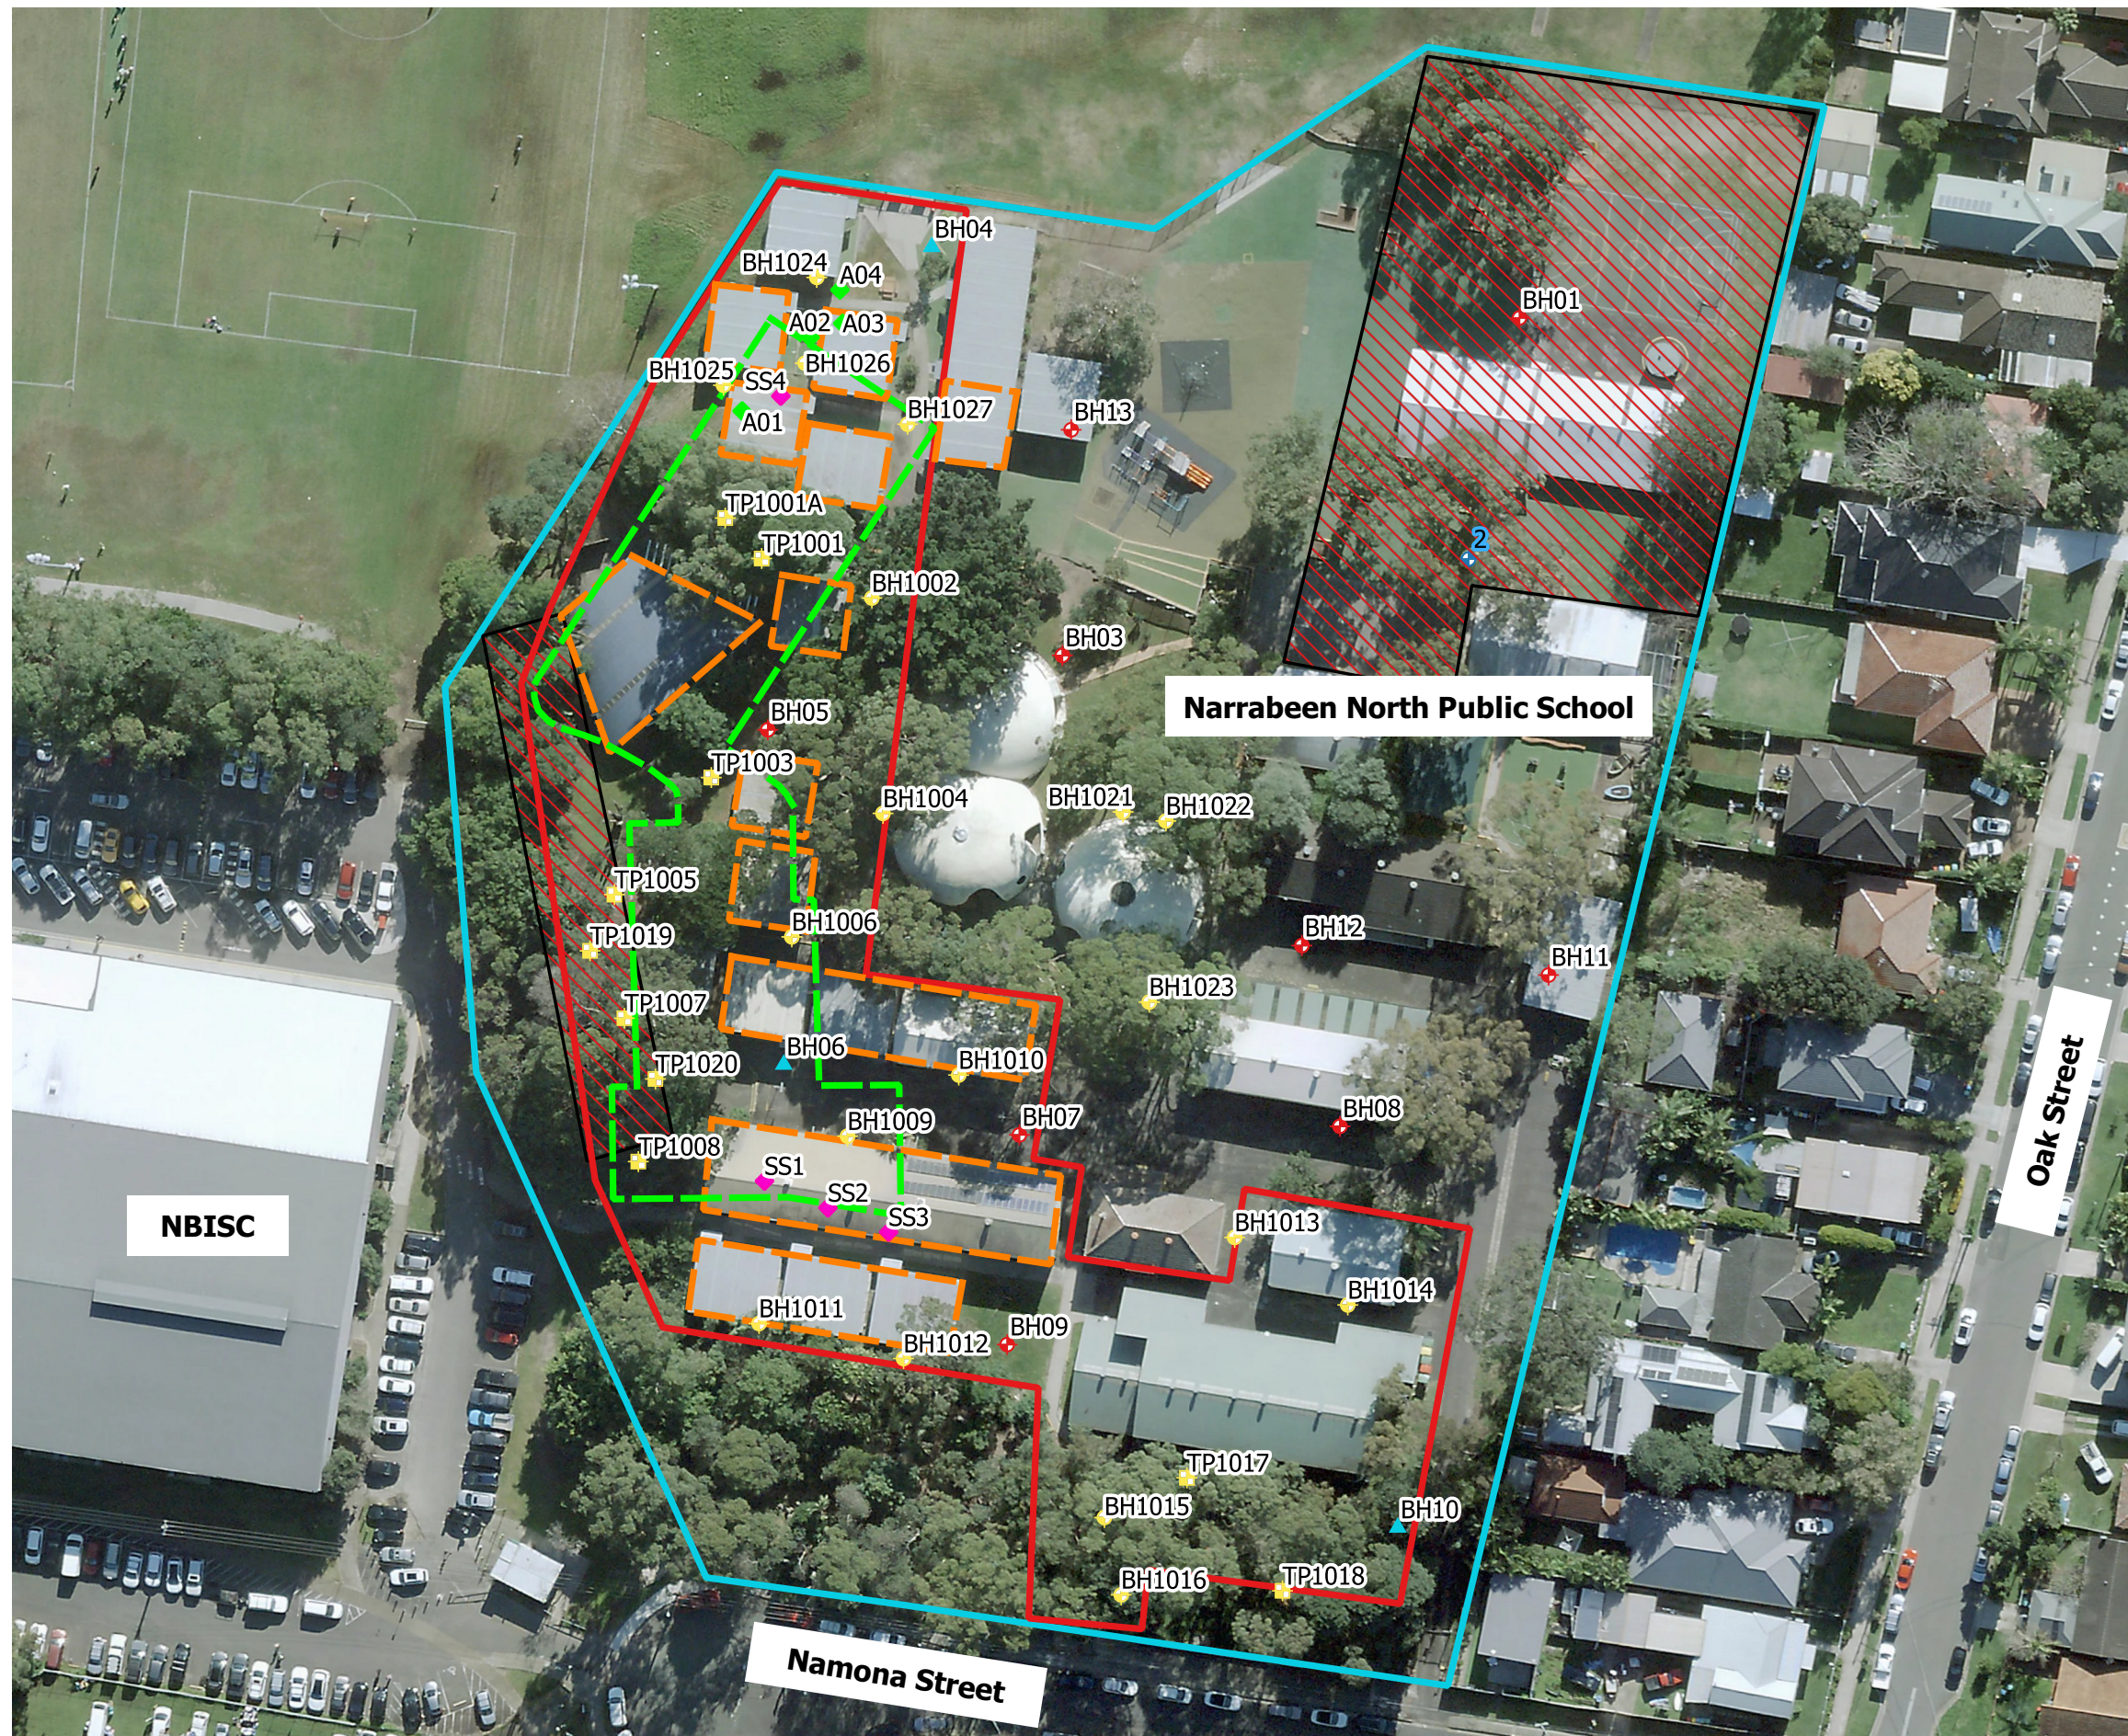
- Notes:
1. Basemap from metromap.com
 2. Locality map from OSM Standard
 3. Test locations and boundaries shown are approximate only
 4. NNPS AMP Asbestos Zones were sourced from Figure 1 of the AMP and are approximate only
 5. CPTs were also undertaken at some borehole locations

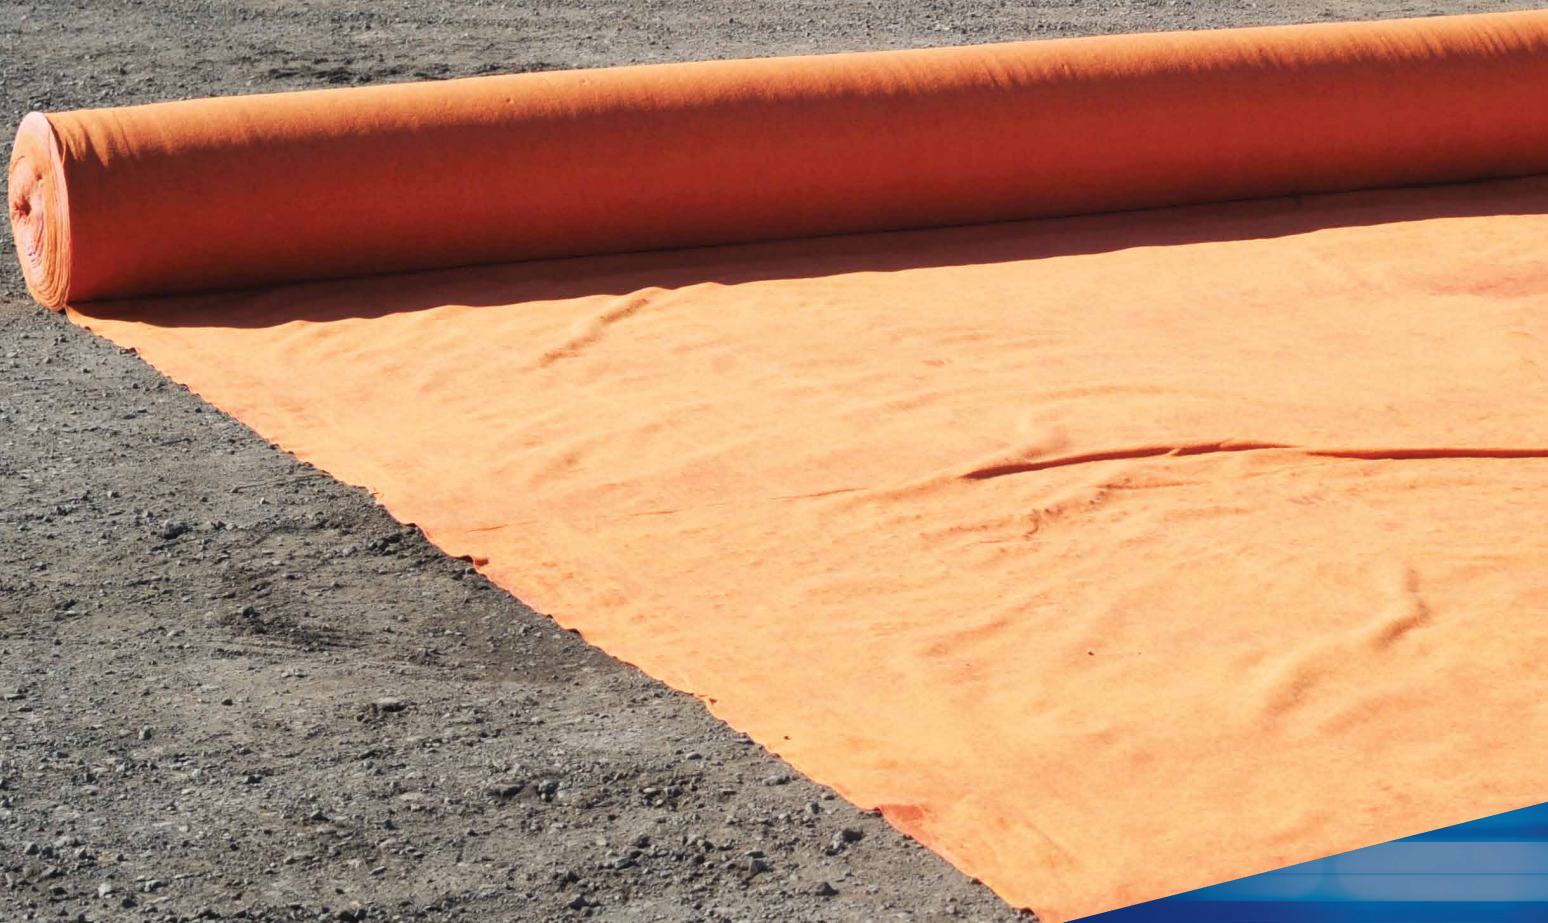
mastaTEX[™] GFO is a high quality staple fiber geotextile, designed for separating contaminated and non-contaminated soils. Due to its bright Orange coloring, mastaTEX[™] GFO is most commonly used as a warning layer in areas liable to future excavations. mastaTEX[™] GFO provides the same performance as other geotextiles in the mastaTEX[™] range.

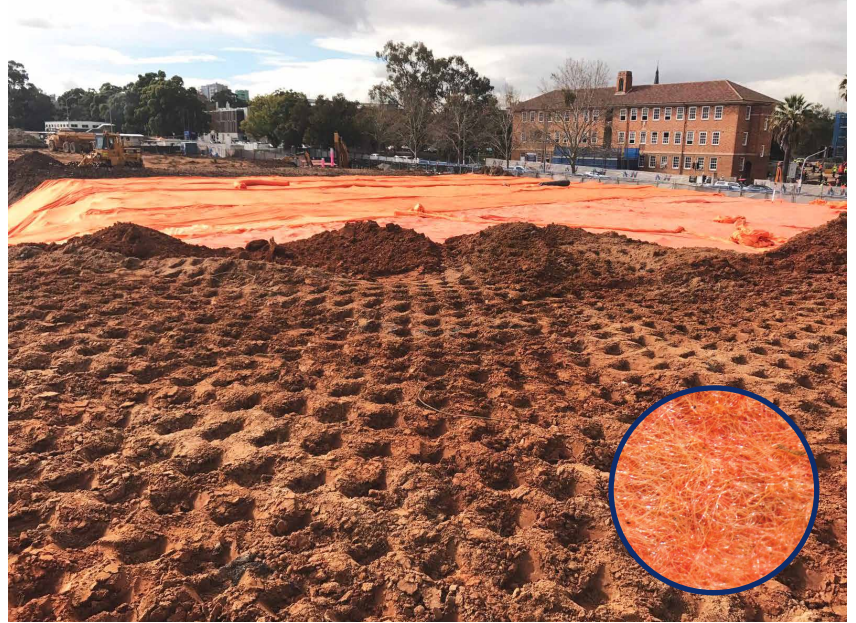
- ✔ Segregation of contaminated soil
- ✔ Filtration
- ✔ Warning Layer

TEST METHOD	UNIT	VALUES
INDEX PROPERTIES			
Material			Polyester (PET)
Grab Tensile Strength	AS 3706.2B	N	500
Wide Strip Tensile Strength	AS3706.2A	kN/m	8.1
Mass	AS 3760.1	gsm	140
TYPICAL HYDRAULIC PROPERTIES MEAN			
Pore Size	AS 3706.7	µm (Microns)	120
Nominal Flow Rate	AS 3706.9	l/m ² /s	240
DIMENSIONS			
Width		m	6
Length		m	150
Roll Diameter		m	400
