Geotechnical Assessment: Stormwater Harvesting and Irrigation Works - Bayview Golf Course, Cabbage Tree Road, Bayview, NSW

P2108485JR01V01
October 2021

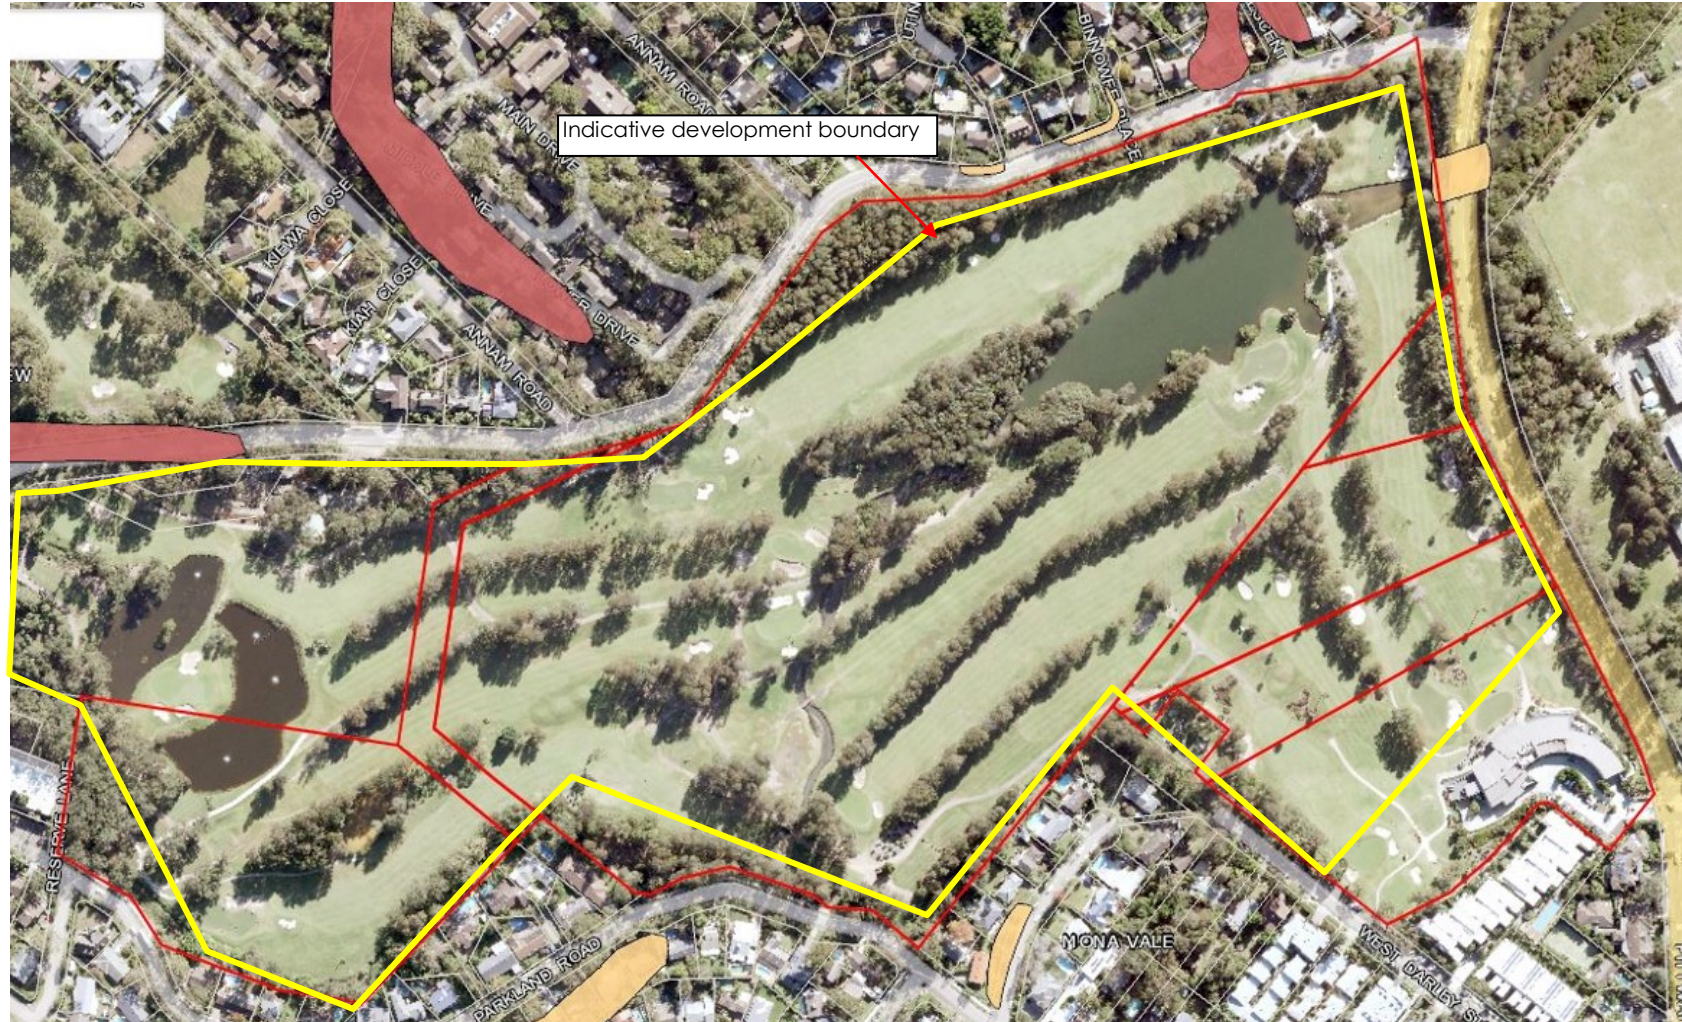
LEGEND
Pittwater Geotechnical Hazard Map

- Geotechnical Hazard H1
- Geotechnical Hazard H2

STORMWATER HARVESTING AND IRRIGATION WORKS, Geotechnical Hazard Map (showing the site location relative to risk classes)
(Source: Pittwater LEP, 2014)

The site area falls outside the landslide risk Hazard 1 or Hazard 2 zones shown on Pittwater Geotechnical Hazard Maps (refer Figure 2 in Attachment A). No evidence of recent land instability was observed within the site, during the site walkover survey.
