GEOTECHNICAL INVESTIGATION:

New Pool at 50 Pacific Parade, Manly

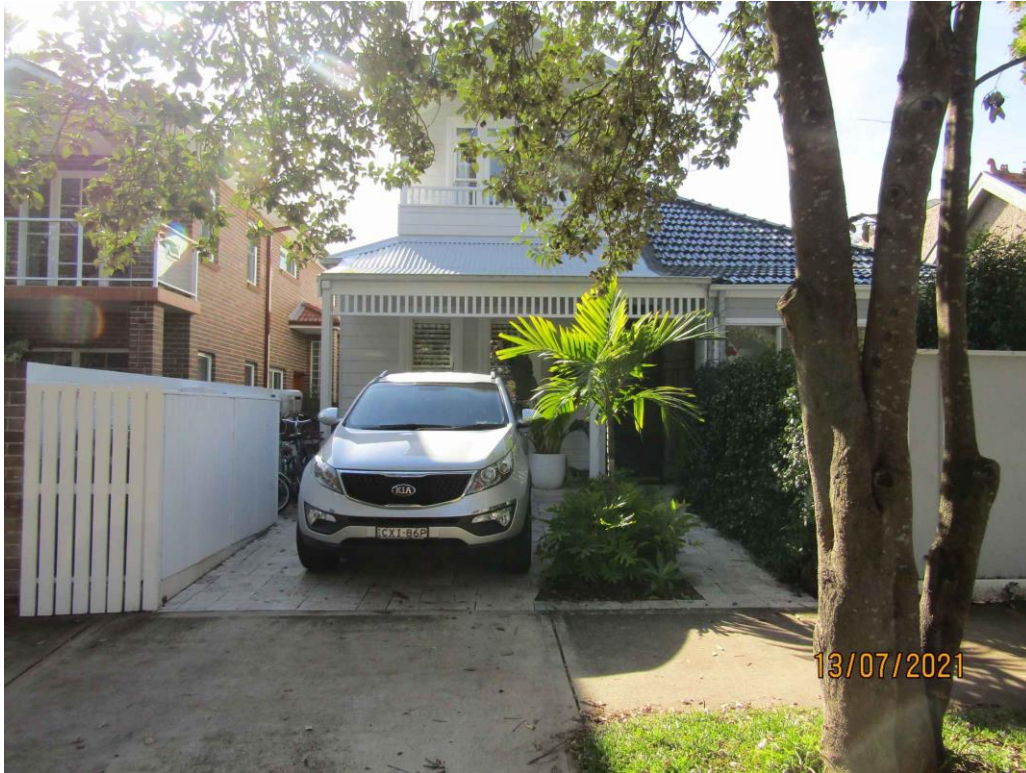
Photo 1

- 2.1 The site was inspected on the 13th July, 2021.
- 2.2 This residential property is near level with the road. The block is located on the near level terrain W of Manly Beach.
- 2.3 At the road frontage, a concrete driveway runs to a paved parking area on the S side of the house (Photo 1). The two storey timber clad duplex is supported by brick piers (Photos 1 & 2). The supporting piers stand vertical (Photo 3). A level lawn extends from the N side of the house to the N property boundary (Photo 2). The adjoining neighbouring properties were observed to be in good order as seen from the street and subject property.

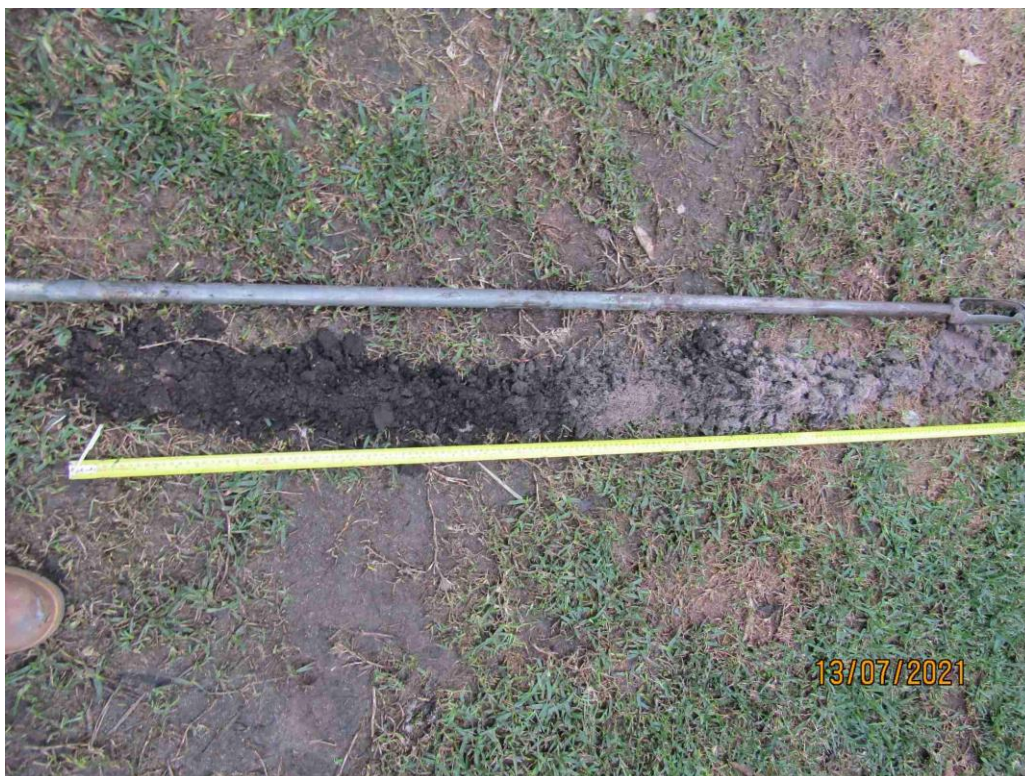
Photo 4

AUGER HOLE 1 (~RL2.4) – AH1 (Photo 4)

Depth (m)	Material Encountered
0.0 to 0.7	TOPSOIL , sandy soil, dark brown, damp, fine to medium grained with fine trace organic matter.
0.7 to 1.2	SAND , grey, damp, Loose to Medium Dense, medium to course grained.
1.2 to 1.7	SAND , grey, wet, Loose to Medium Dense, medium to course grained.

End of Hole @ 1.7m in wet sand. Watertable encountered at ~1.2m.
