# Biodiversity Management Plan

43, 45-49 Warriewood Road,  
Warriewood

Report prepared by  
Land Eco Consulting  
for  
CPS c/- Lesryk Environmental  
April 2020

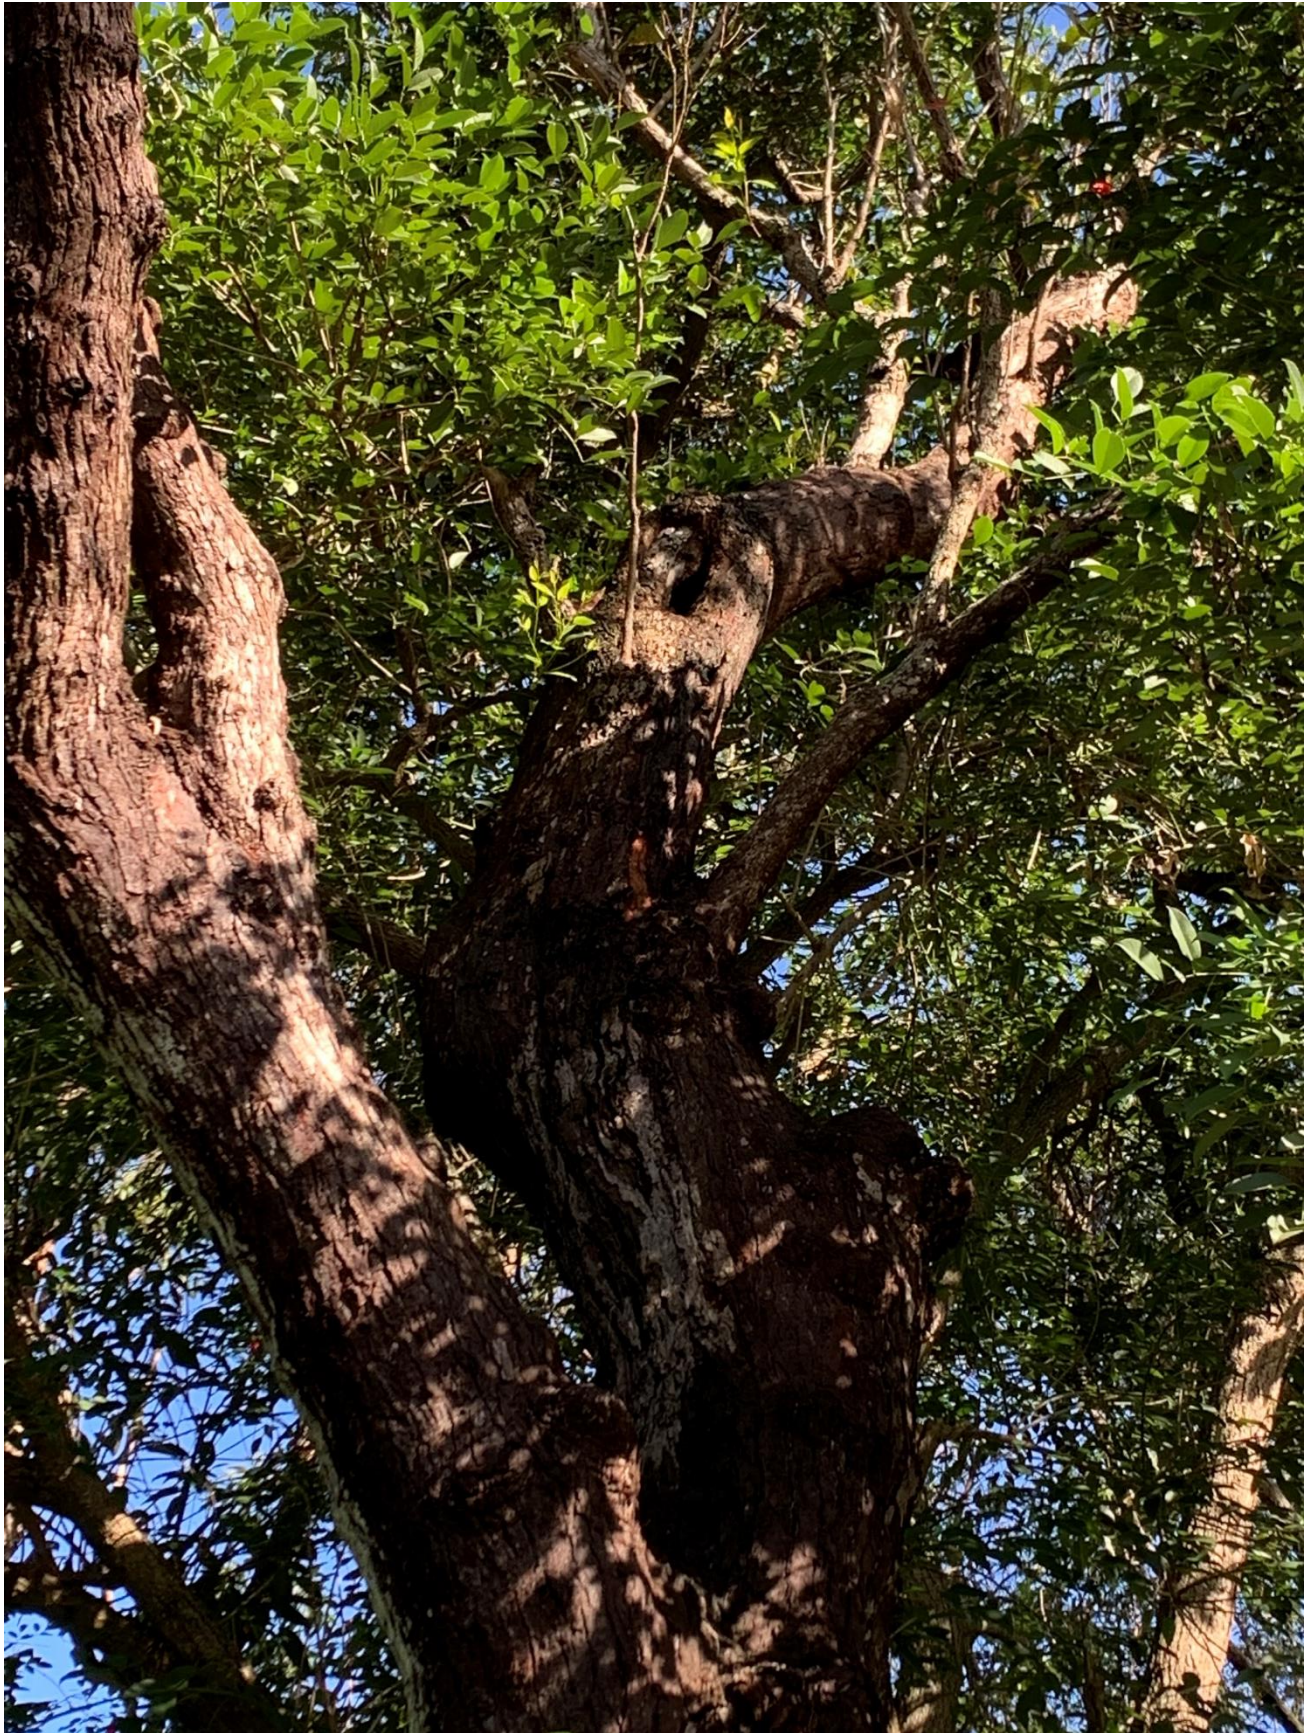
Plate 1. Large hollow in a mature *Eucalyptus robusta*

Hollow-bearing trees may provide habitat for birds, reptiles, frogs, arboreal mammals and microchiropteran bats (microbats). Large hollows were identified in mature *Eucalyptus robusta* in the BMP area (**Plate 1**).

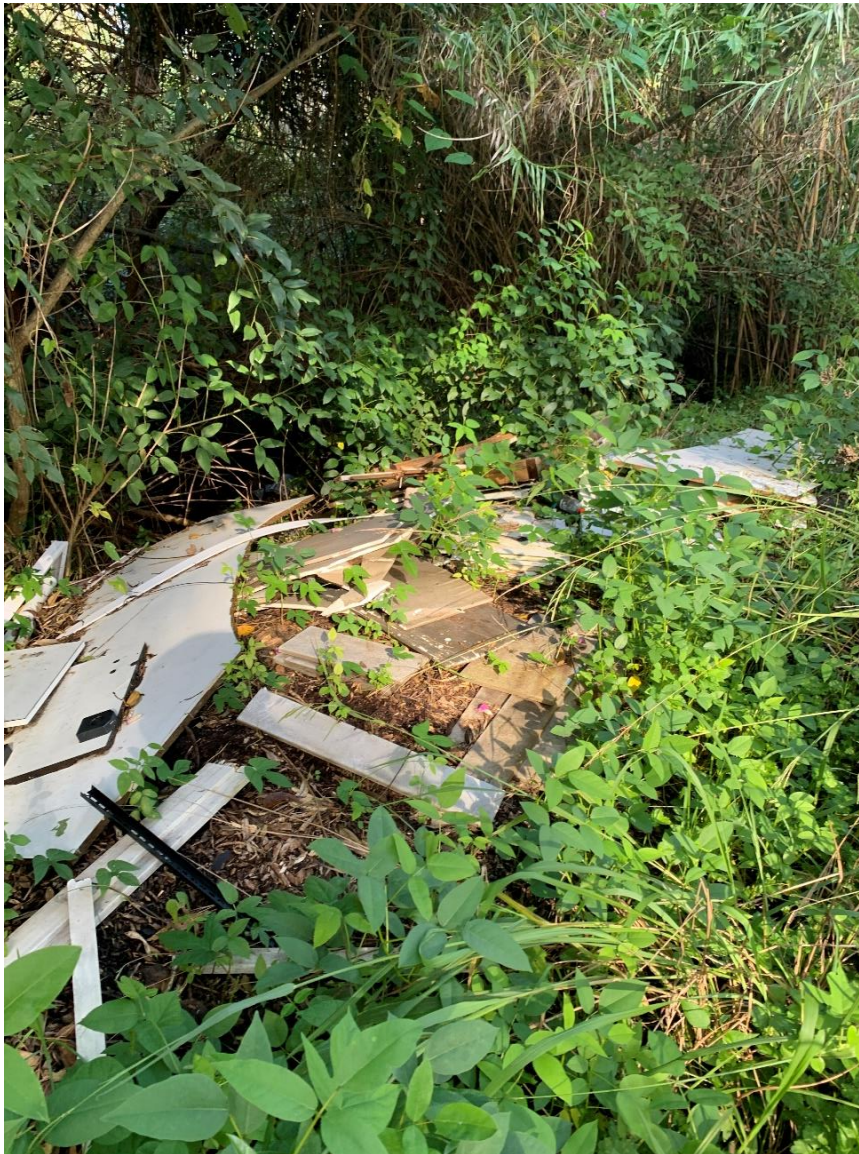
**Plate 2. Dumped rubbish occurs throughout the BMP Area and must be removed as a priority**

Dumped rubbish occurs throughout the BMP area (**Plate 2**). All anthropogenic rubbish must be removed from the BMP as a priority and disposed of in a licensed waste disposal facility. The proponent may be required to remove woody weeds to safely access this rubbish.
