122 Crescent Road, Newport Existing Concrete Hardstand | Structural Certificate

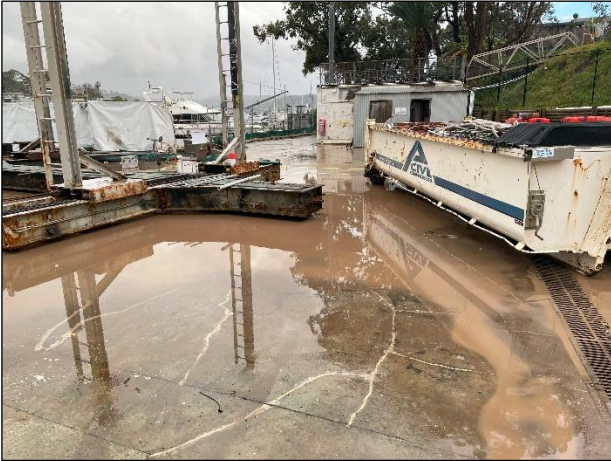
- ❖ Based on the site observations, there appear to be water stagnated within the concrete slab as shown in Figure 1 which might indicate a drainage issue. Assessment by the Project Civil/Hydraulic Engineer is necessary as this might cause future issues with the proposed turf/vegetation.

Figure 1 – Stagnant Water on the concrete hardstand

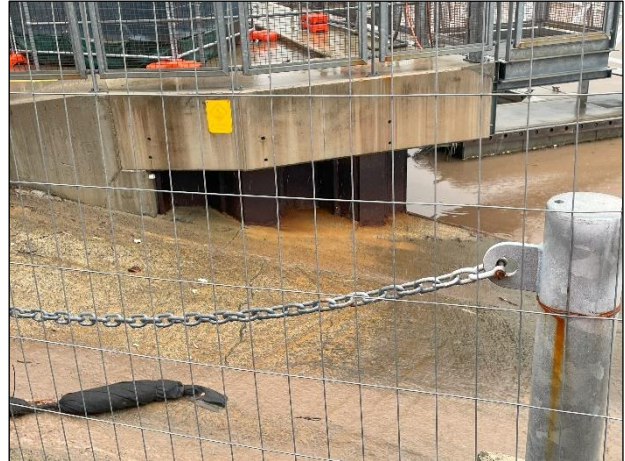
- ❖ There appear to be sheet piling along the sea wall as shown in Figure 2. Due to limited access, we were unable to verify the existence of a permanent wall. Therefore, confirmation of the sheet piling being a sacrificial wall is crucial as it appears to be deteriorated. Otherwise, assessment of the sheet piles will be required to determine its remaining useful life.

Figure 2 – Sheet pile along the sea wall
