Stage 1 - Preliminary Site Investigation

43, 45, and 49 Warriewood Road, Warriewood NSW

Report No: 2148-PSI-01-060723.v1f

Report Date: 7 July 2023

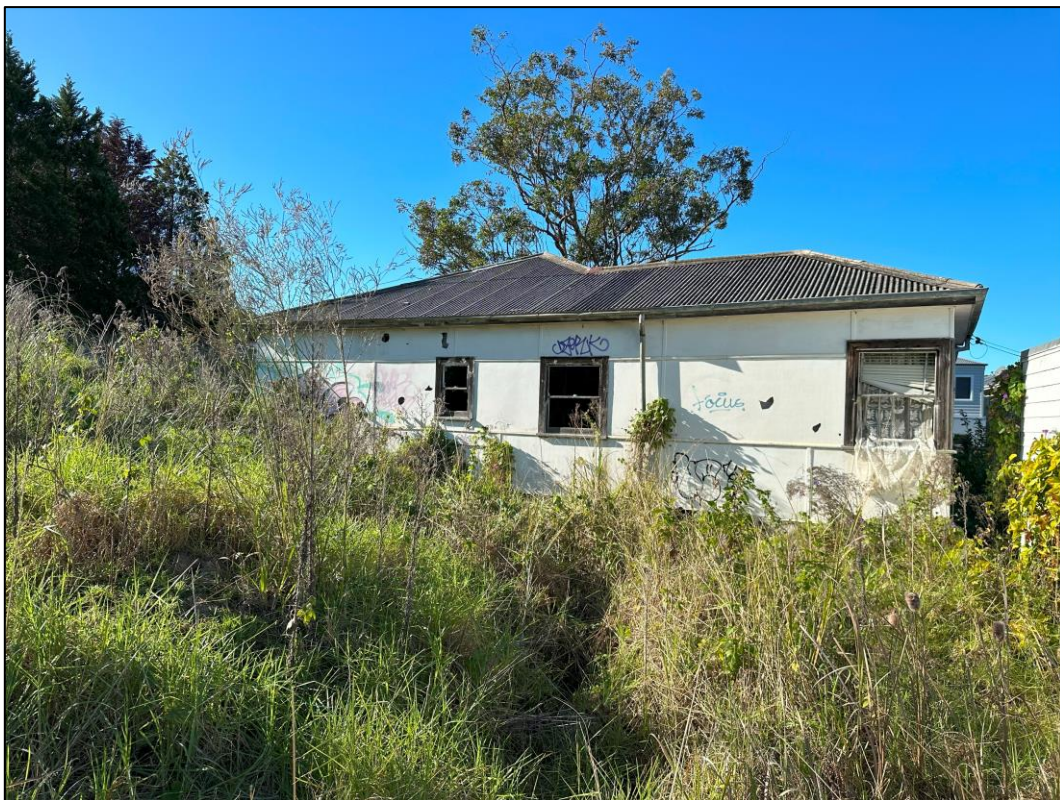
Site Photograph 6.2.1 Fibre cement residential dwelling within the northern portion of 45 Warriewood Road, as observed on 21 June 2023.

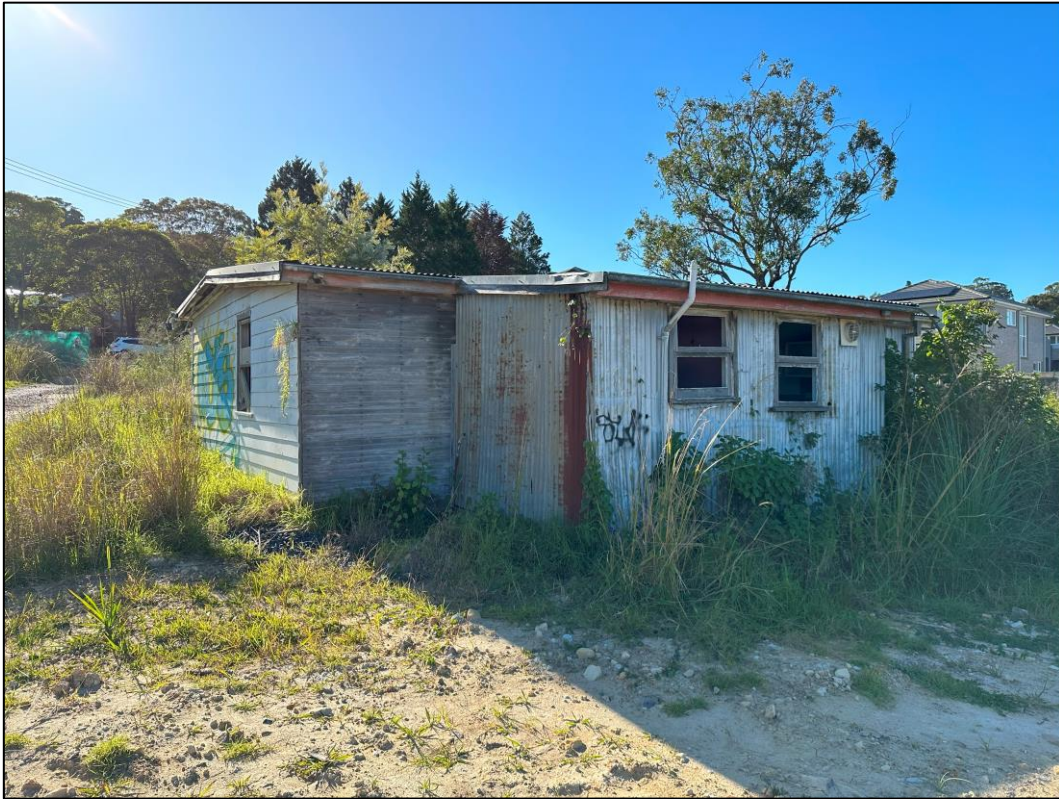
Site Photograph 6.2.2 Shed located within the north-western portion of 45 Warriewood Road, as observed on 21 June 2023.

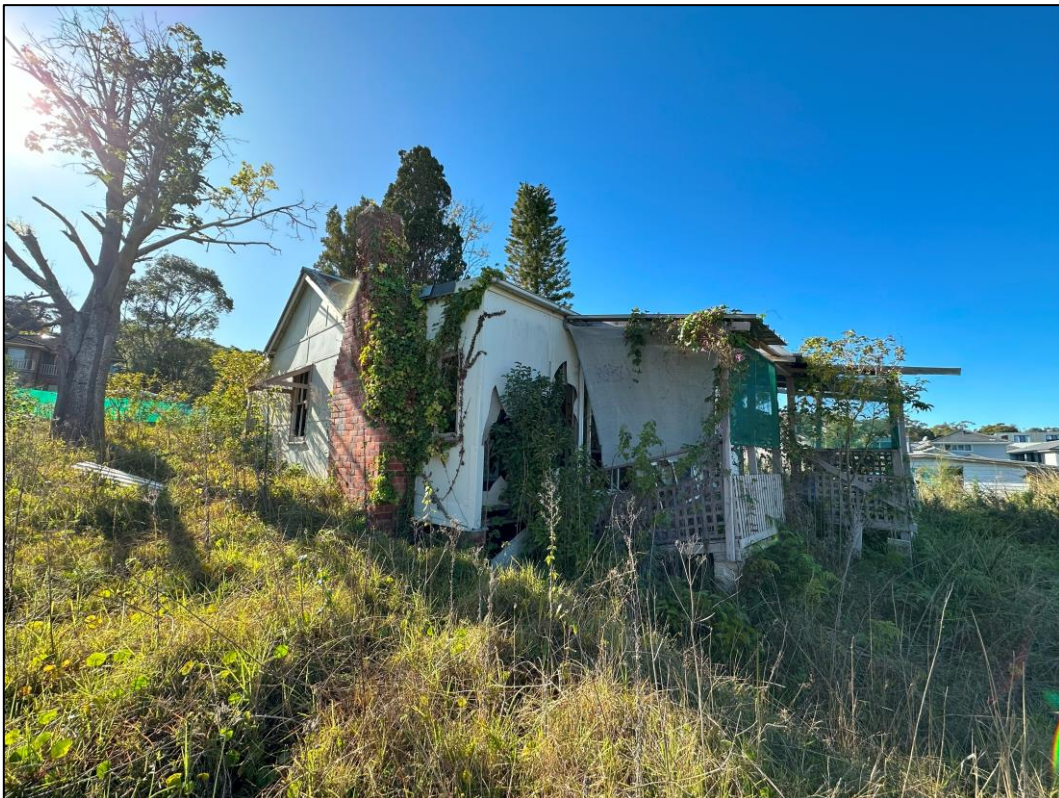
Site Photograph 6.2.3 Main fibre cement dwelling located within the northern portion of 49 Warriewood Road, as observed on 21 June 2023.

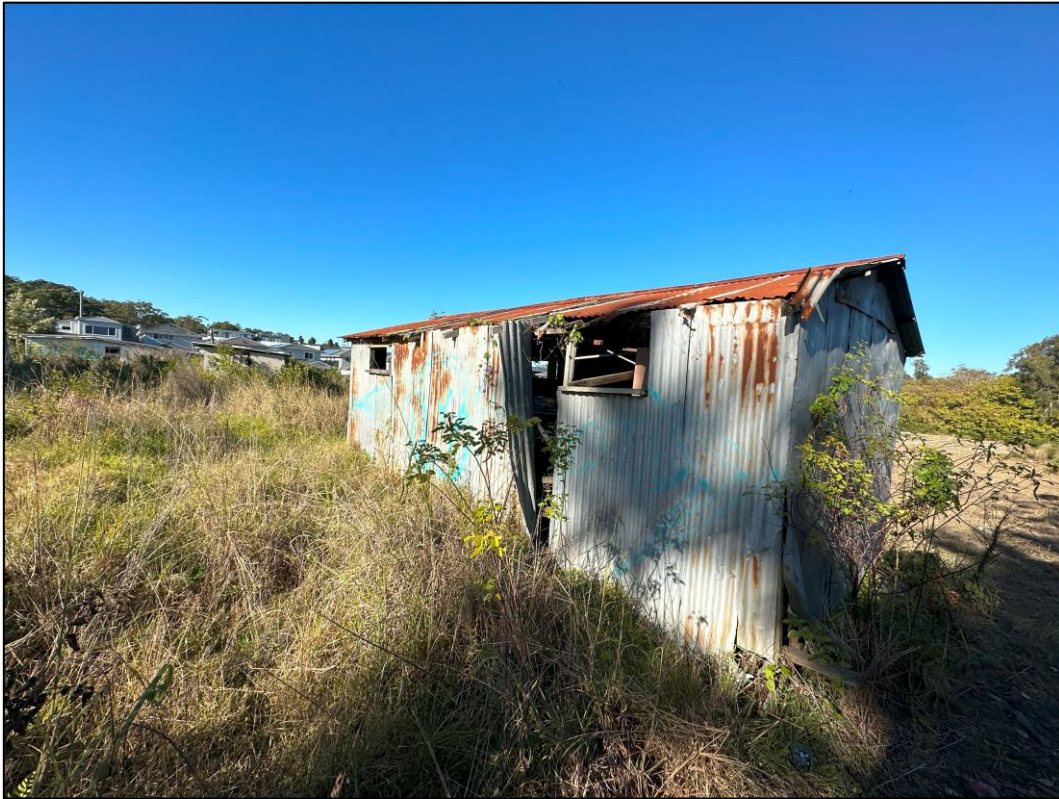
Site Photograph 6.2.4 Metal shed located within the north-western portion of 49 Warriewood Road, as observed on 21 June 2023.

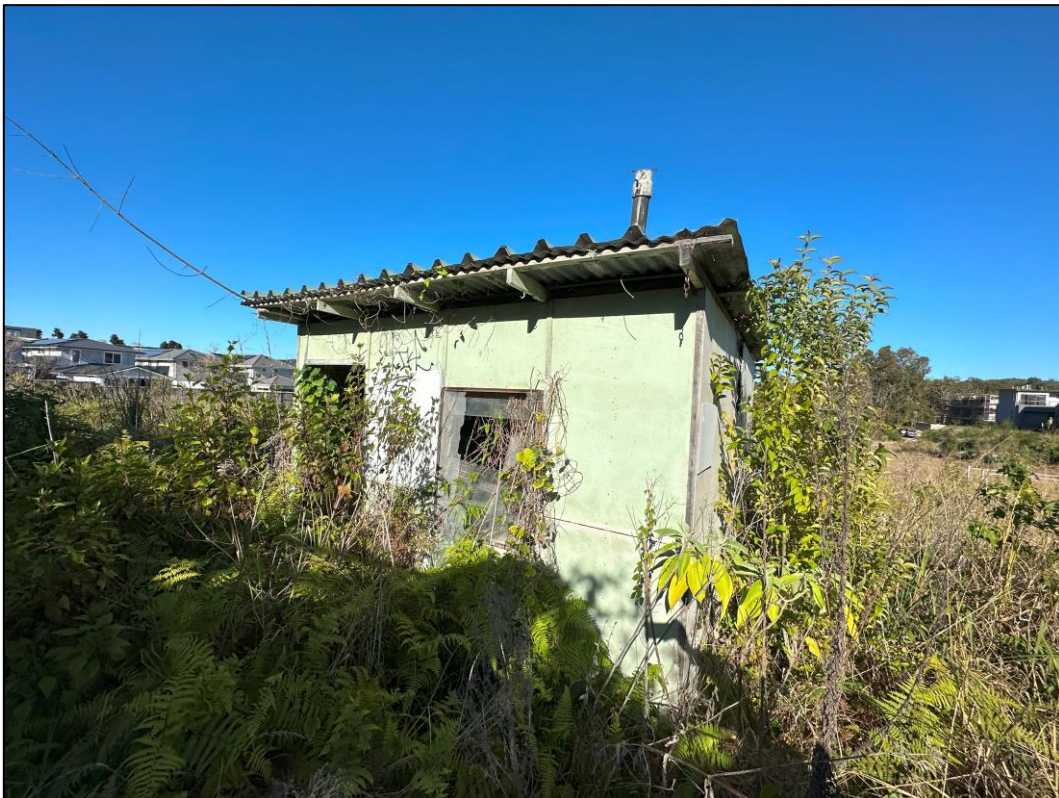
Site Photograph 6.2.5 Fibre cement structure located within the north-western portion of 45 Warriewood Road, as observed on 21 June 2023.

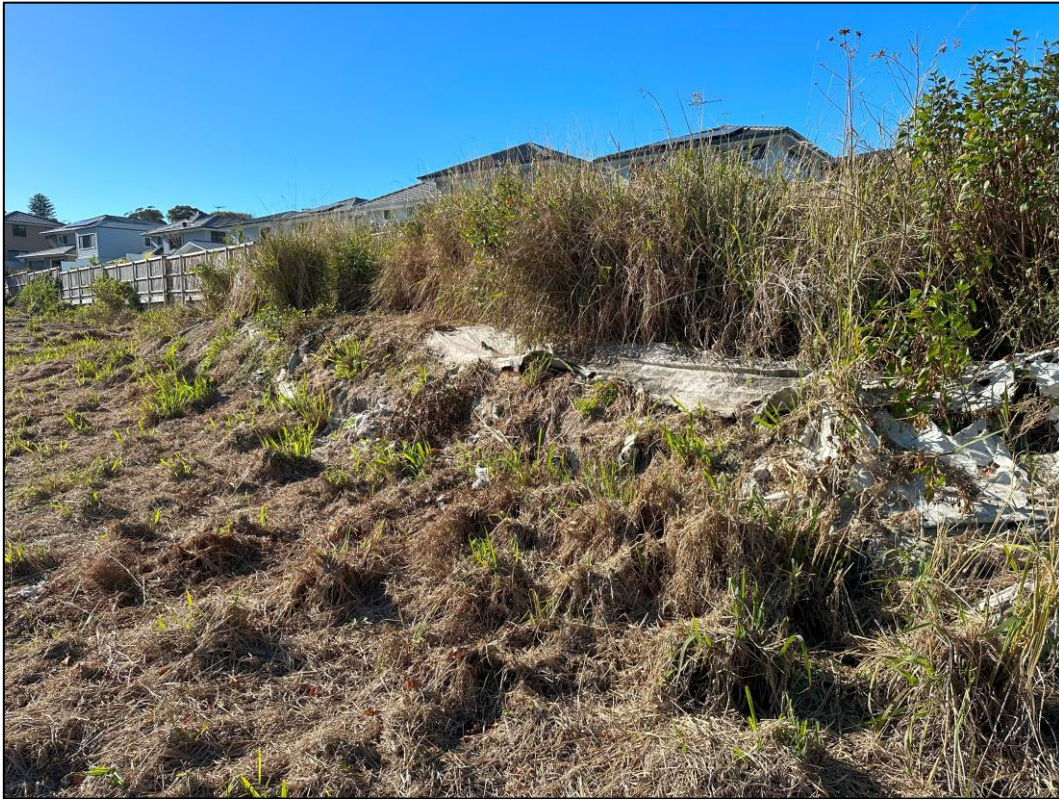
Widespread fill material was not observed across site during the site walkover. Two (2) long stockpiles, approximately 80 m³ each, were observed along the western and eastern boundaries of the site. SE presume that market garden activities and the tilling of land in preparation has contributed to the generation of the stockpiles.

Site Photograph 6.8.1 Fill materials located along the western boundary of the site, as observed on 21 June 2023.

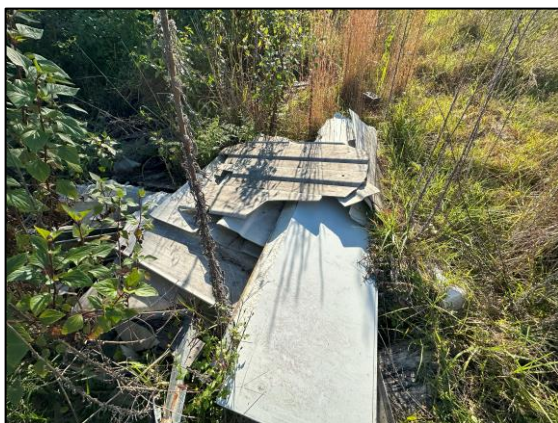
Photograph 6.9.1 Pile of scrap metal and fibre cement sheeting located in the northern portion of the site, as observed on 21 June 2023.

PACM was also observed within the pile of scrap metal and suspected asbestos fibre cement. Scattered suspected asbestos fibre cement fragments were observed within the southern portion of the site across the soil surface.

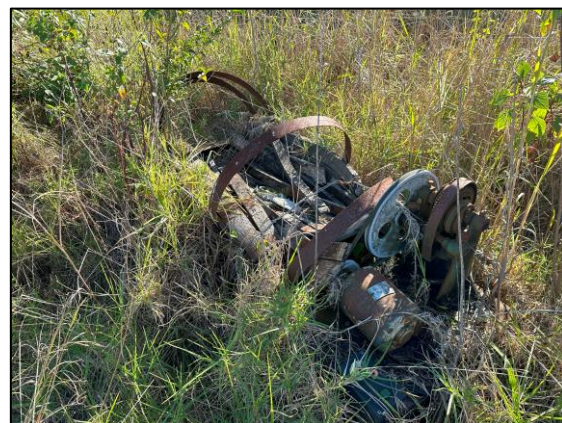
Site Photograph 6.9.2 Pile of scrap metal observed adjacent to the structures at 45 Warriewood Road, as observed on 21 June 2023.

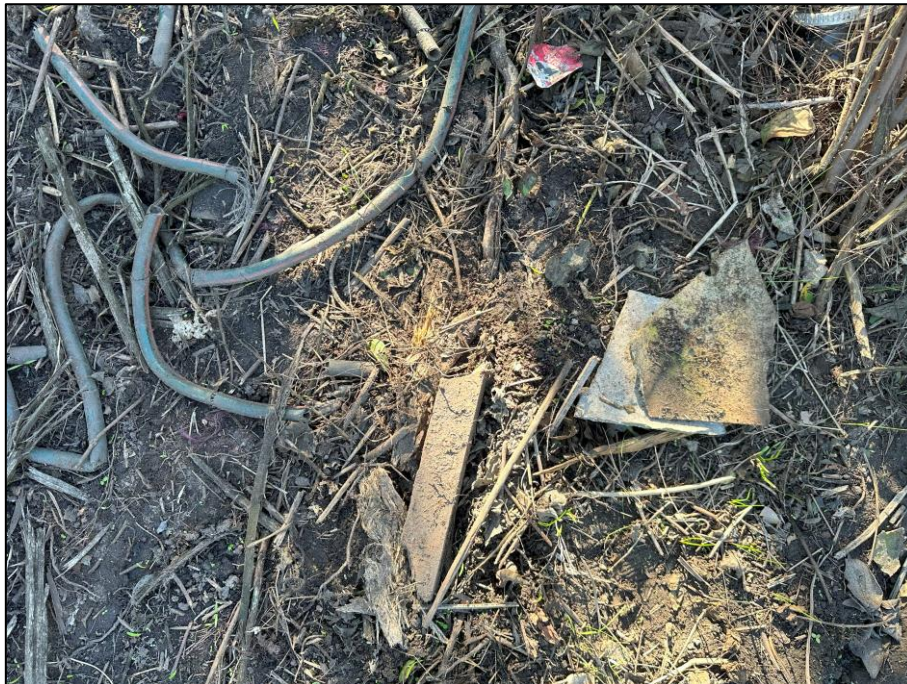
Potential asbestos containing materials (PACM) were observed within localised locations across the soil surface within the site. Evidence of building materials were observed within close proximity to the structures within the

site. As the structures were observed to be in poor condition, SE presume the fibre cement fragments to be a result of weathered building materials.

Photograph 6.10.1 Localised suspected asbestos fibre cement surficial impacts within the southern portion of the site, as observed on 21 June 2023.

Based on the presumed age of the residence, ACM is likely to be present within the building materials. A pre-demolition hazardous building materials survey was not within the scope of this site investigation, but is recommended prior to any demolition activities occurring on the site.

- A targeted DSI across the identified PAECs comprising an intrusive soil assessment is warranted to characterise potential contamination that may be present at the site;
- Undertake a hazardous building materials survey of the structures present on-site prior to demolition (if required);
- Following removal of hazardous building materials (if identified) and subsequent demolition (if required) of the building materials, a clearance inspection should be carried out by an appropriately qualified occupational hygienist / NSW LAA; and
- A supplementary contamination assessment of the building footprints should be carried out prior to any proposed demolition works.

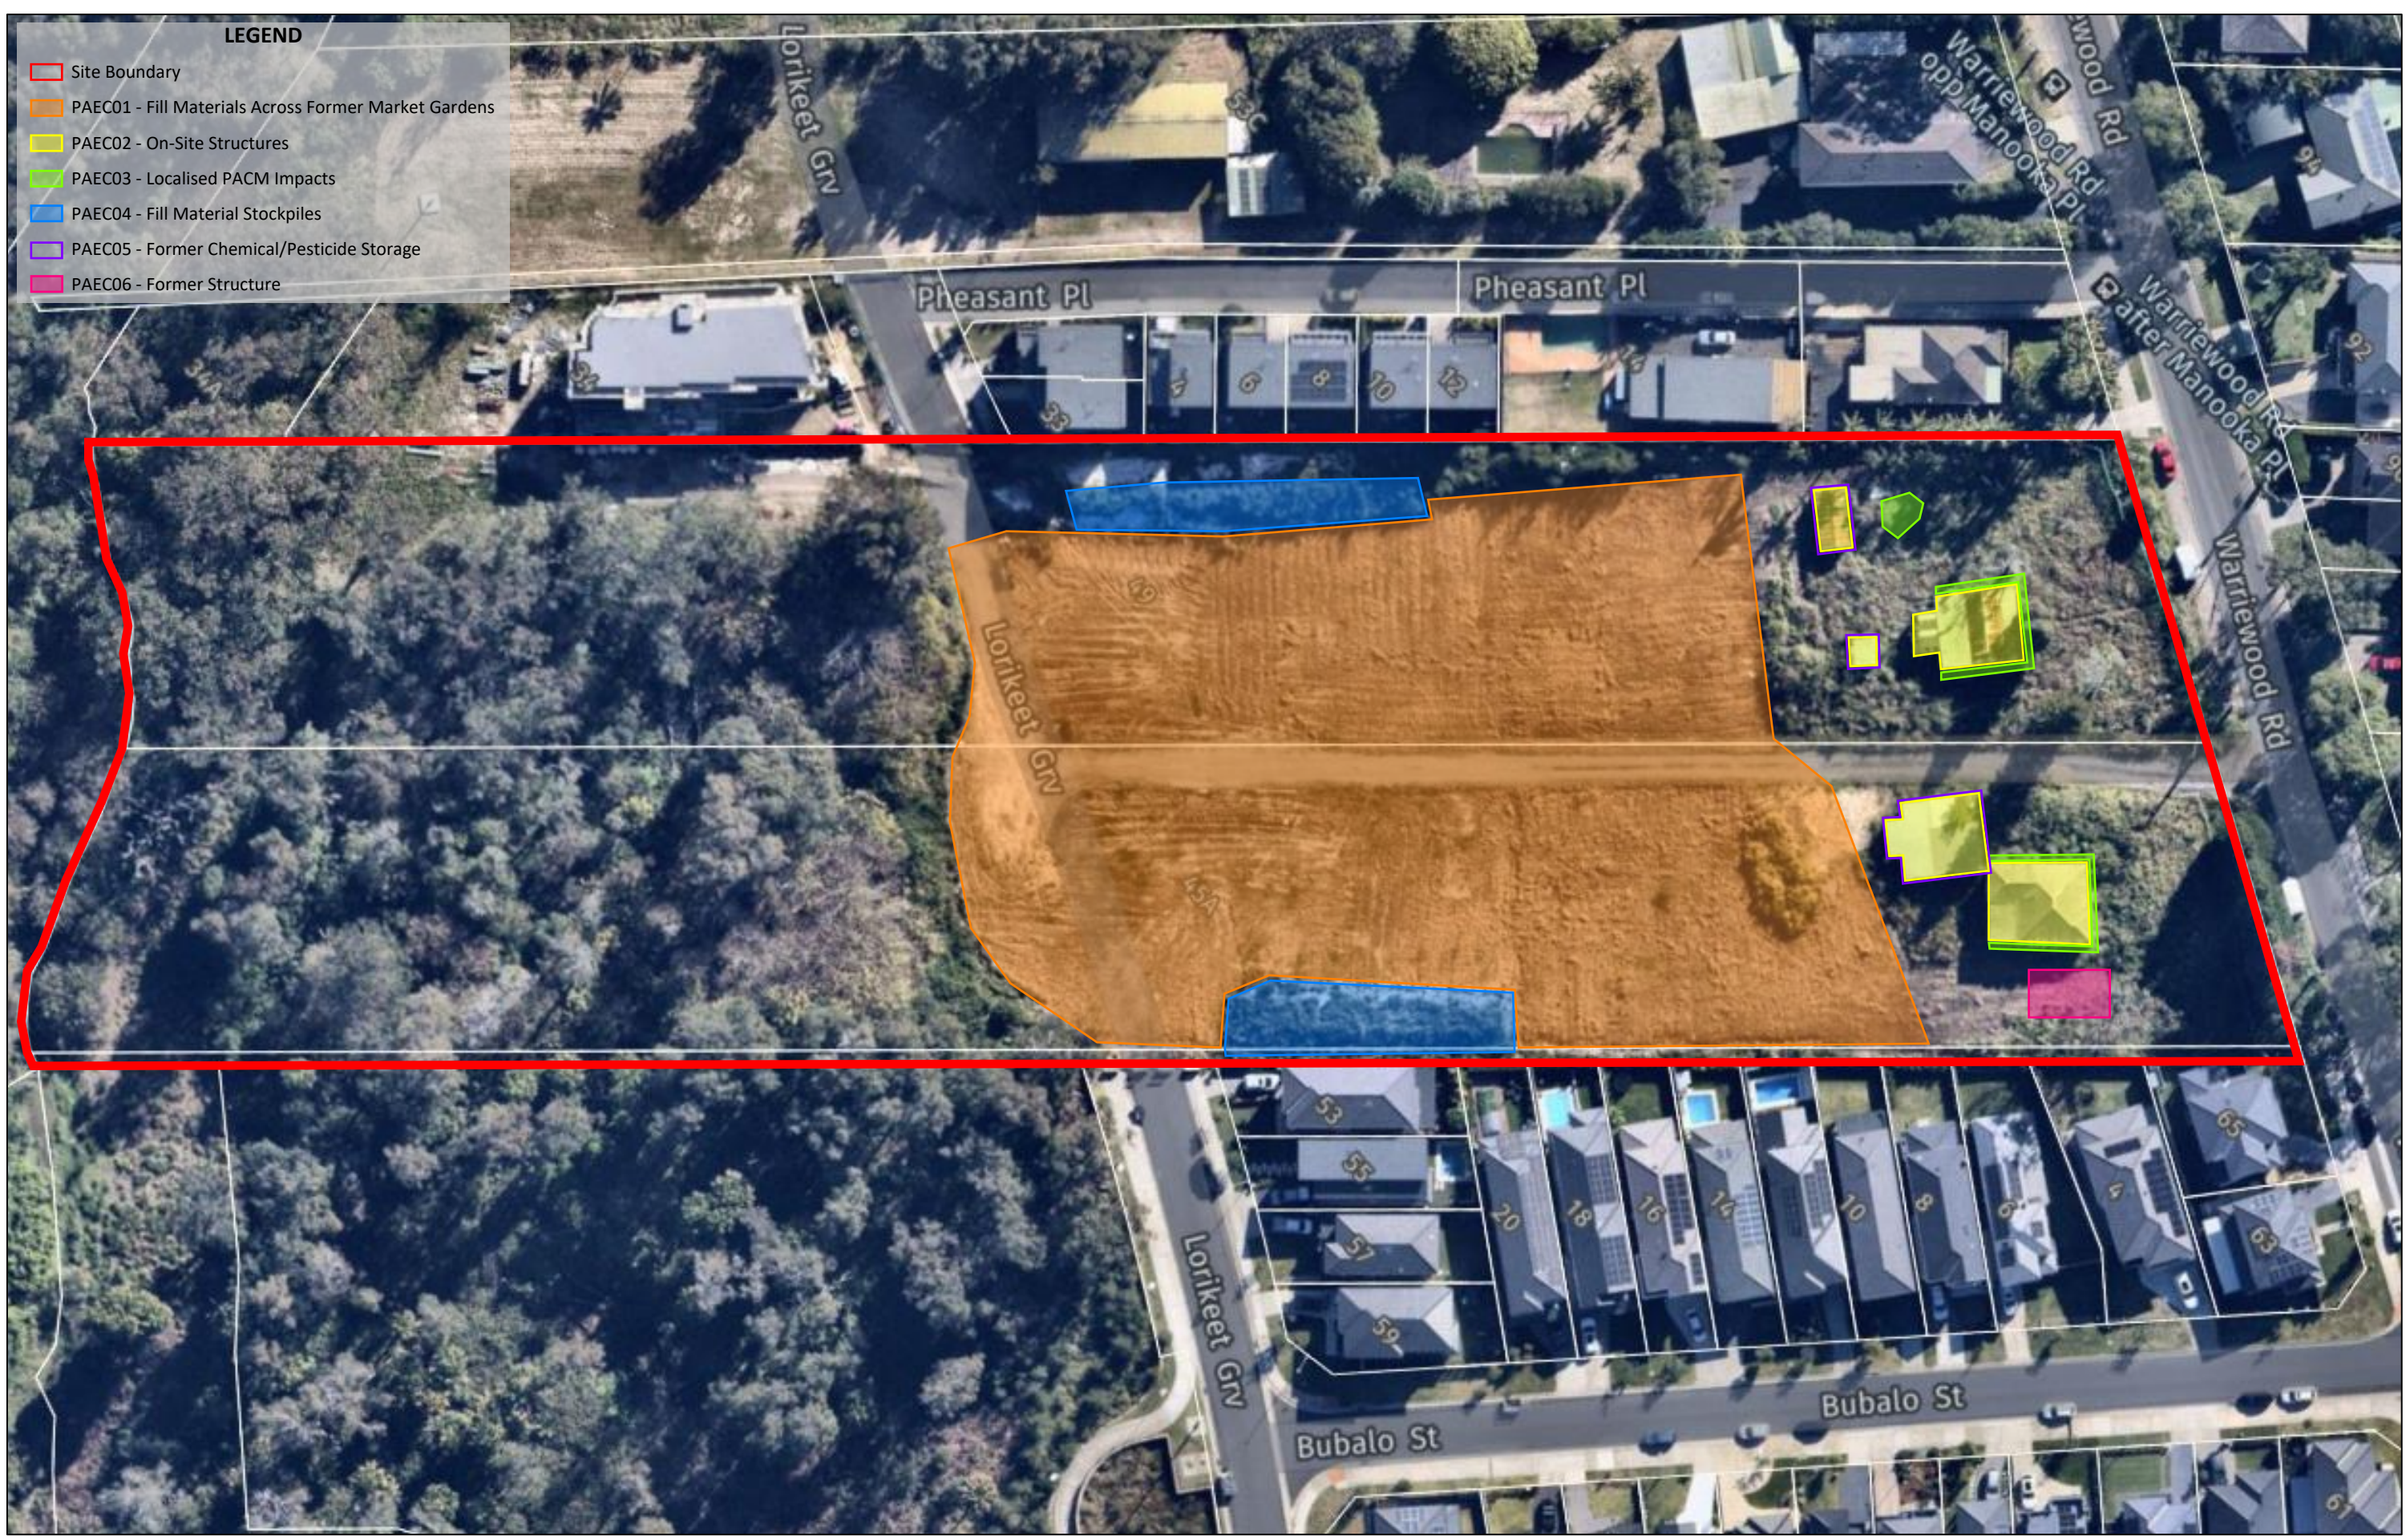
Potential Areas of Environmental Concern

ID	Potential Area of Environmental Concern	Land Use Activity	Contaminants of Potential Concern
PAEC01	Fill Materials Across Former Market Gardens	Uncontrolled Filling, Pesticide Usage	Heavy metals, TRH, BTEX, PAH, OCP, OPP, PCB & Asbestos
PAEC02	On-site Structures	Hazardous Building Materials	Asbestos, Lead, SMF & PCB
PAEC03	Localised suspected ACM Impacts	Weathered Building Materials	Aesthetics & Asbestos
PAEC04	Fill material stockpiles along eastern and western boundaries of site	Uncontrolled Filling, Pesticide Usage	Heavy metals, TRH, BTEX, PAH, OCP, OPP, PCB & Asbestos
PAEC05	Former Chemical/Pesticide Storage within Sheds	Chemical/Pesticide Storage	Heavy metals, TRH, BTEX, PAH, OCP, OPP, PCB
PAEC06	Former Structure within 45 Warriewood Road	Uncontrolled Demolition	Heavy metals, TRH, BTEX, PAH, PCB & Asbestos

- Site Boundary
- PAEC01 - Fill Materials Across Former Market Gardens
- PAEC02 - On-Site Structures
- PAEC03 - Localised PACM Impacts
- PAEC04 - Fill Material Stockpiles
- PAEC05 - Former Chemical/Pesticide Storage
- PAEC06 - Former Structure

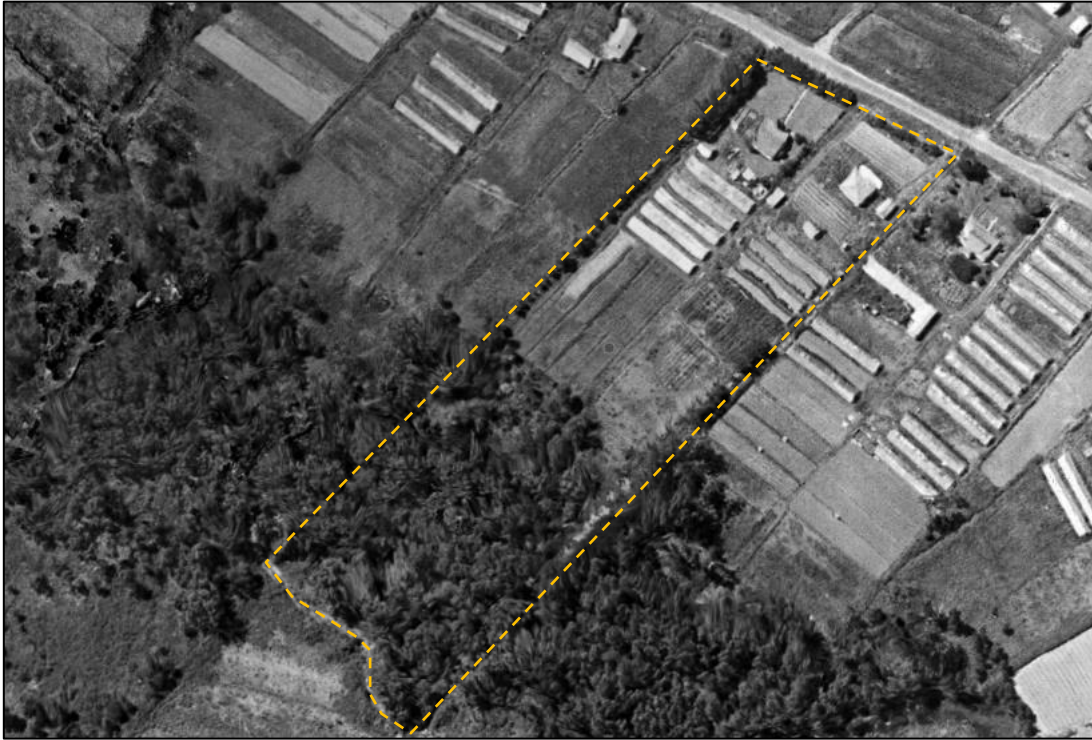
Image Date	Site Features	Surrounding Land Use Settings
1955	<p>The site is observed to have one (1) dwelling within the northern portion of 45 Warriewood Road and a shed immediately east of the dwelling. A small structure is present further south of the main dwelling and four (4) presumed greenhouses are present south of the smaller structure. The central portion of the site appears to be utilised as a market garden.</p> <p>One (1) dwelling is present within the northern portion of 49 Warriewood Road and two (2) sheds appear to be present south of it. Five (5) presumed greenhouses are present south of the sheds and the central portion of the site appears to be utilised as a market garden.</p> <p>The southern portion of the site appears to be dense bushland and shrubbery.</p>	Surrounding land observed to be rural residential with market garden activities in all directions.
1965	<p>The dwelling and shed within the northern portion of 45 Warriewood Road appears to be extended to the south. An additional structure has appeared to the south-west of the dwelling. An additional four (4) presumed greenhouses have appeared to the south of the original. Market garden activities are not evident within the central portion of 45 Warriewood Road.</p> <p>The presumed greenhouses within 49 Warriewood Road appear to have been demolished.</p>	No significant change to surrounding land use.

Historical Aerial Photograph 1. 1955 historical aerial image of site.

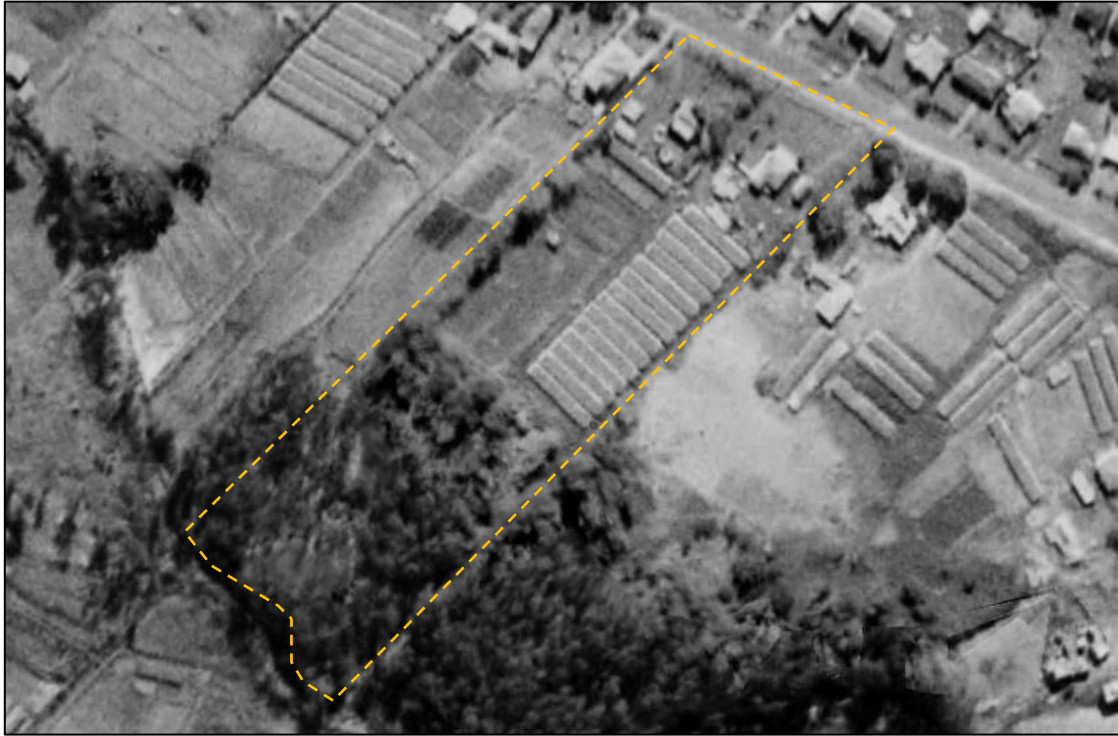
Historical Aerial Photograph 3. 1975 historical aerial image of the site.

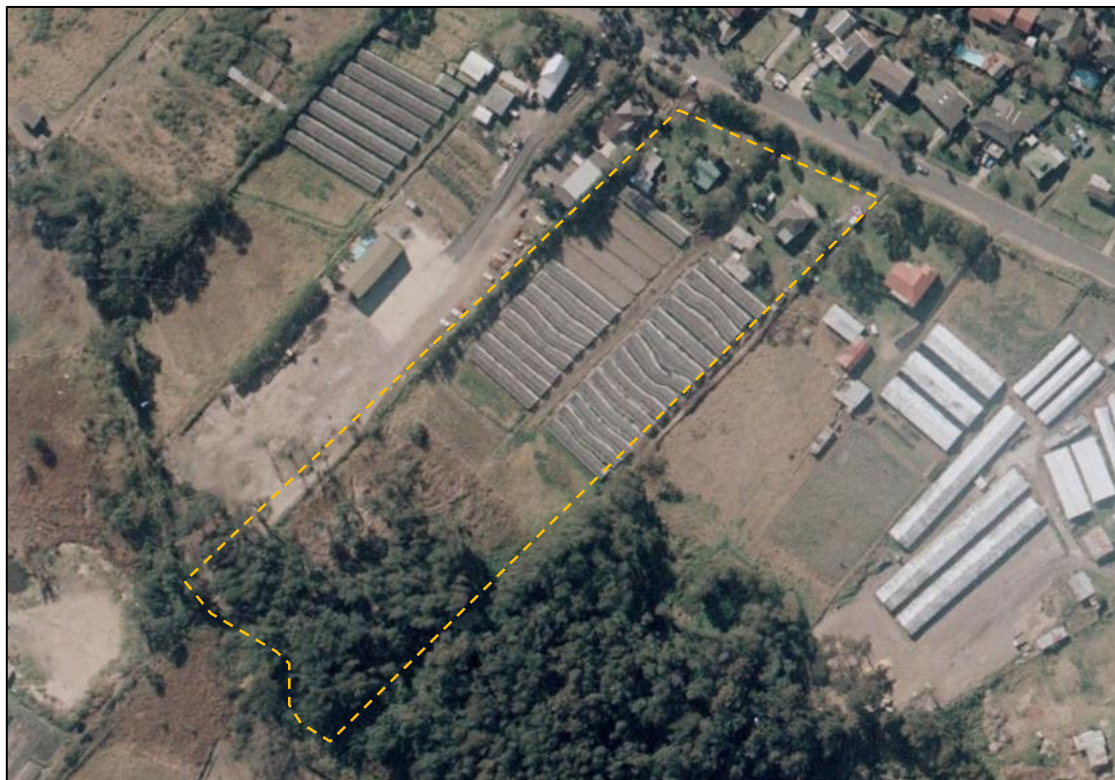
Historical Aerial Photograph 4. 1986 historical aerial image of the site.

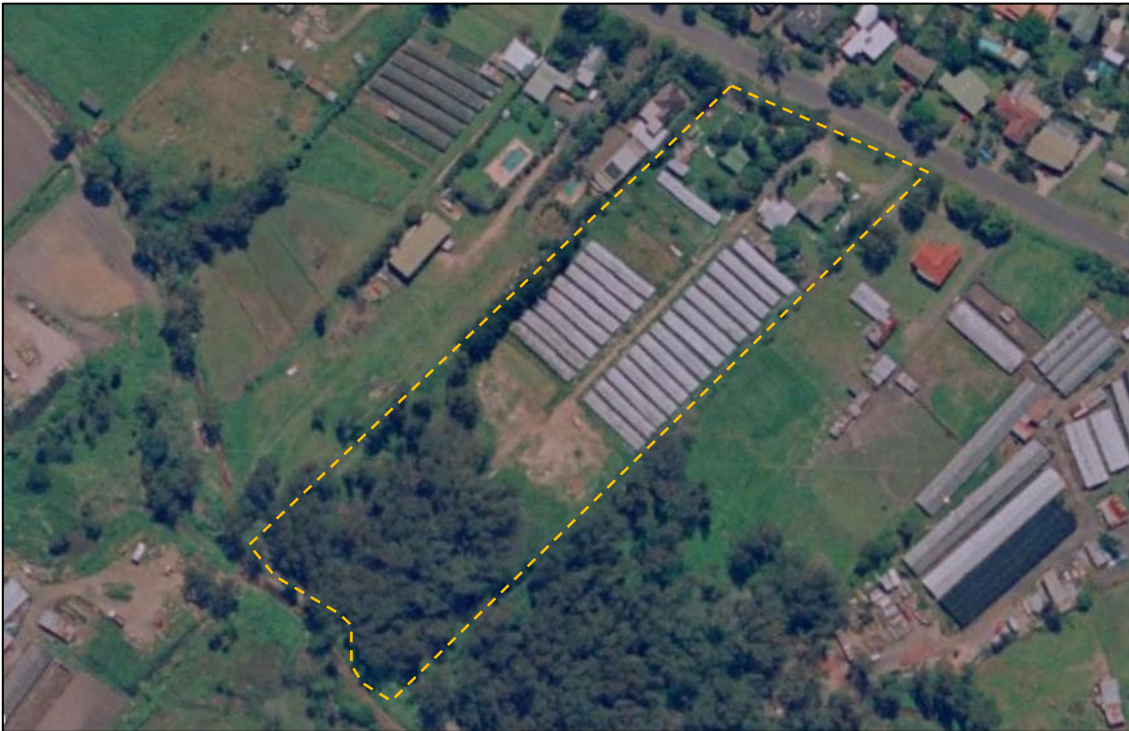
Historical Aerial Photograph 5. 1998 historical aerial image of the site.

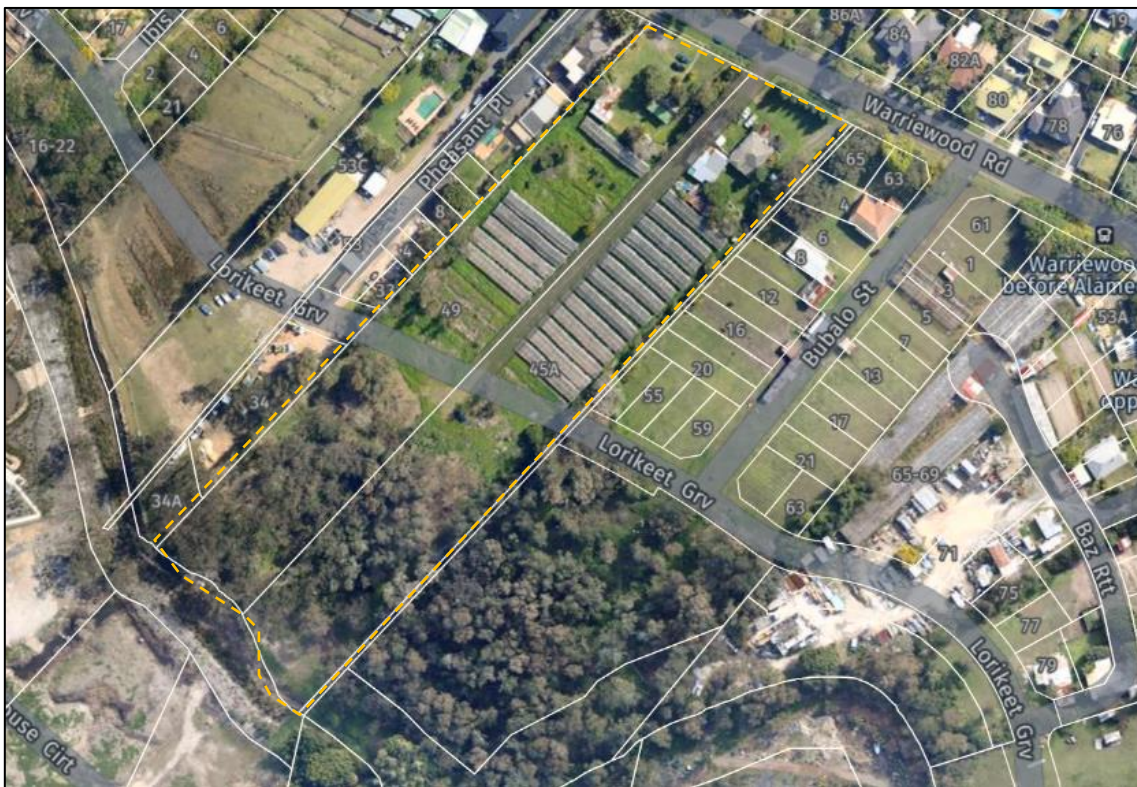
Historical Aerial Photograph 6. 2010 historical aerial image of the site.

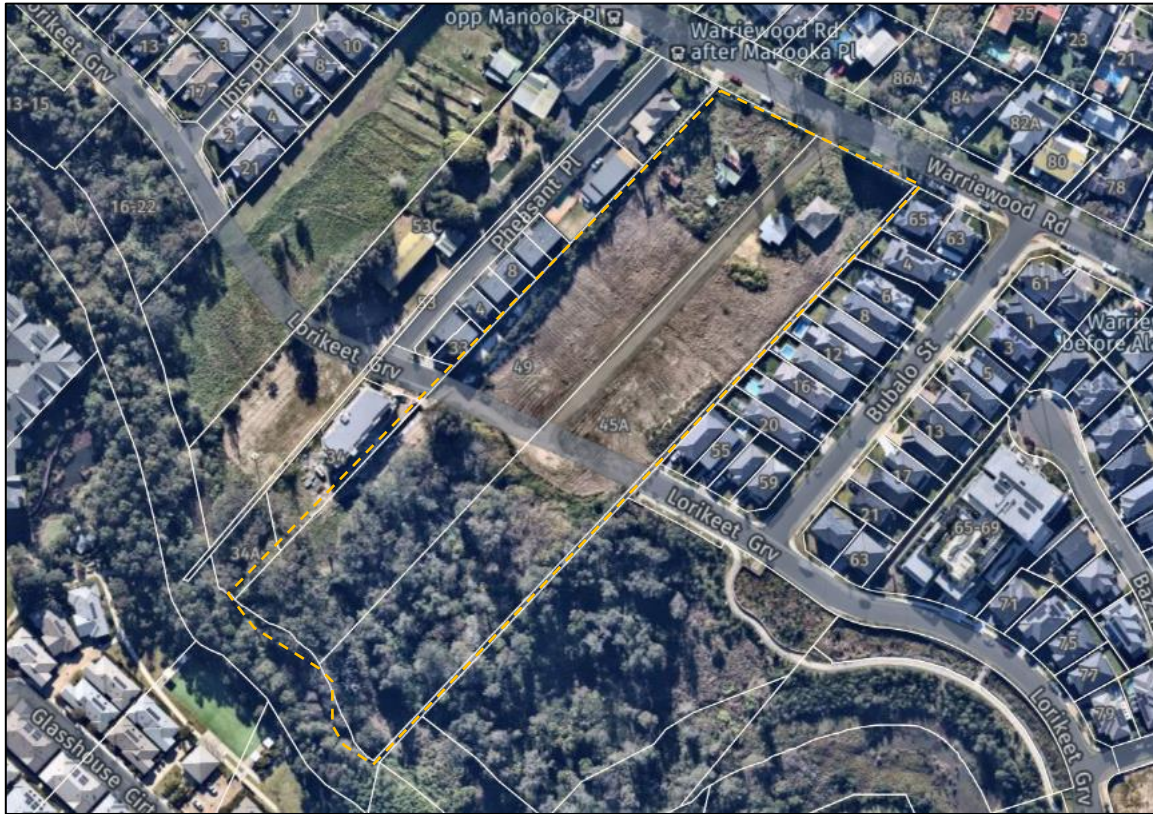
2009	No significant changes observed across the site.	Development of low-density residential starting to the east.
2023	All greenhouses within the site appear to have been demolished.	Increase in low-density residential to the east, west and south of the site.

Historical Aerial Photograph 7. 2023 Historical aerial image of the site.
