Report Title: Geotechnical Report 41 Coasters Retreat, Coasters Retreat  
Report Date: 14/5/21

## **GEOTECHNICAL INVESTIGATION:**

New House at **41 Coasters Retreat, Coasters Retreat**

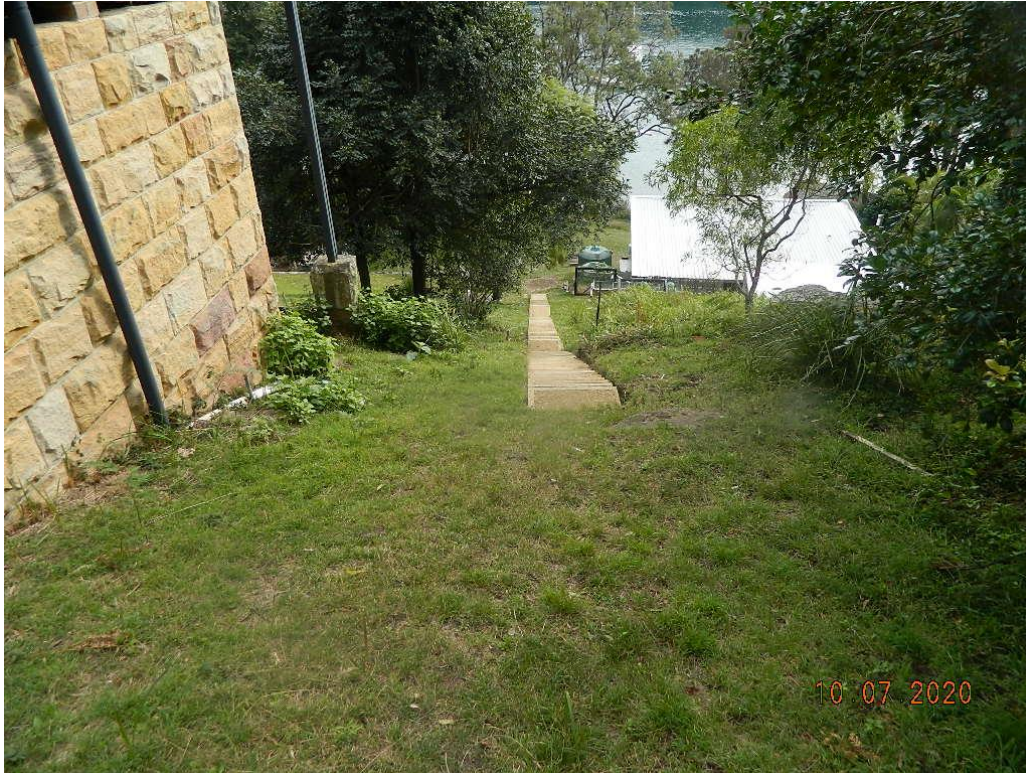
Photo 1

- 2.3** The property is accessed by boat and by timber steps which run up the slope (Photo 1). A moderately sloping lawn is located on the downhill side of the property (Photos 2 to 4). Detached Sandstone joint blocks that originate from the slope above are embedded in the lawn (Photos 5 & 6). The rocks appear to be in stable positions on the slope. A timber clad shed in good condition is located on the S side of the property (Photo 7). Hawkesbury Sandstone cliff faces up to ~5m high are outcropping uphill of the property (Photos 8 & 9). They display no undercutting or other geological defects and are considered stable. Many small to medium sized loose boulders are

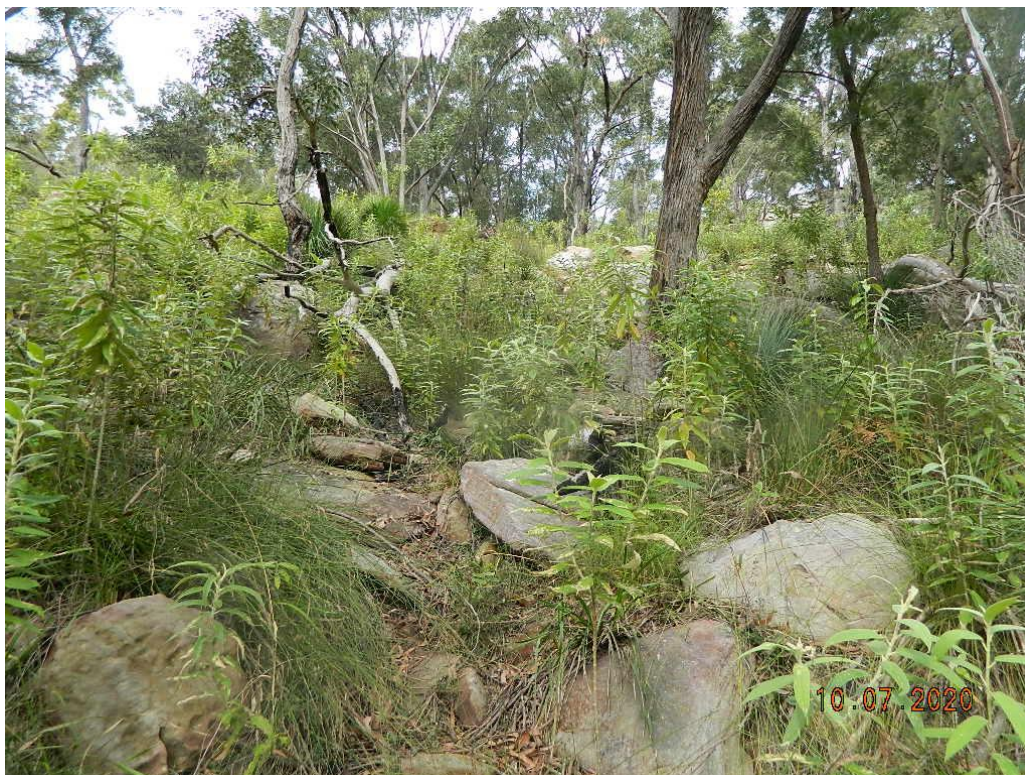
Photo 10

scattered on the steep slope above the cliff faces (Photo 10). The boulders are in stable positions on the slope. Overall the slope across the property is considered stable. The adjoining neighbouring properties were observed to be in good order as seen from the subject property.

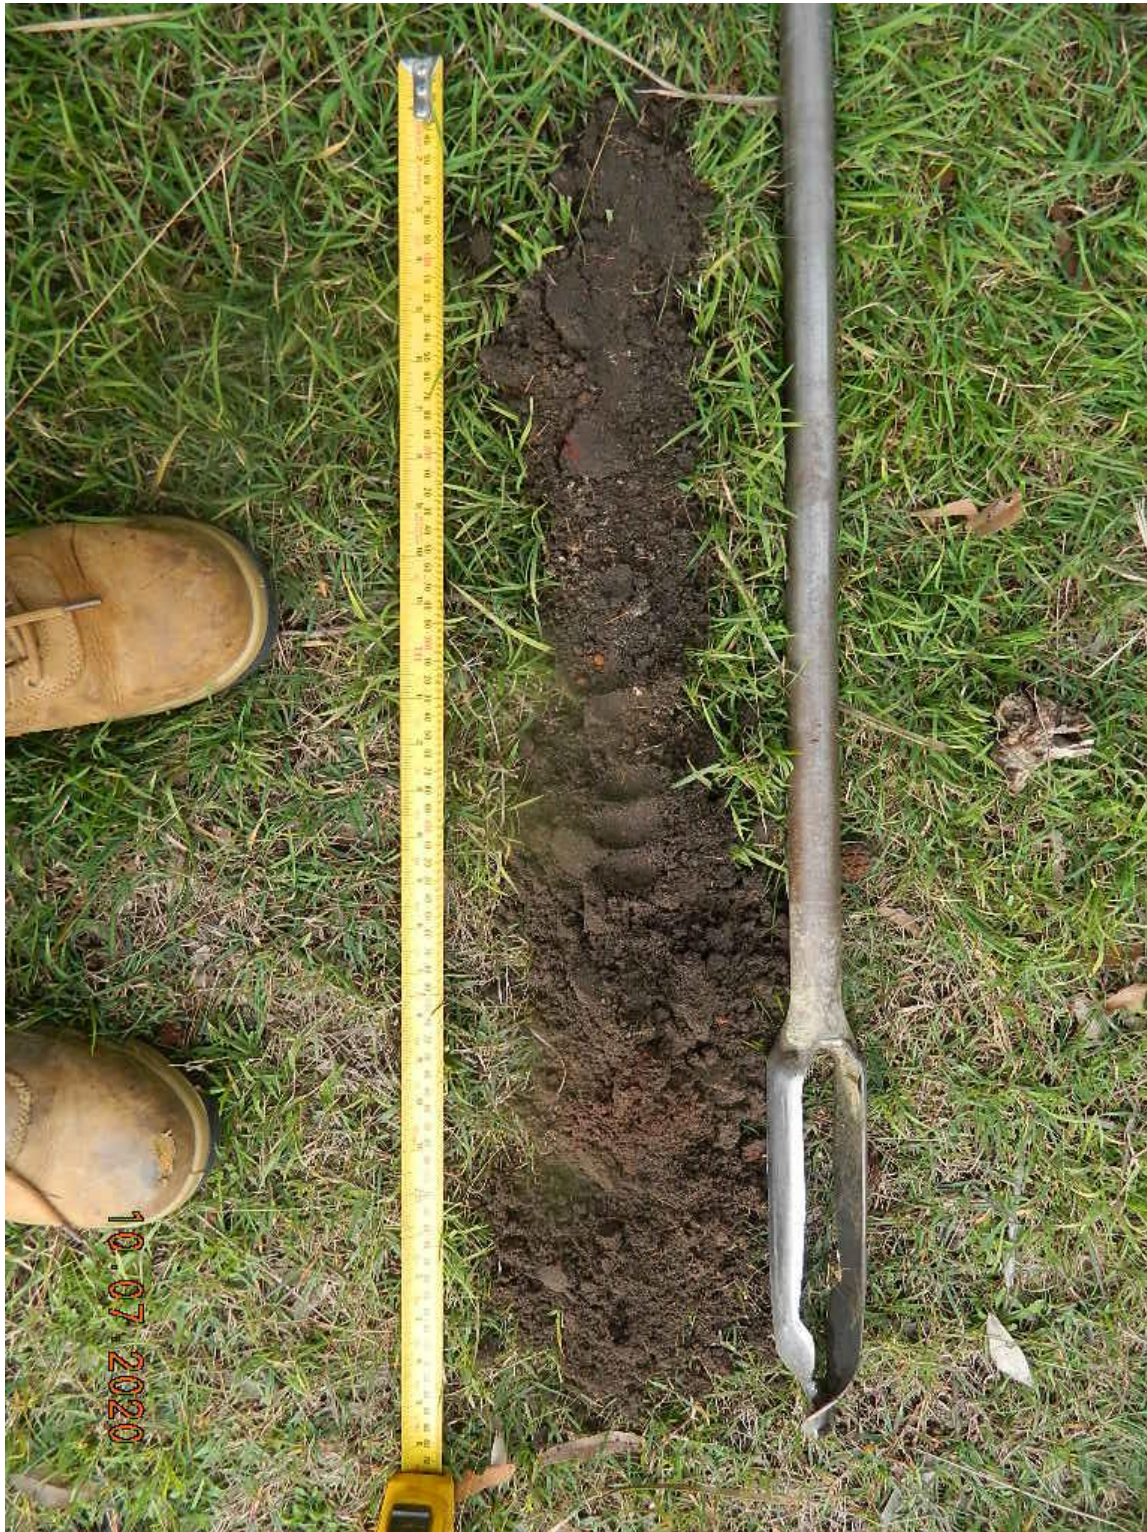
Photo 11: AH1 – Downhole is from top to bottom

#### AUGER HOLE 1 (~RL30.1) – AH1 (photo 11)

Depth (m)	Material Encountered
0.0 to 0.7	<b>TOPSOIL</b> , sandy soil, dark brown, fine to medium grained, moist with fine trace organic matter.

Refusal @ 0.7m auger grinding on rock. No watertable encountered.

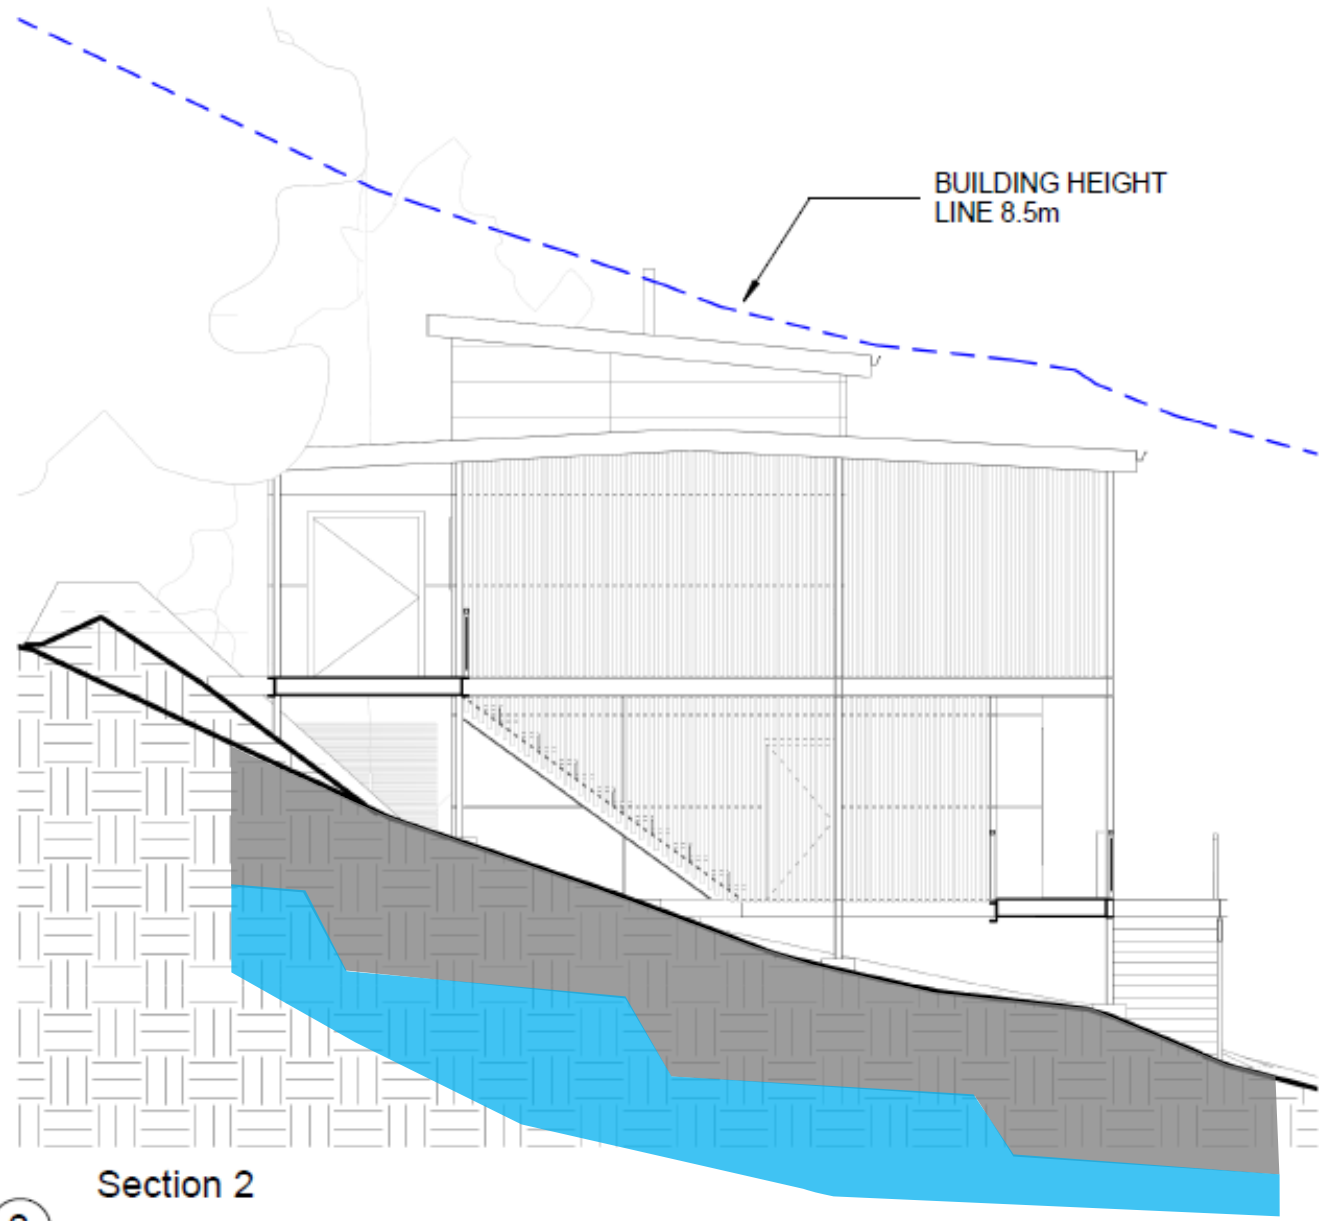
# TYPE SECTION – Diagrammatical Interpretation of expected Ground Materials

opposite is true. The rock is overlain by colluvium of sufficient density to its old age. In the test locations, the depth to rock ranged between 0.7 to 2.6m below the current surface. Many large floaters are located at the surface and are expected through the profile. The sandstone underlying the property is estimated to be Very Low to Medium Strength or better. See Type Section attached for a diagrammatical representation of the expected ground materials.

- Colluvium
- Hawkesbury Sandstone – Medium Strength
