# **Marine Habitat Survey**

## **158B & C (Lots 52 & 53) McCarrs Creek Road, Church Point**

Report Date: 28 June 2023

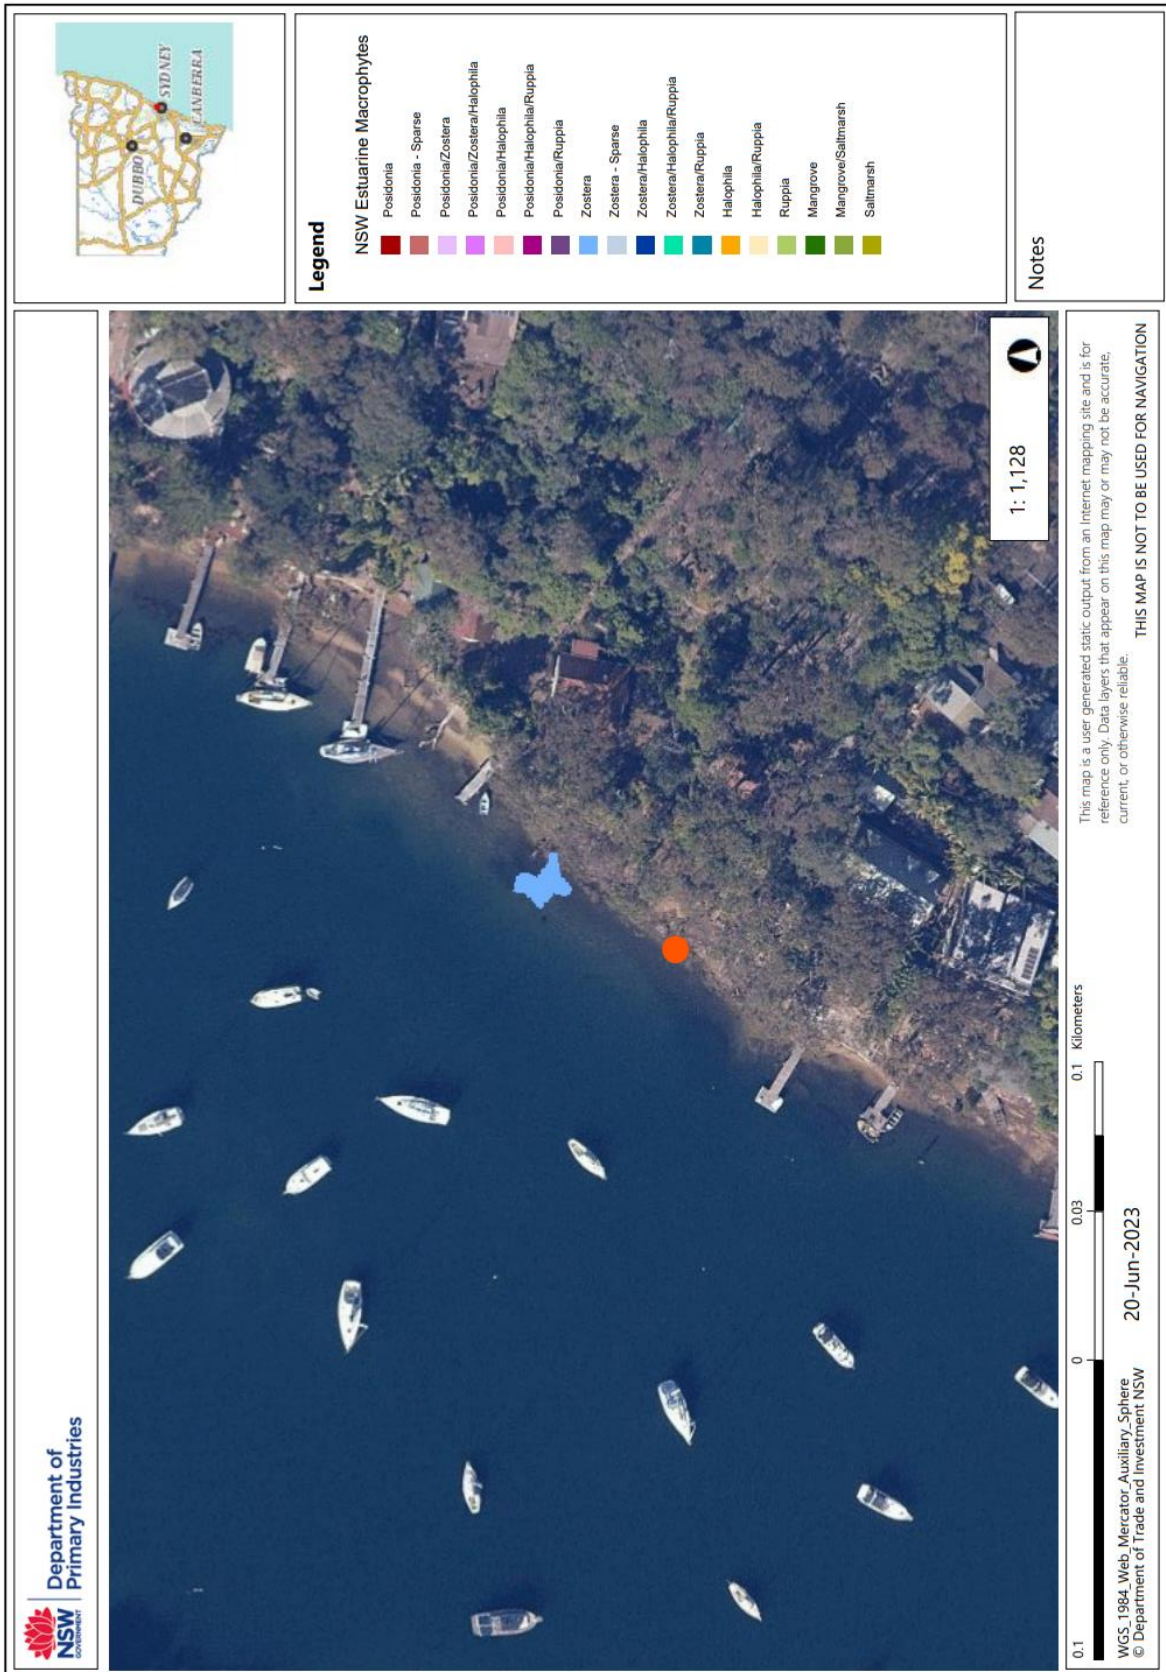
McCarrs Creek, particularly in the upper reaches. A moderately sized bed of *Z. capricorni* has been previously mapped close to shore to the northeast of the Subject Site (Figure 2).

Figure 2: NSW DPI Fisheries mapping in the vicinity of the Subject Site (Source: NSW DPI 2023).  
● Subject Site

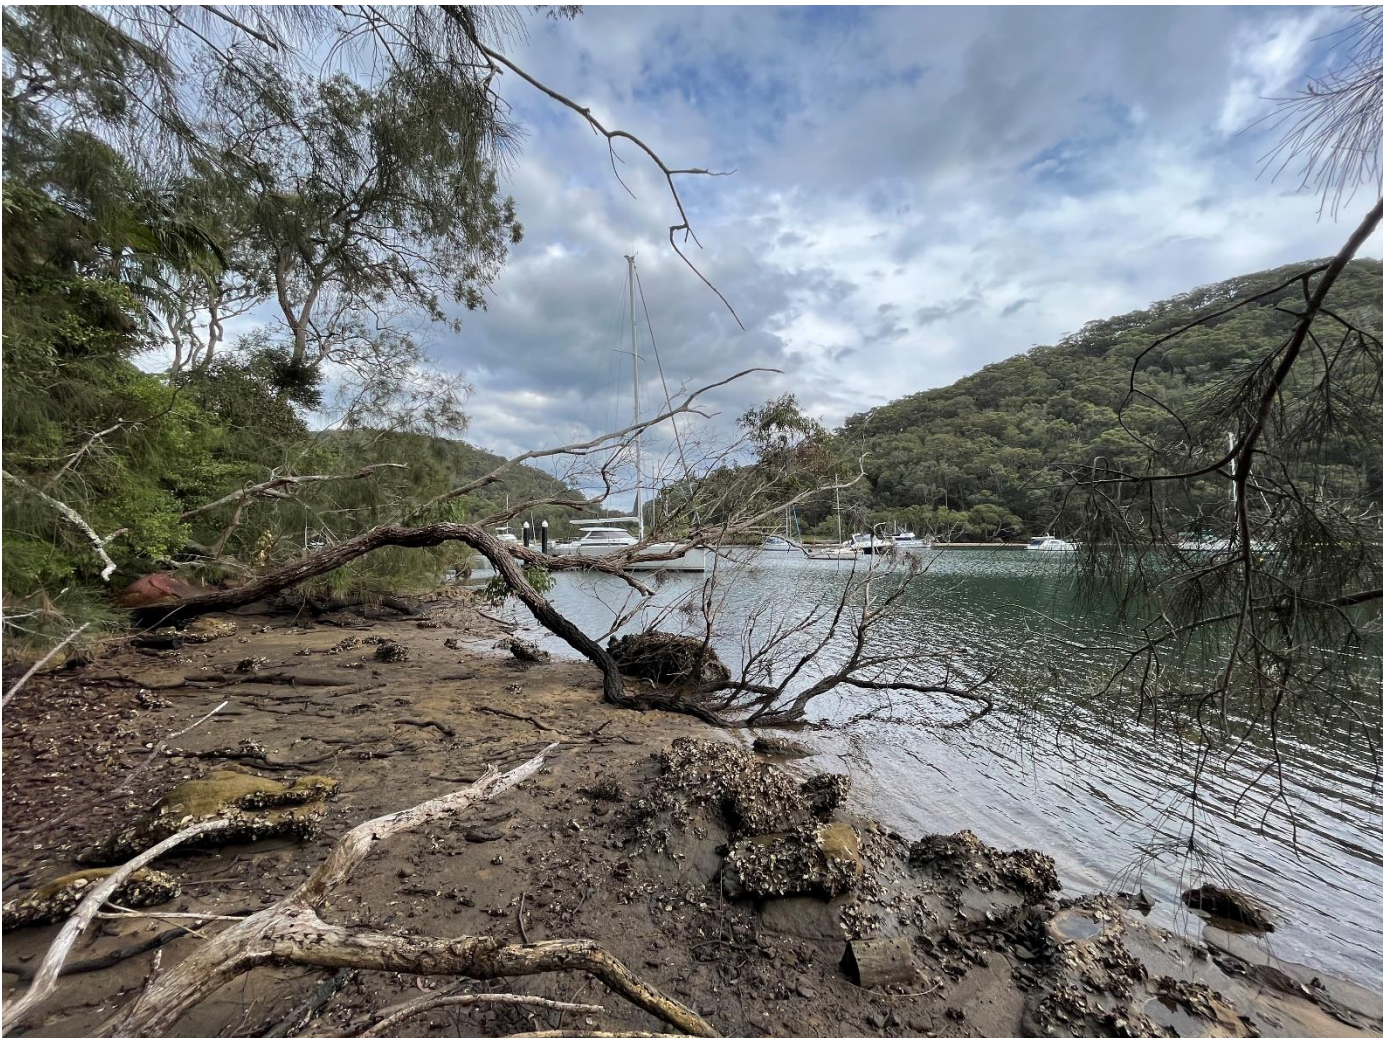
The proposed structures will originate from the natural shoreline on the Subject Site and extend approximately 28 m west into McCarrs Creek (Figure 3 and 4).

Figure 3: Existing natural waterfront at the Subject Site.

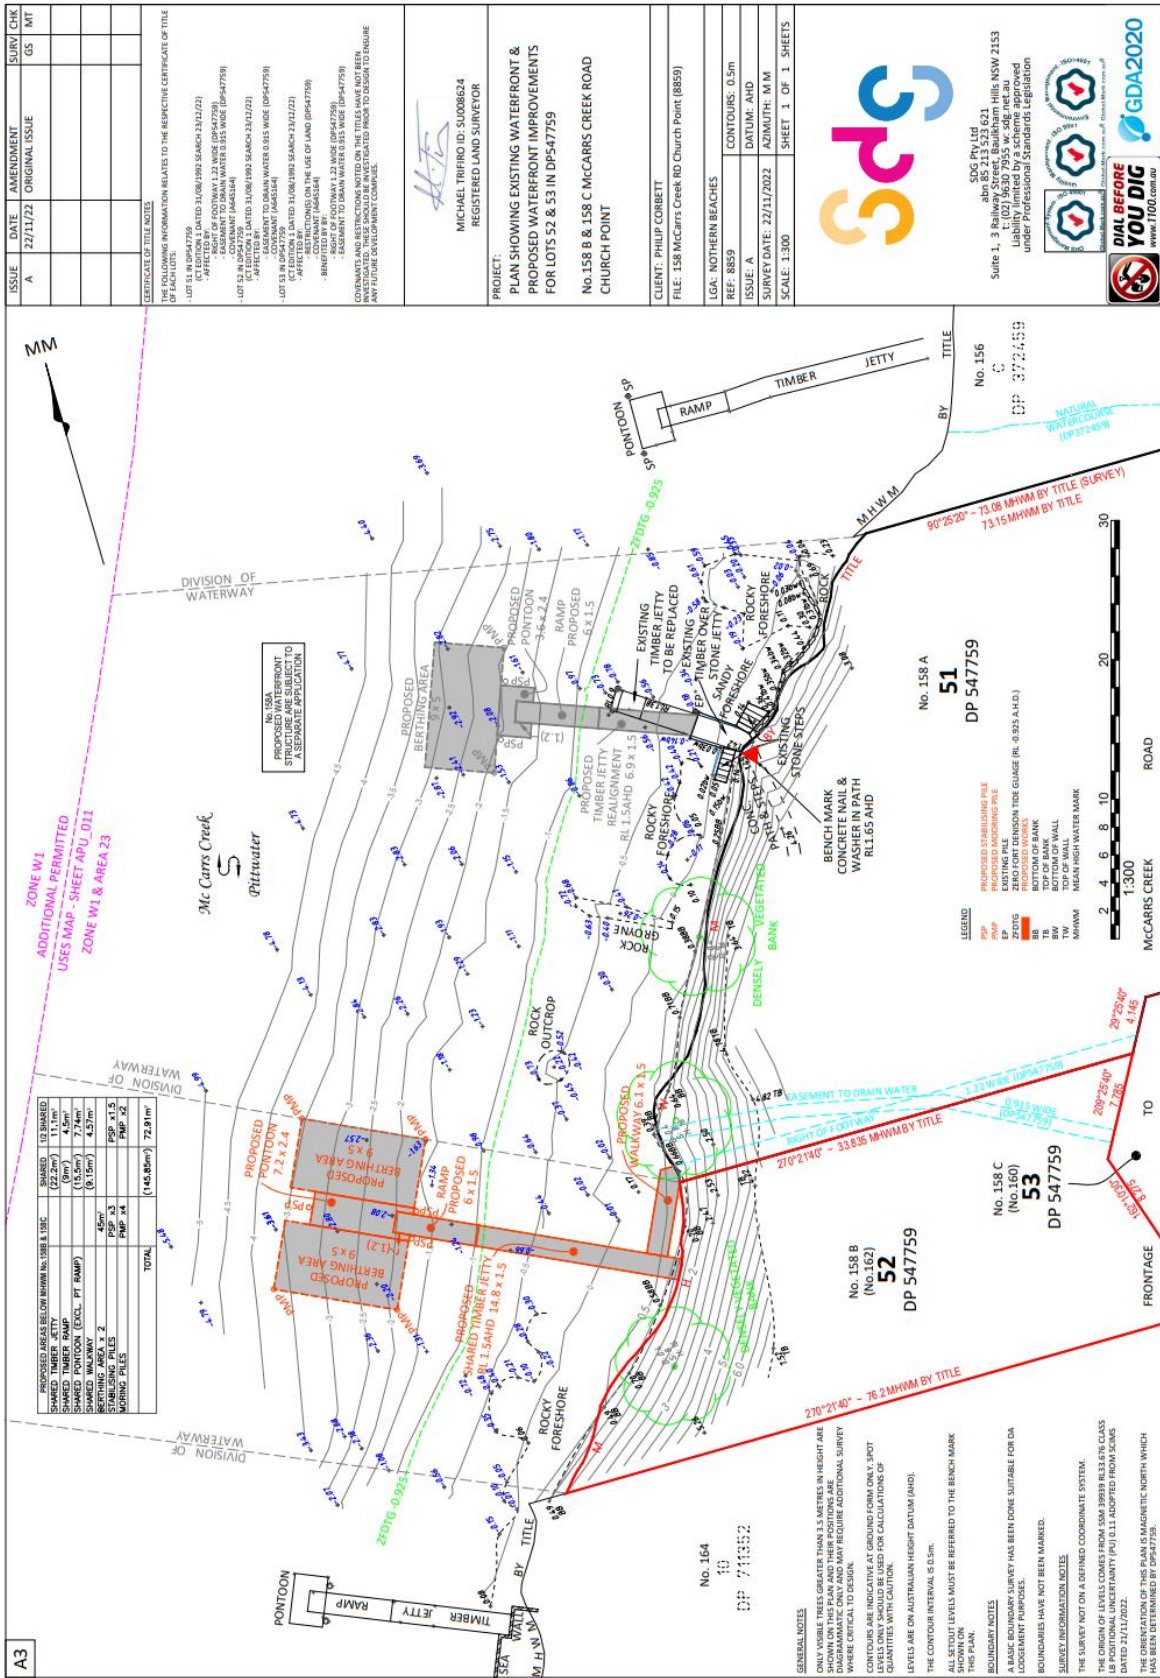
- Construction of new walkway (6.1 x 1.5 m),
- Construction of new timber jetty (14.8 x 1.5 m), realigned with existing stone jetty,
- Construction of new ramp (6.0 x 1.5 m),
- Construction of new pontoon (7.2 x 2.4 m) and three stabilising piles; and
- Construction of two new berthing areas (9.0 x 5.0 m each) with two mooring piles each.

Figure 4: Plans of the proposed waterfront structures at the Subject Site.

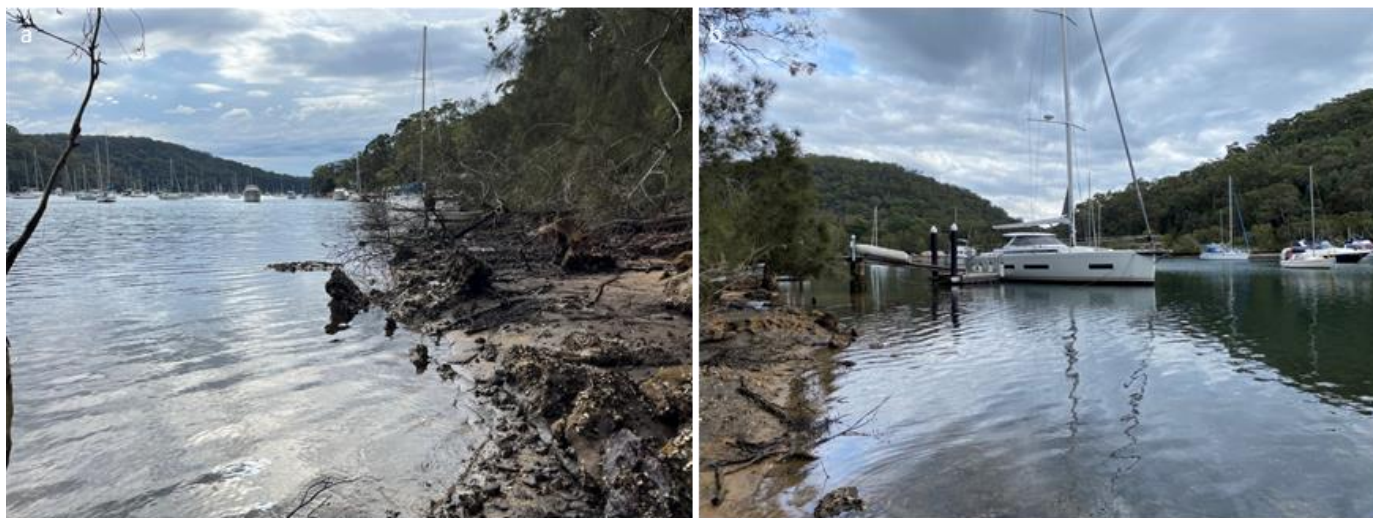
The adjoining shoreline is a natural waterfront that backs onto a densely vegetated escarpment, rising approximately 40 m to McCarrs Creek Road, with a westerly aspect across McCarrs Creek. The waterfront at the Subject Site comprised of naturally vegetated rock escarpment, rock platform and boulders, a mixed muddy, sandy and silty shore and a moderately sized fallen tree. Waterfront to the northeast of the Subject Site comprised of naturally vegetated shoreline before residential jetties, ramp and pontoons. To the southwest, structures include a seawall, jetty, ramp and pontoon (Figure 5).

Figure 5: Waterfront structures to the (a) northeast and (b) southwest of the Subject Site.

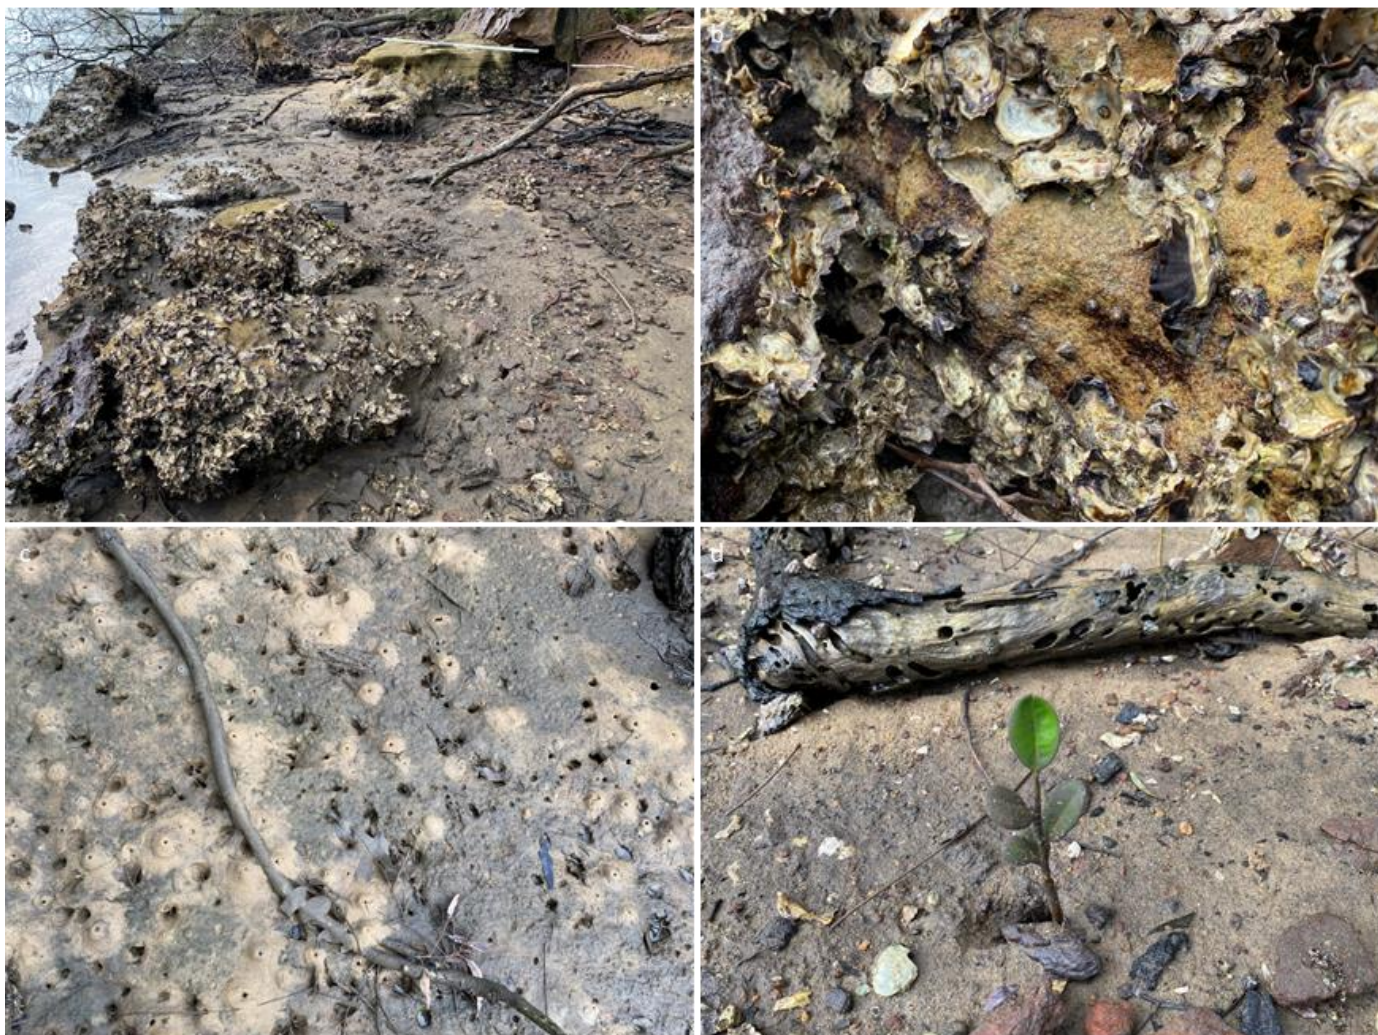
Intertidal habitat at the Subject Site comprised of rock boulders and small rock platforms, soft sandy, silty and muddy fine sediment, with a branch from a moderately sized fallen tree across the lower intertidal section.

Rock boulders and small rock platforms at the bottom of the vegetated escarpment provided habitat for the high intertidal zone with small, dense patches of Sydney Rock Oysters (*Saccostrea glomerata*) on lower sections. Large rock boulders across the lower section of the site in the mid intertidal zone supported larger assemblages of *S. glomerata*, as well as other invertebrates, including the sessile Variegated Limpet (*Cellana tramoserica*) and the mobile Gold-mouth Conniwink (*Bembicium auratum*) and Striped-mouth Conniwink (*B. nanum*) (Figure 6). The fallen branch provided additional habitat for these mobile species. Soft sediment in the mid and low intertidal zones was observed to be rich with epibenthic fauna given the high amount of bioturbation, likely attributed to Smooth Shore Crabs (*Cyclograpsus audouinii*) which were observed under boulders in low intertidal areas. In this area, some recently settled Grey Mangrove (*Avicennia marina*) seedlings were observed attempting to colonise in the sediment, however, no established mangrove saplings or trees were observed within the Study Area. These seedlings were not observed to be within the proposed design footprint. The low intertidal zone at the water's edge was observed to have accumulations of shell debris, with any boulders bordering the Mean Low Water Mark (MLWM) supporting similar communities as in mid intertidal zones.

Figure 6: Typical intertidal habitat at the Subject Site, showing (a) large rock boulders with assemblages of invertebrate species, (b) common intertidal invertebrate communities with *S. glomerata*, *C. tramoserica*, *B. auratum* and *B. nanum*, (c) bioturbated sandy and silty sediment and (d) Mangrove seedling in the low intertidal zone.

- Disturbance to and potential removal of some intertidal habitat during construction of walkway, jetty and associated piles. Boulders that lay within the design footprint may need to be repositioned to accommodate for new structures. Species affected are limited to common intertidal invertebrates and will likely colonise on nearby rock habitat.

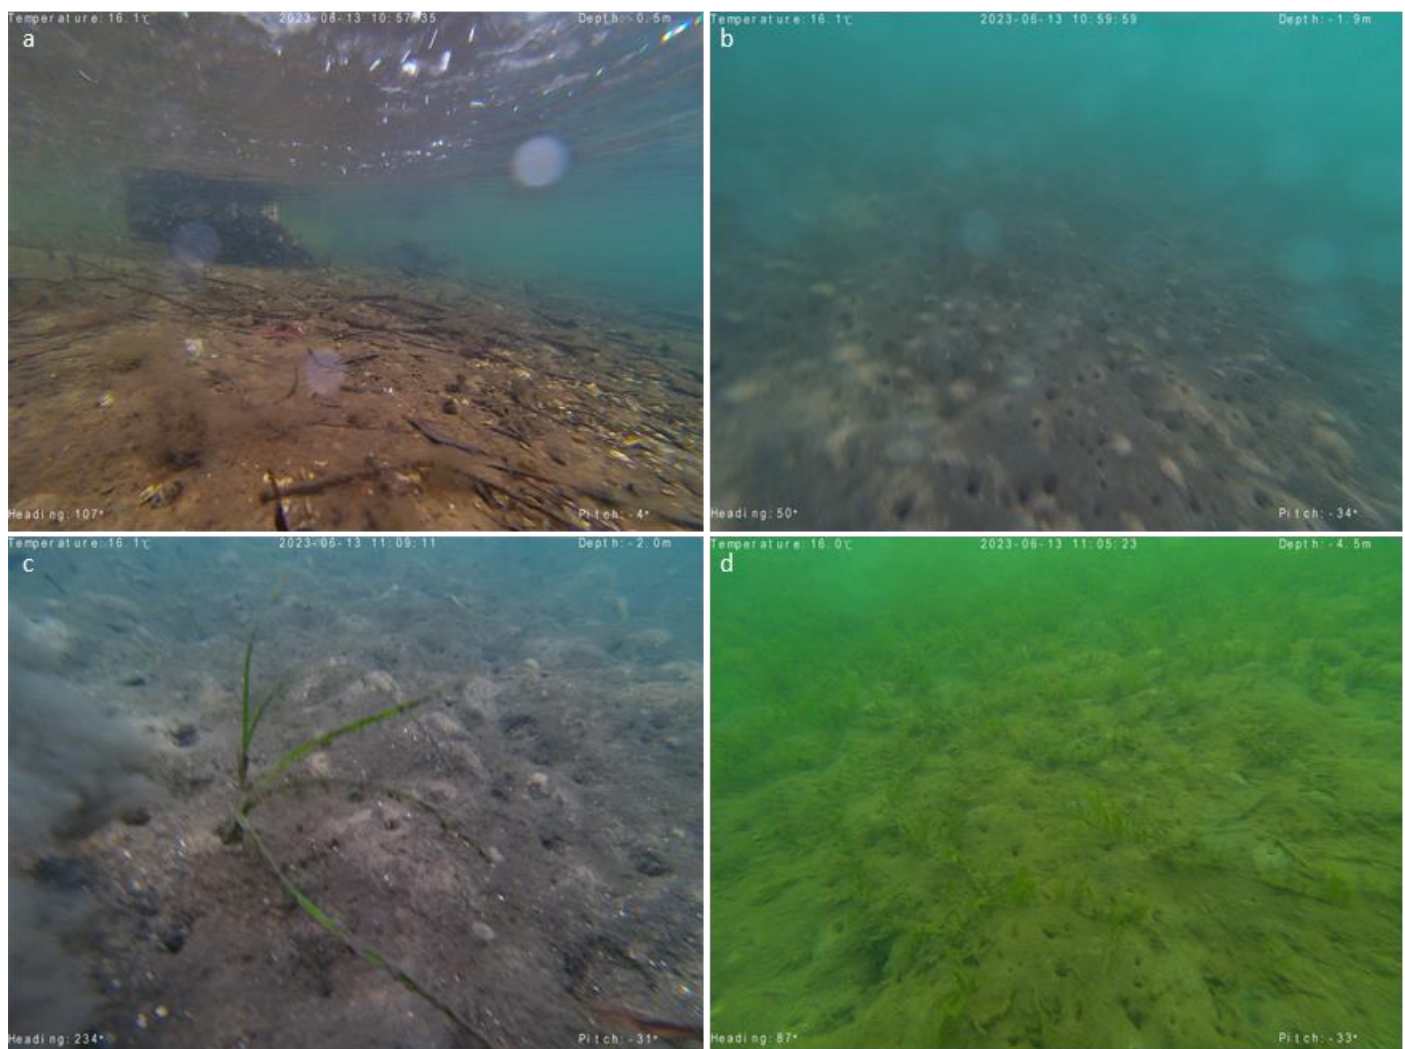
The silty seabed in shallow areas of the Subject Site was covered by a high amount of shell debris and detritus from the nearby terrestrial vegetation. Rock and rubble close to shore on the northeastern side provided substrata for occasional assemblages of Sydney Rock Oysters (*Saccostrea glomerata*), however, other utilisation of habitat in this area was minimal except for sporadic occurrences of filamentous algal growths (Figure 7).

In deeper areas approximately 8-10 m from shore, the sediment across the Subject Site became heavily bioturbated, indicating the presence of epibenthic fauna such as polychaetes, crustaceans or fish (Figure 7). On the southwest side of the Subject Site approximately 10 m from shore, an isolated low-density clump of *Zostera capricorni* seagrass and a low-density clump of *Halophila ovalis* seagrass were observed

adjacent to each other around the -2.0 m depth contours (Figure 7) and approximately 7 m to the south of the proposed structure (Figure 8). Native seagrass was limited to these clumps, however, between 35 and 40 m from shore at the -5.0 m depth contour a bed (6.0 m<sup>2</sup>) of the invasive *Caulerpa taxifolia* was observed in medium density (Figure 7), and approximately 15 m seaward of the proposed structure (Figure 8).

Figure 7: Typical subtidal habitat of (a) shallow subtidal habitat with rock boulders, detritus, shell debris and filamentous algal growth, (b) silty, soft sediment heavily bioturbated, (c) low-density clump of *Z. capricorni*; and (d) medium-density bed of *C. taxifolia*.

The invasive green alga *C. taxifolia* was observed in a medium density bed on the silty soft sediment on the western border of the Study Area.

The invasive green alga *Caulerpa taxifolia* was observed in high densities at the western border of the Subject Site. The proposed works may facilitate the further spread of this species. It is essential that care is

to be taken to ensure construction equipment is clean before leaving site and does not facilitate the spread of this species to new sites.
