**STAGE 2 DETAILED SITE
INVESTIGATION (DSI)**
(Including Stage 1 PSI information)

**Proposed Development
'The Boathouse'
Governor Phillip Park
Palm Beach NSW 2108**

Part of Lot 7005 in DP 1117451

(Report ID : EBG-02853.Stage2.DSI.09.20.R01)

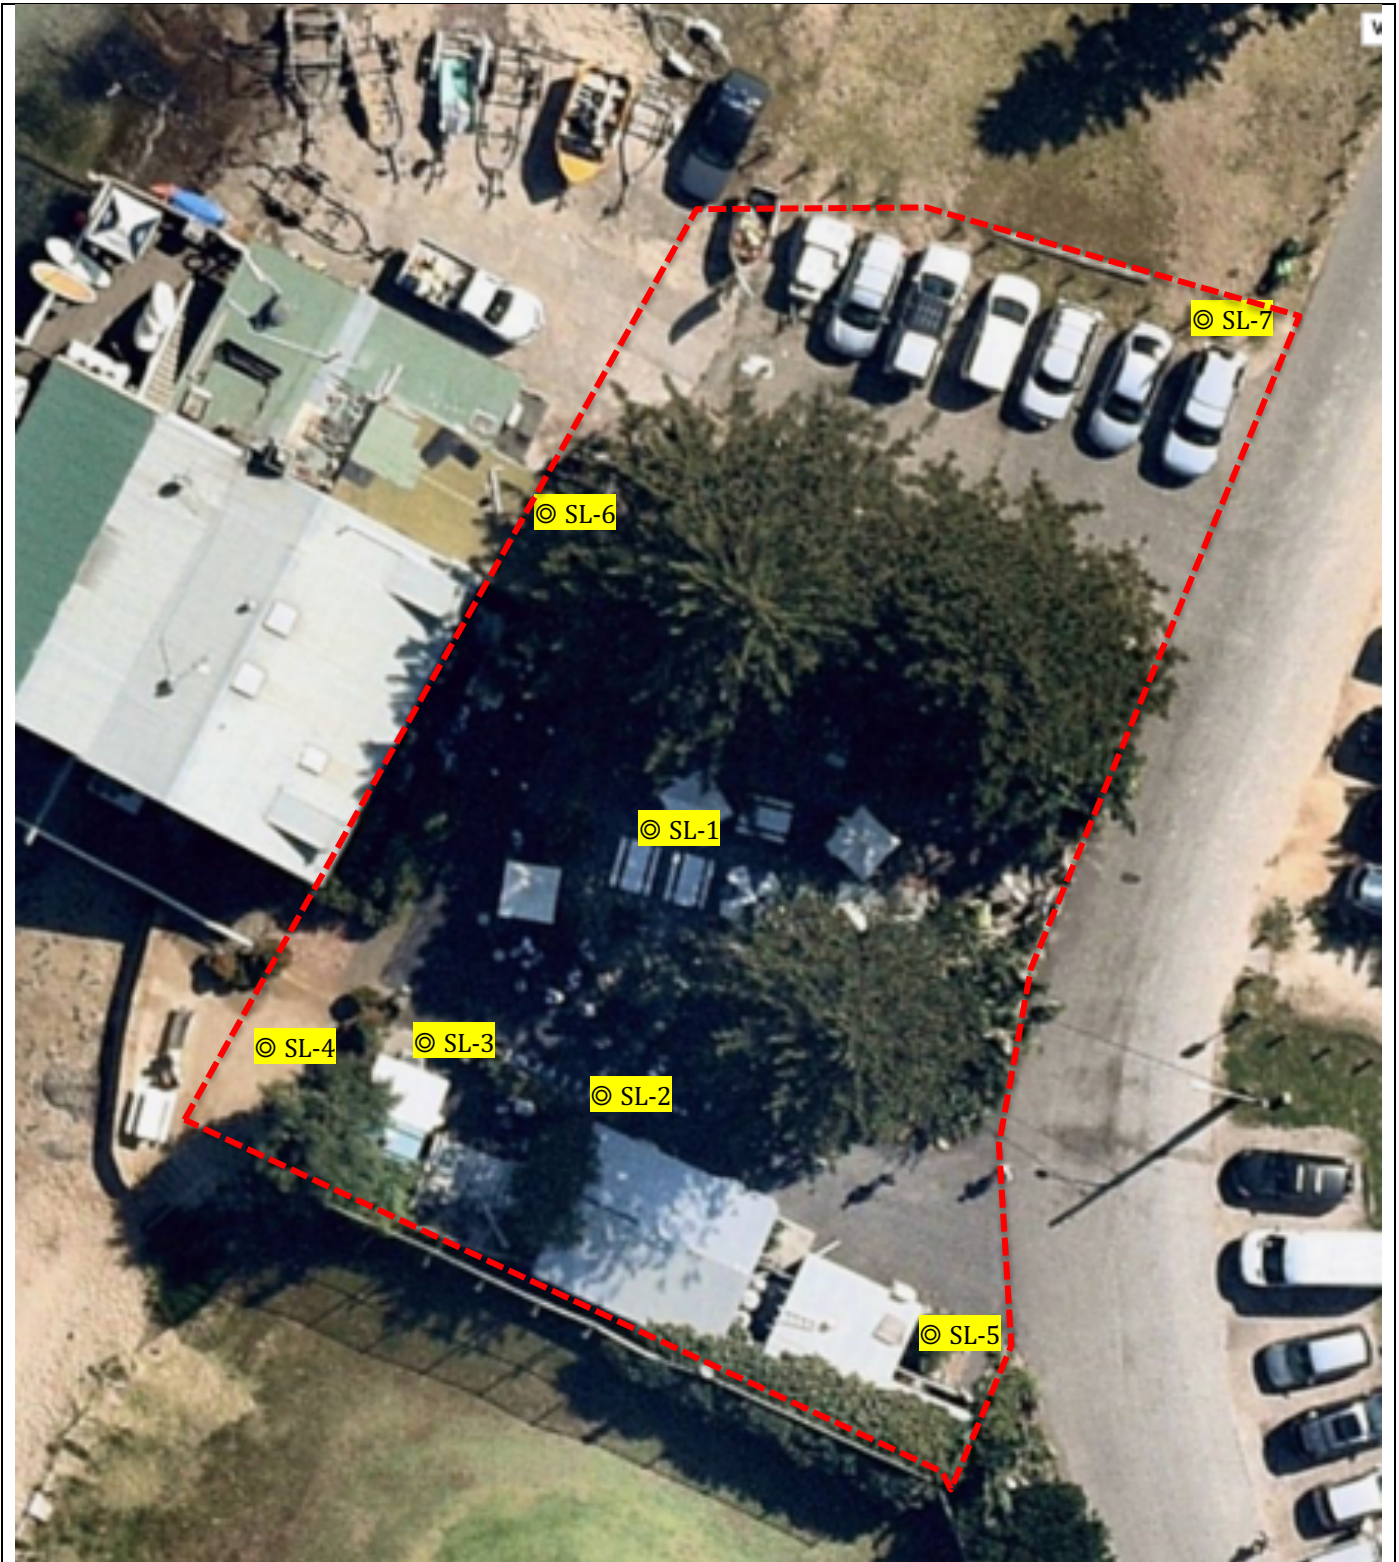
The subject of this investigation is a small part of the total Lot and DP. The investigation area is between 1000 and 2000 square metres. As such according to EPA NSW *Sampling Design Guidelines* (Sept 1995), a minimum of 7 sampling points are required to characterise the site (based on a 95% confidence to detect a hot spot with a 19.9 metre circumference for a site up to 2000 sq/m). A sample was taken of each stratigraphic layer down to natural soils (generally two samples). The locations of the boreholes are shown in *Figure 2 - 02853-F02 (Appendix A)*.
