**re: DA-STAGE GEOTECHNICAL INVESTIGATION / LANDSLIDE RISK APPRAISAL  
PROPOSED HORSE ARENA DEVELOPMENT & BUILDING ADDITIONS  
NO.113 [LOT 6 DP749791] ORCHARD STREET WARRIEWOOD NSW**

DA-STAGE GEOTECHNICAL INVESTIGATION / LANDSLIDE RISK APPRAISAL  
PROPOSED HORSE ARENA DEVELOPMENT & BUILDING ADDITIONS  
NO.113 [LOT 6 DP749791] ORCHARD STREET WARRIEWOOD NSW

report ref: R/18-023.A\_rev1

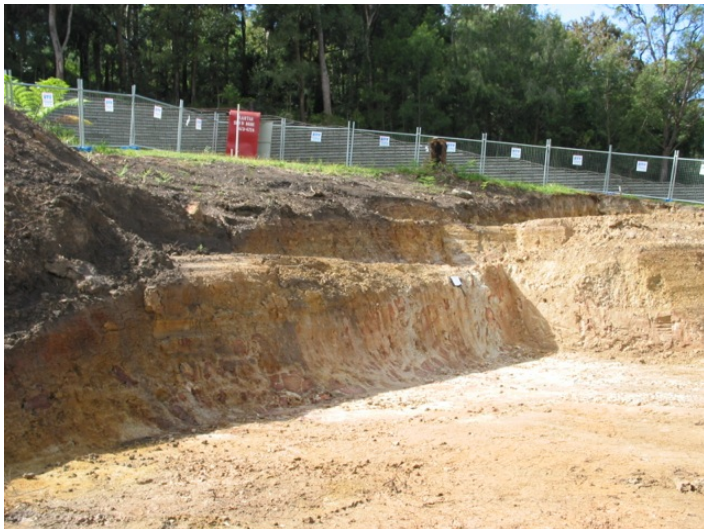
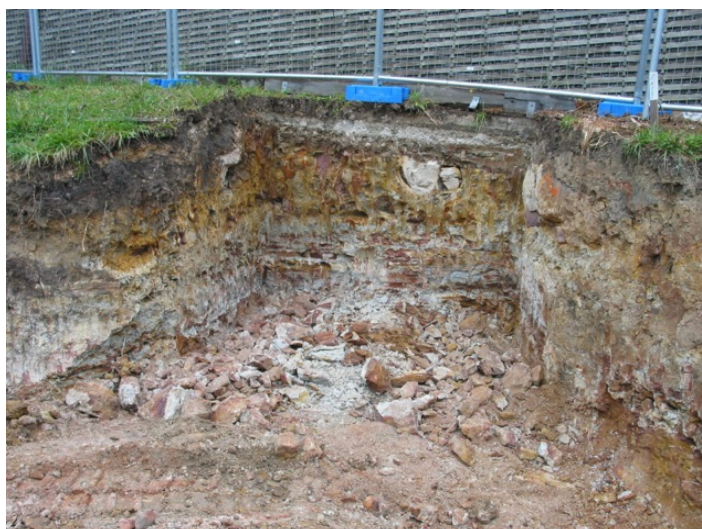
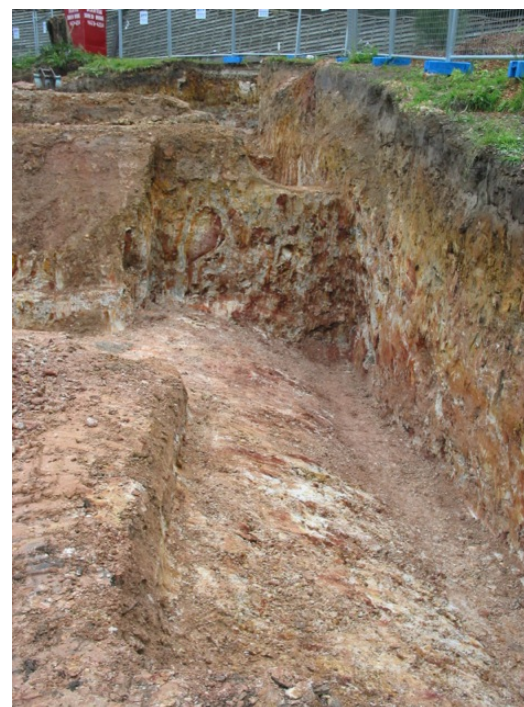
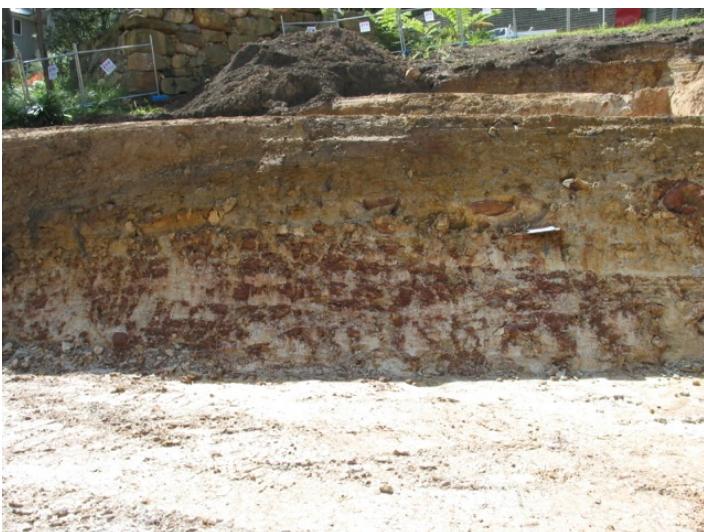
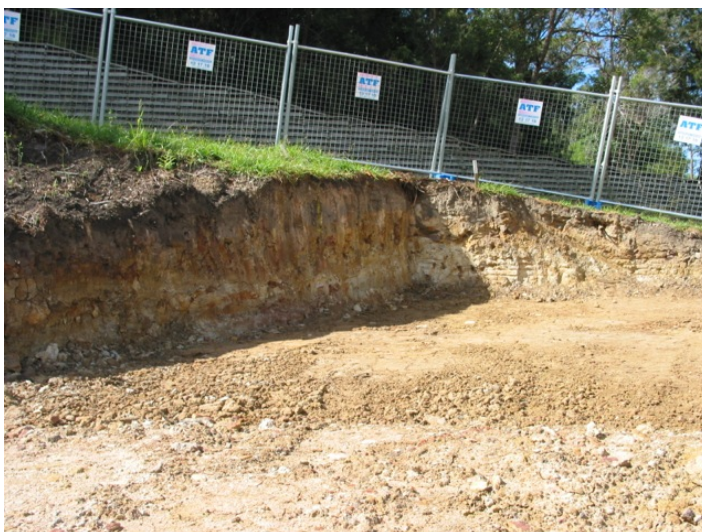
<b>Project No:</b> 18-023	<b>Scale:</b> NTS	ANTICIPATED SUB-SURFACE CONDITIONS NO.113 ORCHARD STREET WARRIEWOOD NSW (Jill Hunter)	<b>Figure 3B</b>
<b>Drawn:</b> wnd	<b>Date:</b> 20 Aug 18

- ❑ Photos by Davies Geotechnical Pty Ltd, Barkala Rd Bayview, April - July 2008.
- ❑ Subsurface conditions for Newport Formation. Sandstone/siltstone/claystone stratigraphy, RL range 22m - 32m AHD.

The slope section G1 in Figure 3A and the photographs provided in Figure 3B indicate our interpretation of the geotechnical slope model and the anticipated subsurface conditions at the site, based on the mapped slope features and site geology.

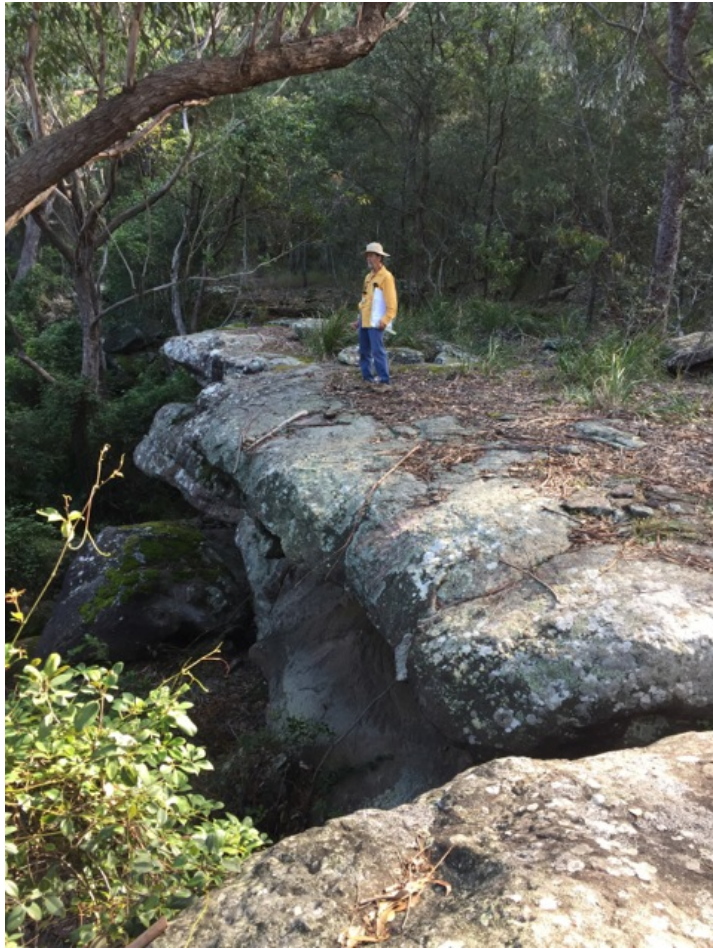
View west along escarpment cliff line from rear boundary of No.113

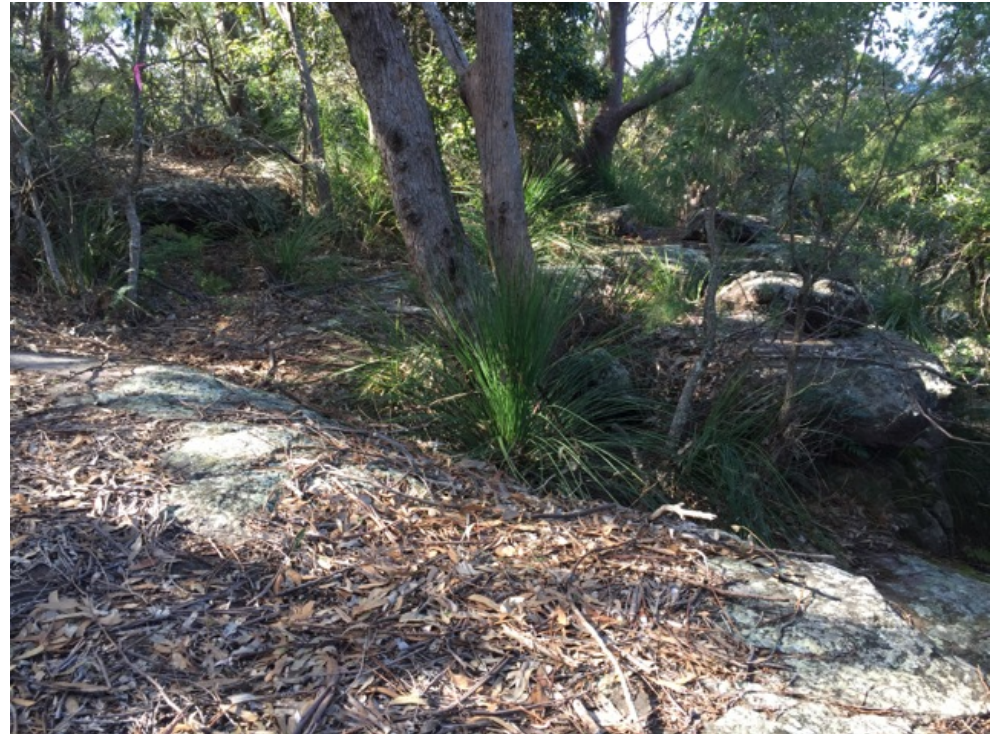
View north along western boundary of No.113, typical of broad ridge crest upslope from escarpment

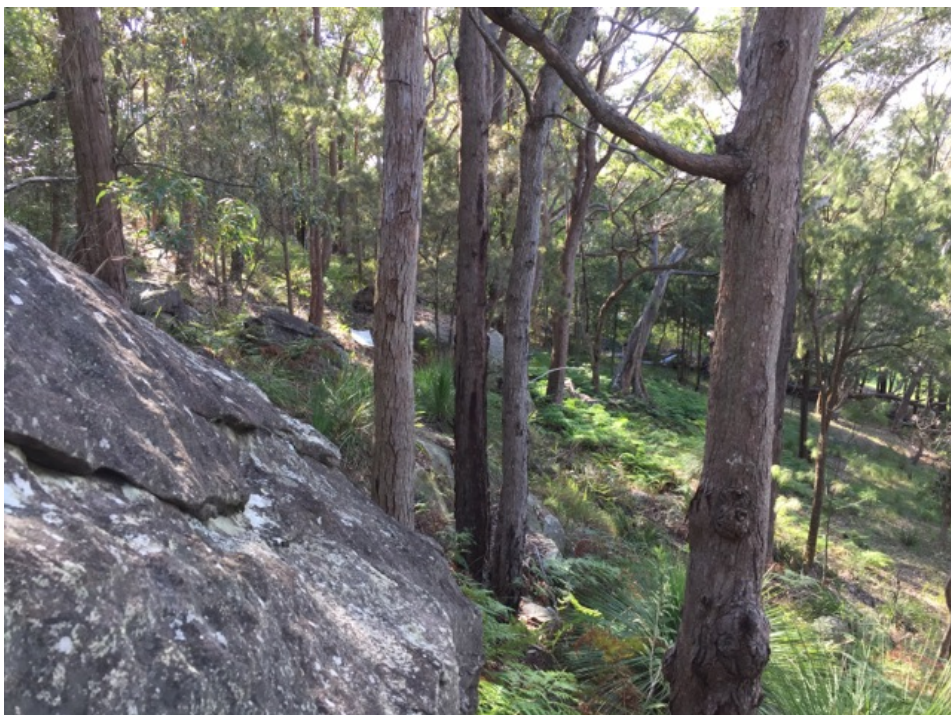
View north along escarpment zone

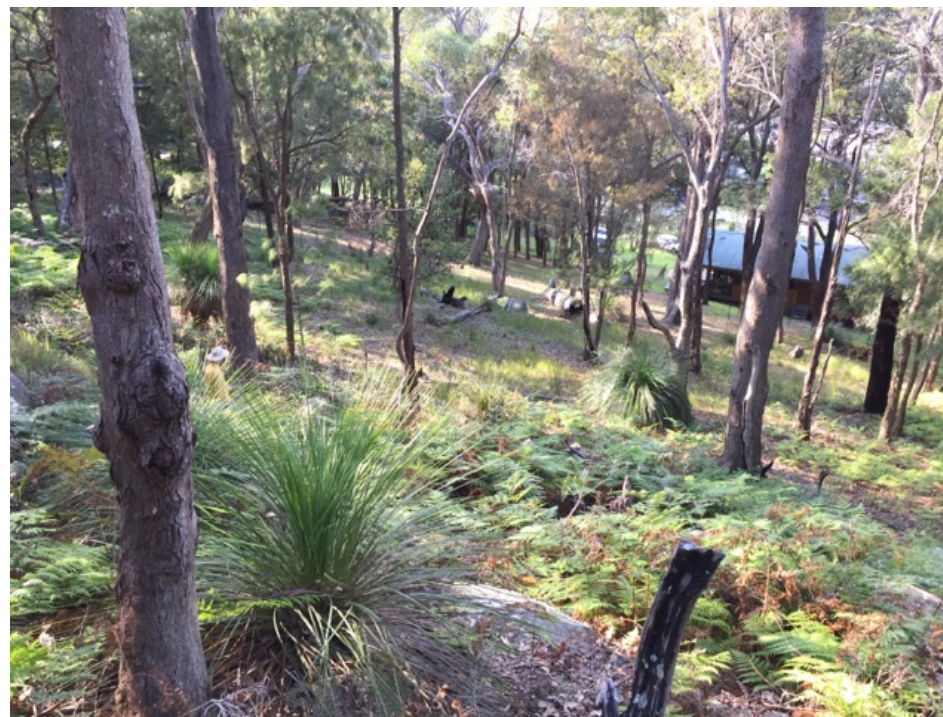
View ENE from escarpment, looking down the 17° hillslope, across paddock site, and towards dwelling

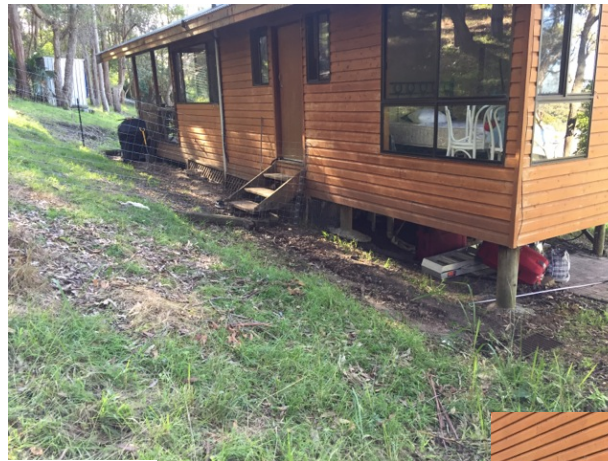
View NE to rear of dwelling.  
Isolated sandstone floater resting on slope surface

Excavated batters must not undercut or de-stabilise the foundation of any boulders or sandstone blocks/"floaters". Where necessary, modify the batter design or support to suit local circumstances.

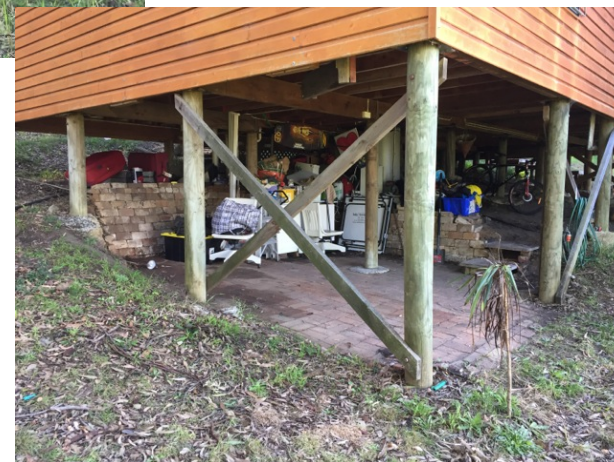
Dwelling pole footings

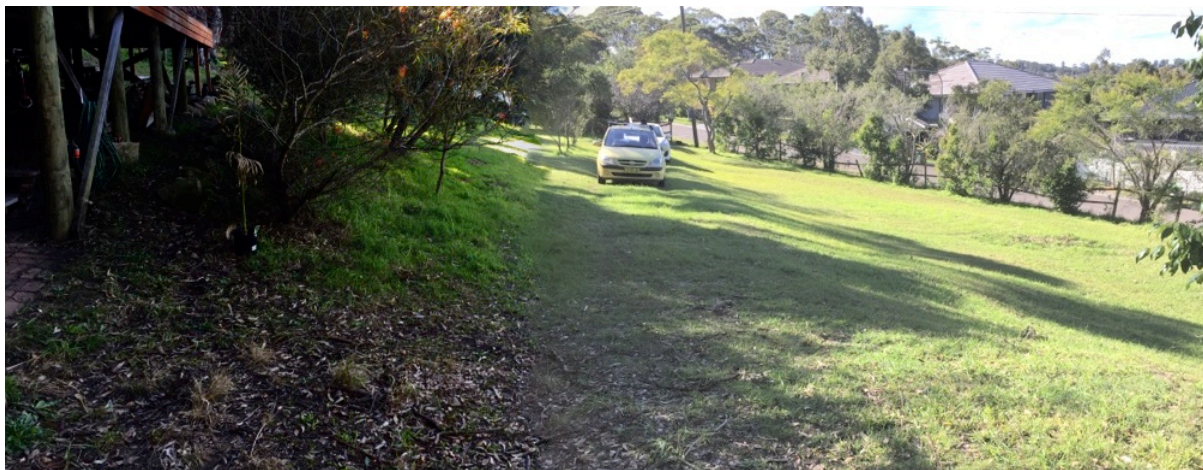
View NNE across front of dwelling and lower footslope area (site of proposed Horse Arena)

The Horse Arena has been lowered marginally to RL24.5m, and requires excavation up to 2m depth at the NW corner, diminishing along the uphill western side to about 1.5m depth across the front area of the dwelling. It is noted here that the excavation may undercut the footings of existing dwelling. Fill up to 3.8m depth is required along the eastern (Orchard St) side.
