GEOTECHNICAL RISK MANAGEMENT POLICY FOR PITTWATER
FORM NO. 1 – To be submitted with Development Application

Development Application for Mr Kevin Xue
Name of Applicant
Address of site No. 206 Hudson Pde, clareville, nsw 2107

Ref: ESWN-PR-2022-1546 No. 206 Hudson Parade, Clareville, NSW 2107

Geotechnical Investigation

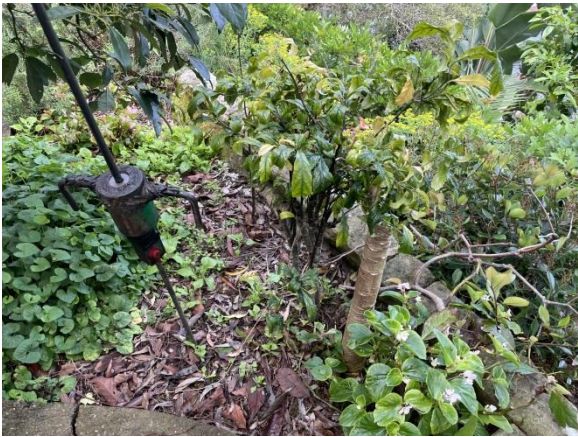
<p>Photograph 1 Dynamic Cone Penetrometer(DCP) Test at DCP1 within rear garden</p>	<p>Photograph 2 DCP test in progress at DCP2 within rear garden</p>	<p>Photograph 3 DCP test at location of DCP3 within rear garden</p>

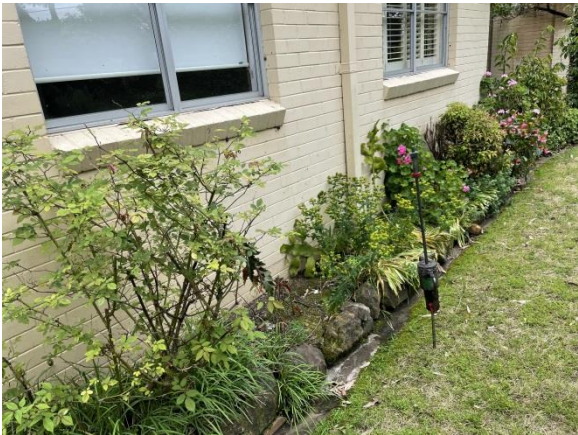
<p>Photograph 4 DCP test at location of DCP4 within front yard</p>	<p>Photograph 5 Sandstone outcrops exposed along rear stairs</p>	<p>Photograph 6 Sandstone outcrops exposed along rear stairs</p>
