REPORT TO
ALLAN GROUP DEVELOPMENTS

ON
GEOTECHNICAL DESK STUDY

FOR
PROPOSED RESIDENTIAL DEVELOPMENT

AT
**10-12 CLIFFORD STREET & 33-35 FAIRLIGHT
STREET, FAIRLIGHT, NSW**

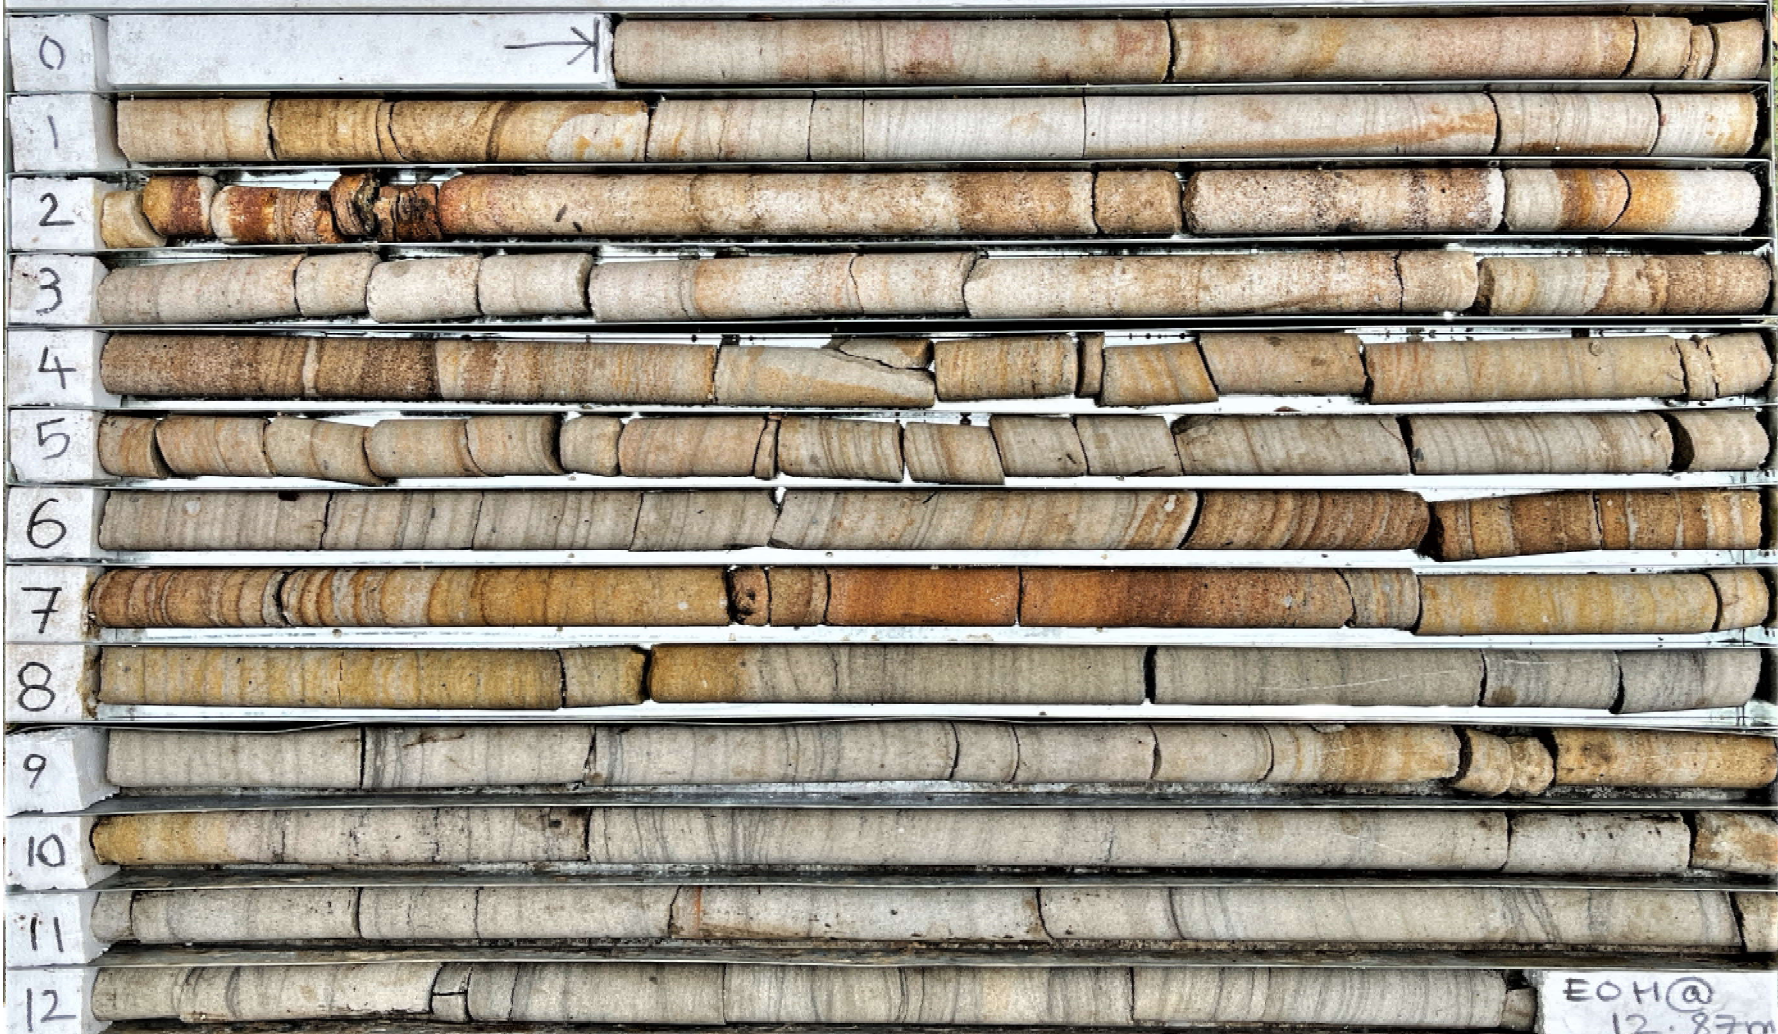
Job No: 34479SJ
Borehole No: BH4
Depth: 0.3m - 12.87m

34479SJ BH4 START CORING AT 0.3m

EOH@
12.87m

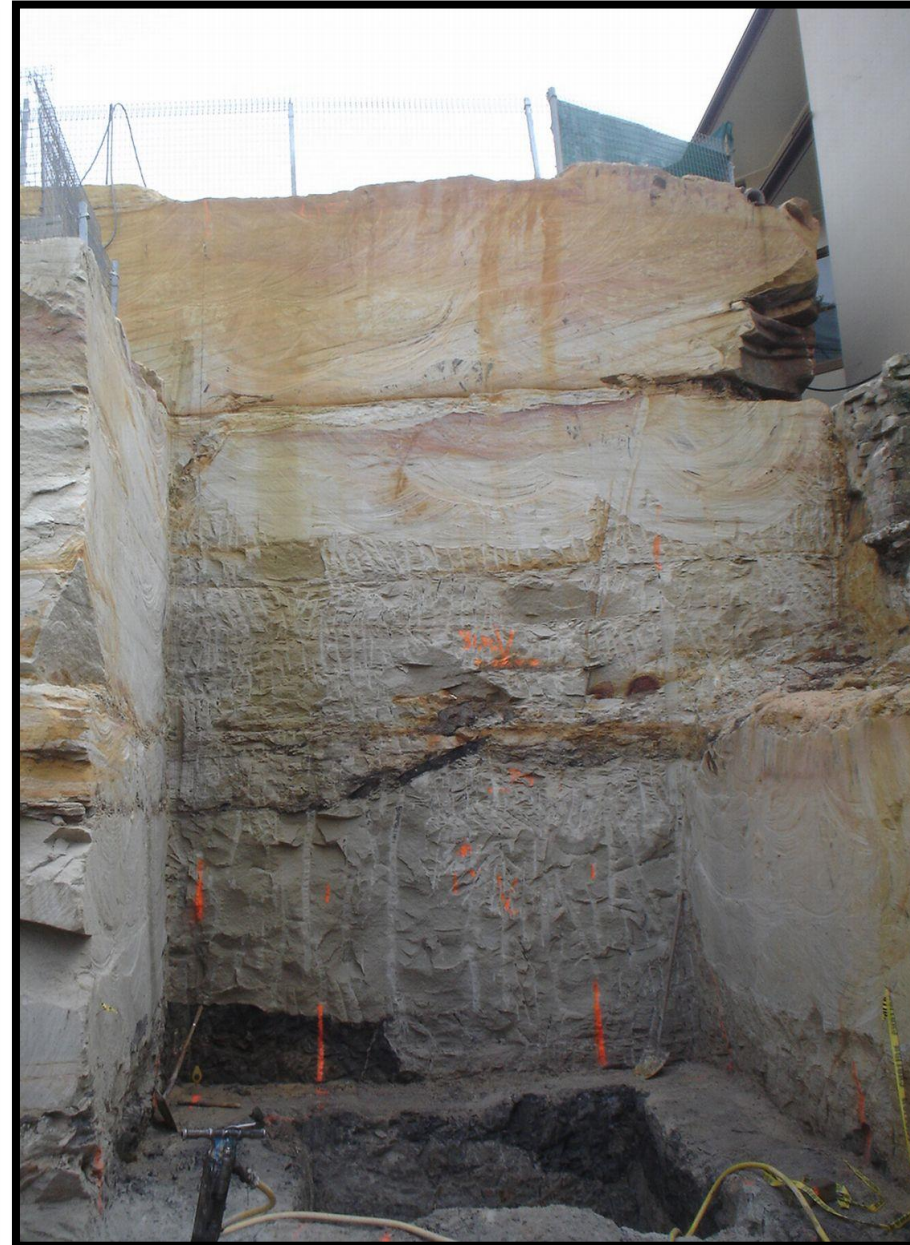
Rear, north-eastern corner of basement excavation, looking north

Photographs taken during construction stage inspections at No.10 Clifford Avenue

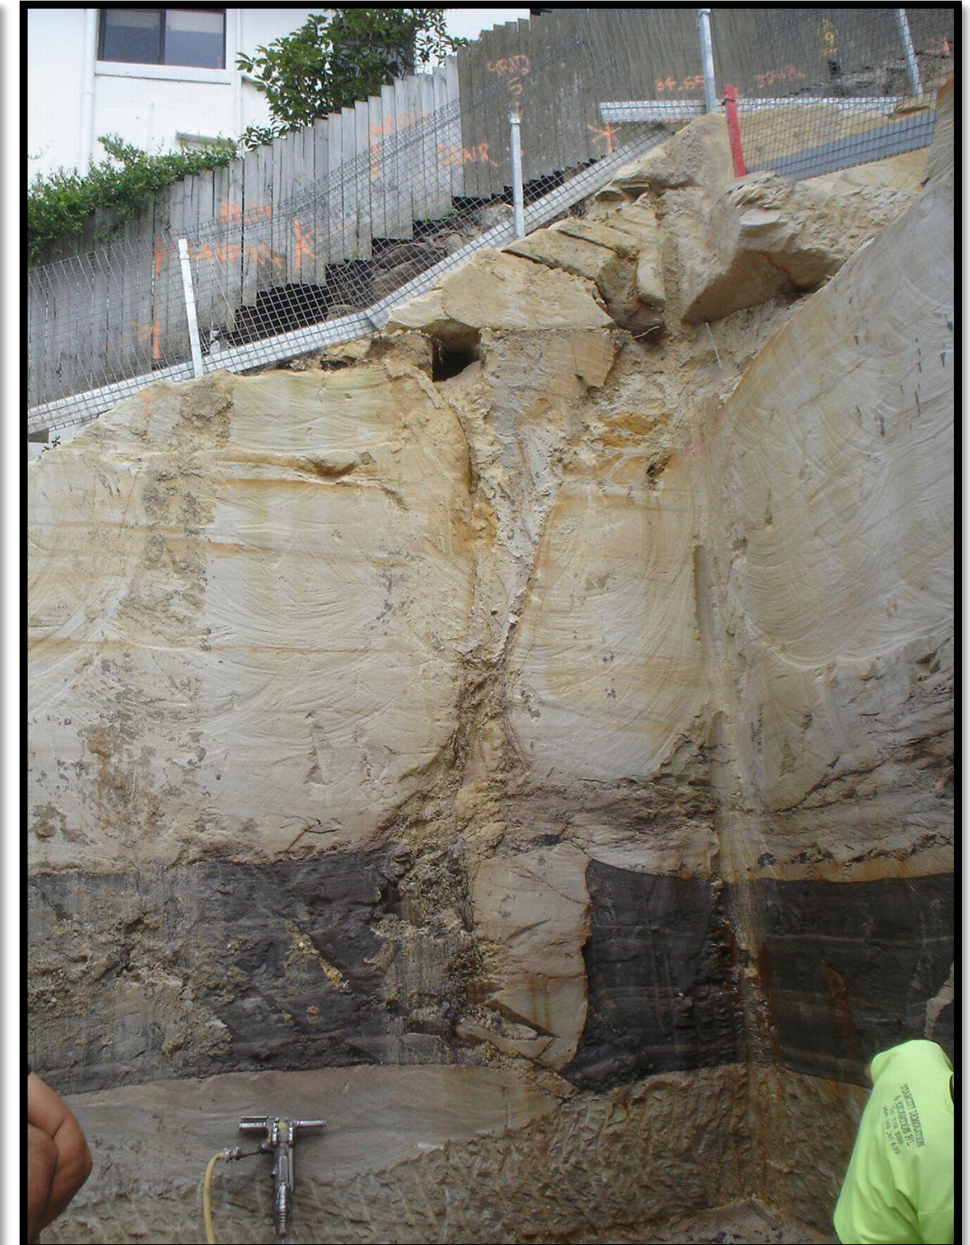
Rear north-western corner of basement excavation, looking west
