Construction Impact & Management Statement for soon to be Lodged Development Application

August 2018

Site:	Lot 1001963 in DP 638 Pittwater Road BROOKVALE, NSW
Client:	Anthony Chirillo c/ Freeman & Chirillo PO Box 7380 WARRINGAH MALL 2100 Phone: 61 412 652 559 Email: tony@freemanchirillo.com.au
Author:	Kyle A Hill Registered (Arb Aus #1884) Practising & Consulting Arborist Post Graduate Certificate in Arboriculture, Uni of Melb Diploma of Horticulture–Arboriculture TAFE, Grow SA Certificate of Horticulture, TAFE Certificate Advanced Tree Care TAFE Founder -Growing My Way Tree Services (1977) Member of International Society of Arboriculture Member of Arboriculture Australia

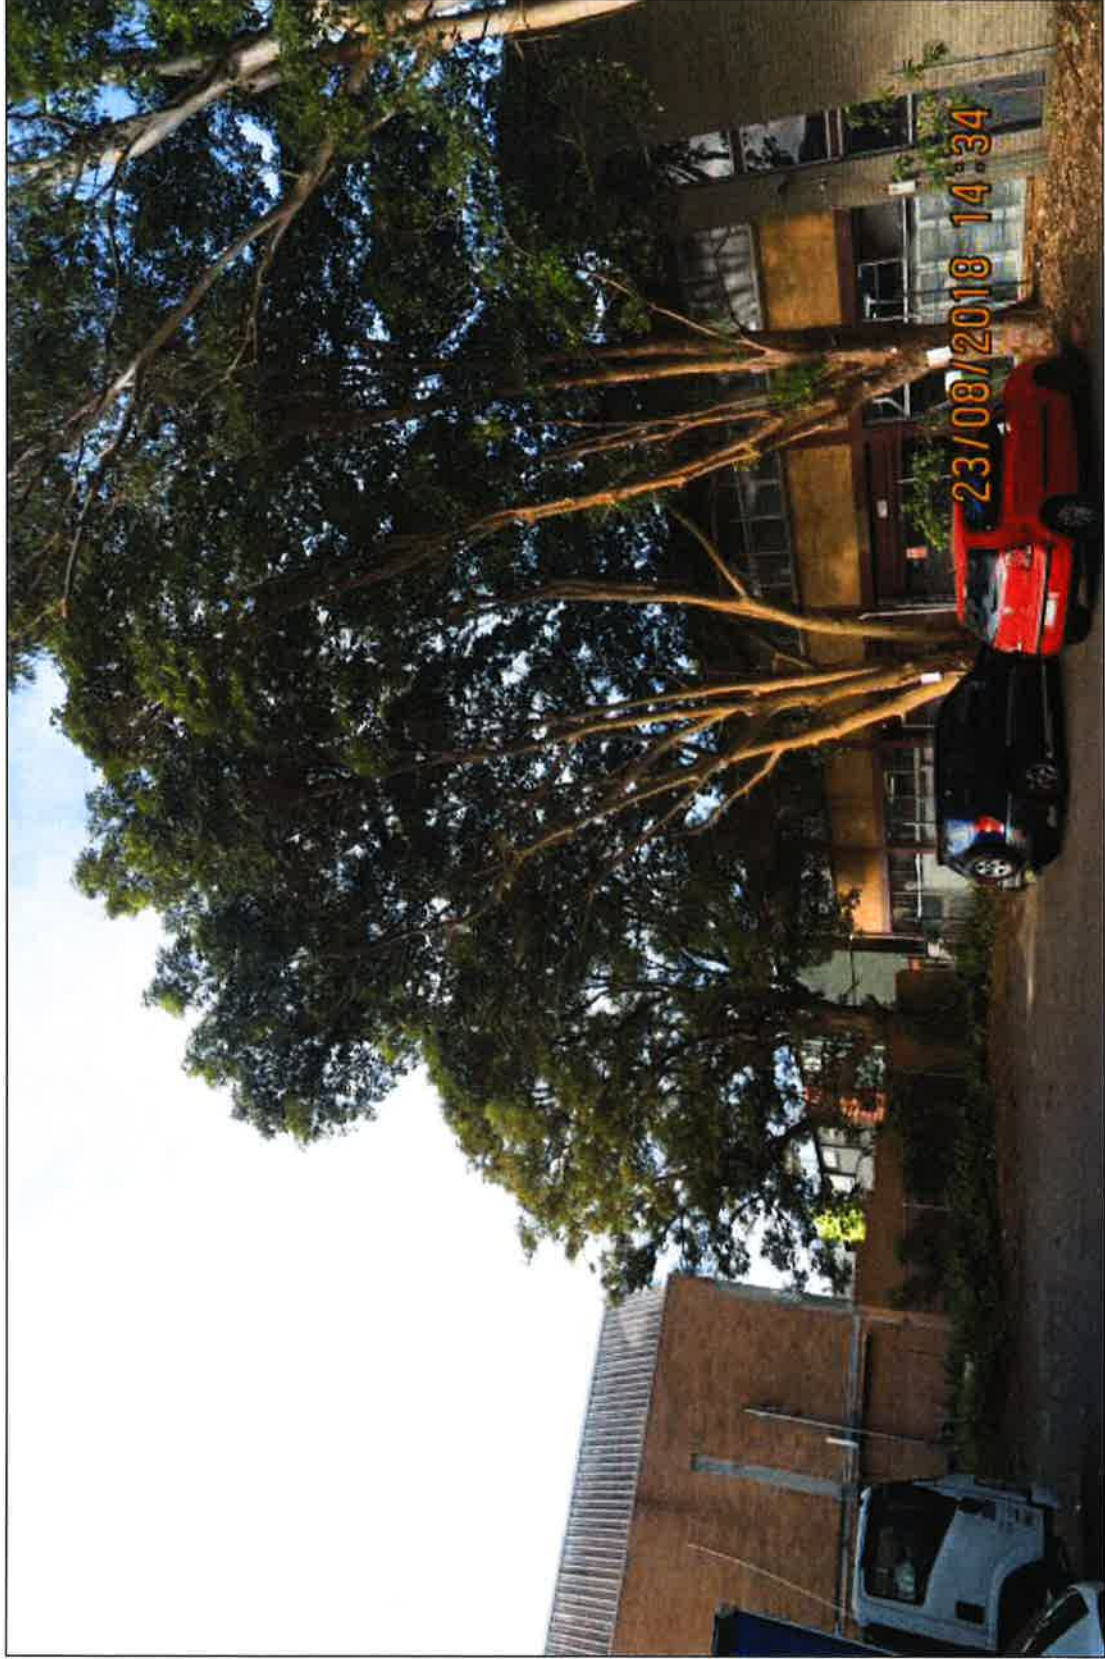
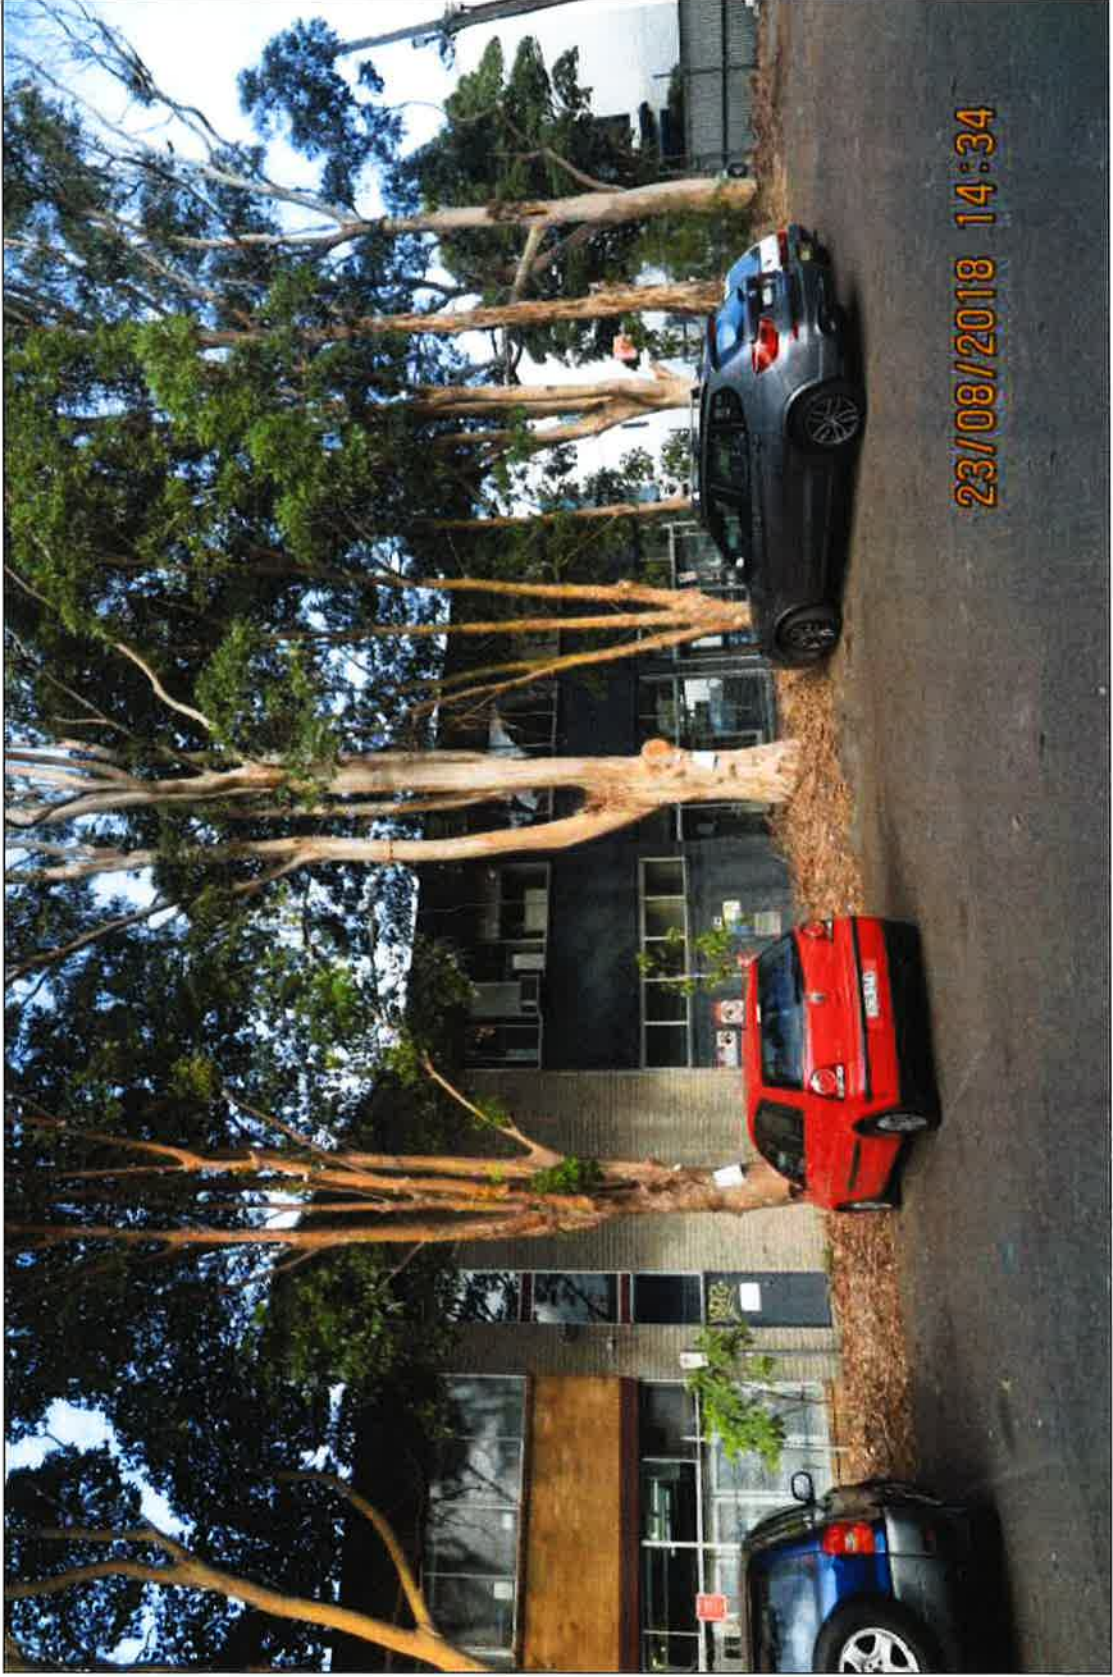
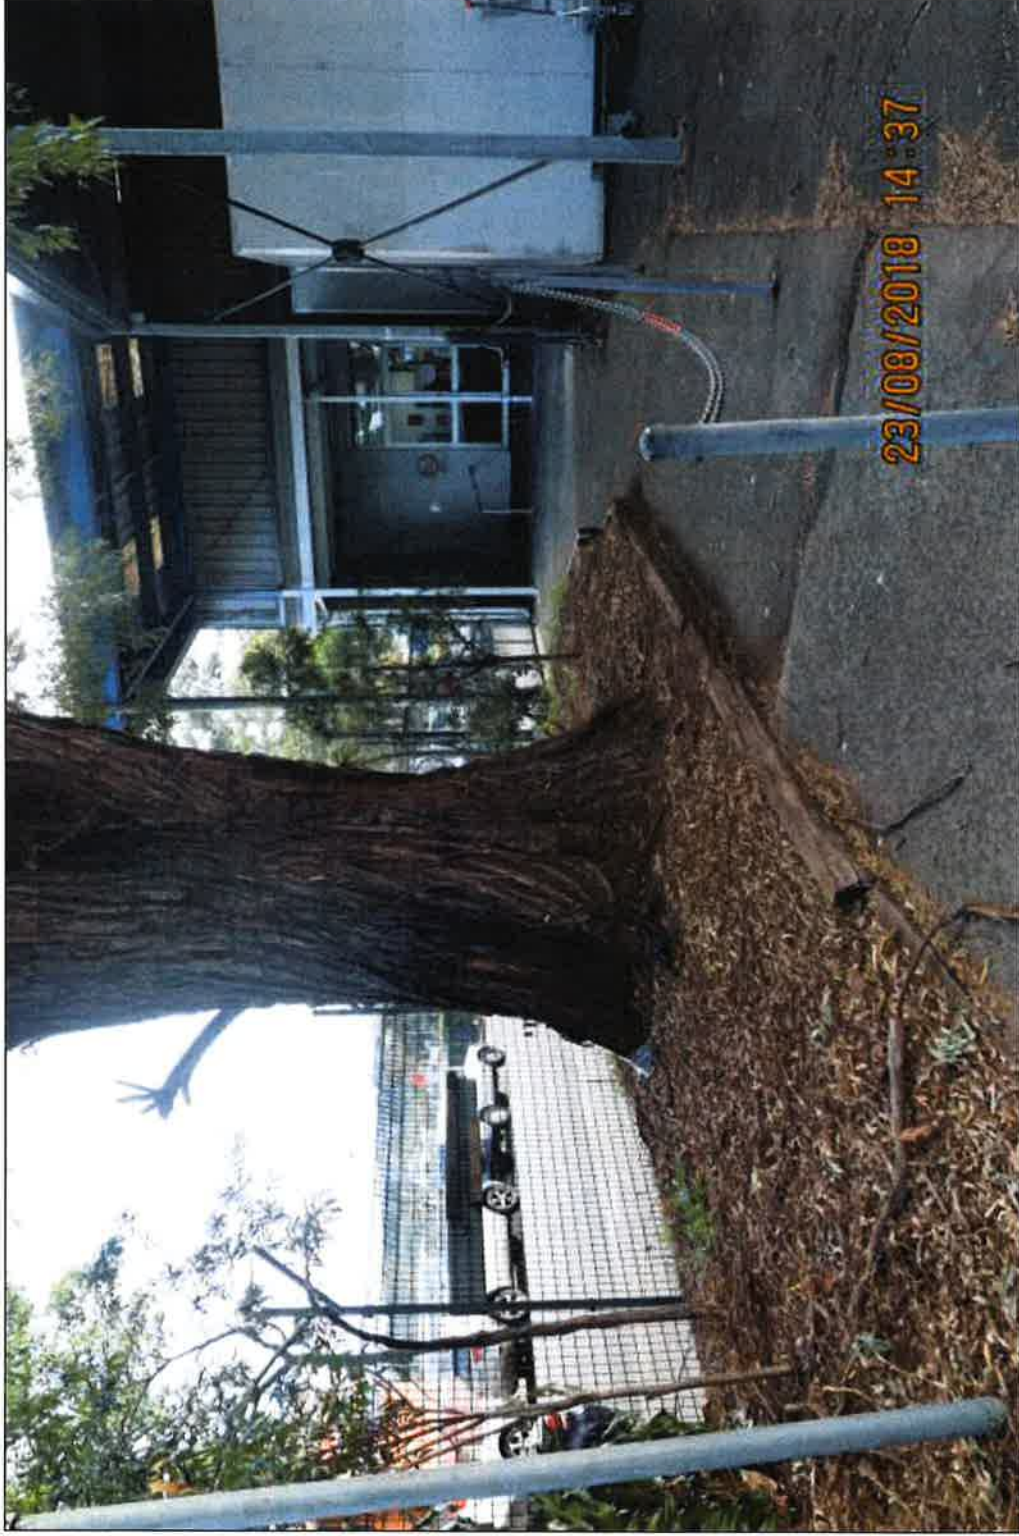
Figure 4: Above & previous 2 pages illustrates location & condition of the discussed trees within the rear of the subject site.

Trees #5 & #6 display 'symptoms of stress', i.e. dead/dying branches up to large diameter (>50mm Ø).

- NBC protected Tree #4 is assessed as being required to be replaced.
- NBC Protected Tree #5 is to be Retained, Managed (as part of a group) & Protected. Protection will be in the form of temporary metal mesh fencing isolating (as a group) this tree. Management of ‘live woody tree roots’ requires manual excavation to a depth of one (1.00m) along the required line of excavation for establishment of basement levels (x3). As per the previous pages specifications any ‘live woody tree root’ exposed must be managed by the sites retained Practicing/Consulting Arborist.

- NBC Protected Tree #6 is to be Retained, Managed (as part of a group) & Protected. Protection will be in the form of temporary metal mesh fencing isolating (as a group) this tree. Management of ‘live woody tree roots’ requires manual excavation to a depth of one (1.00m) along the required line of excavation for establishment of basement levels (x3). As per the previous pages specifications any ‘live woody tree root’ exposed must be managed by the sites retained Practicing/Consulting Arborist.

- NBC Protected Tree #7 is to be Retained, Managed (as part of a group) & Protected. Protection will be in the form of temporary metal mesh fencing isolating (as a group) this tree.

- NBC Protected Tree #8 is to be Retained, Managed (as part of a group) & Protected. Protection will be in the form of temporary metal mesh fencing isolating (as a group) this tree. Management of ‘live woody tree roots’ requires manual excavation to a depth of one (1.00m) along the required line of excavation for establishment of basement levels (x3). As per the previous pages specifications any ‘live woody tree root’ exposed must be managed by the sites retained Practicing/Consulting Arborist.

- NBC Protected Tree #9 is to be Retained, Managed (as part of a group) & Protected. Protection will be in the form of temporary metal mesh fencing isolating (as a group) this tree. Management of ‘live woody tree roots’ requires manual excavation to a depth of one (1.00m) along the required line of excavation for establishment of basement levels (x3). As

- per the previous pages specifications any 'live woody tree root' exposed must be managed by the sites retained Practicing/Consulting Arborist.
- NBC Protected Tree #10 is to be Retained, Managed (as part of a group) & Protected. Protection will be in the form of temporary metal mesh fencing isolating (as a group) this tree. Management of 'live woody tree roots' requires manual excavation to a depth of one (1.00m) along the required line of excavation for establishment of basement levels (x3). As per the previous page 16 specifications any 'live woody tree root' exposed must be managed by the sites retained Practicing/Consulting Arborist.

- NBC Protected Tree #11 is to be Retained, Managed (as part of a group) & Protected. Protection will be in the form of temporary metal mesh fencing isolating (as a group) this tree. Management of 'live woody tree roots' requires manual excavation to a depth of one (1.00m) along the required line of excavation for establishment of basement levels (x3). As per the previous page 16 specifications any 'live woody tree root' exposed must be managed by the sites retained Practicing/Consulting Arborist.

- NBC Protected Tree #12 is to be Retained, Managed (as part of a group) & Protected. Protection will be in the form of temporary metal mesh fencing isolating (as a group) this tree. Management of 'live woody tree roots' requires manual excavation to a depth of one (1.00m) along the required line of excavation for establishment of basement levels (x3). As per the previous page 16 specifications any 'live woody tree root' exposed must be managed by the sites retained Practicing/Consulting Arborist.

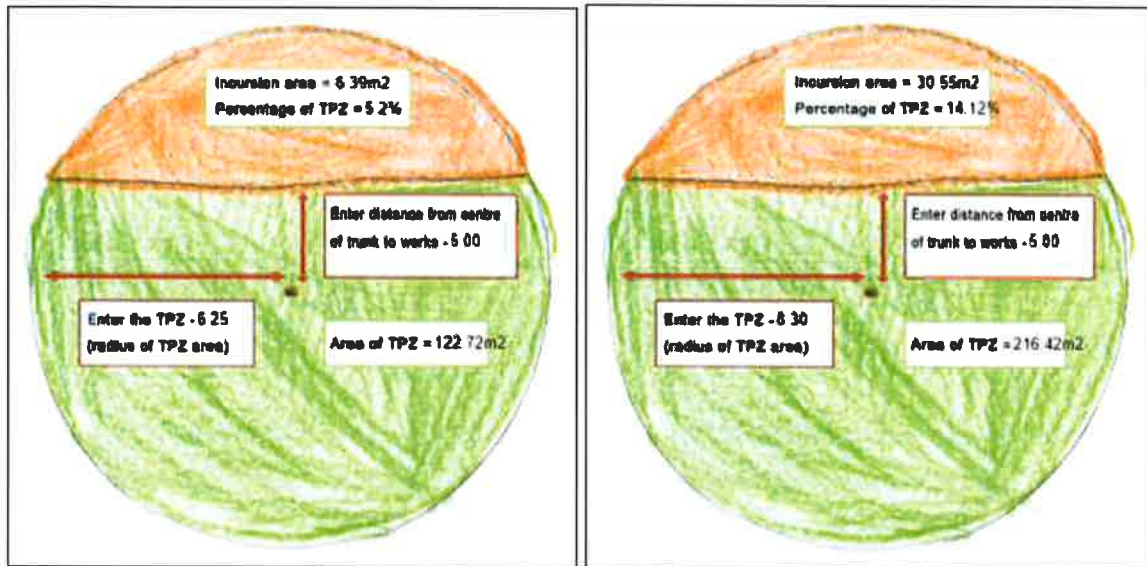
Figure 6: Confirms TPZ smallest breach of 5.2% (left illustration above) for Tree #7) & a 14.1% breach for Tree #12 the greatest breach (above right).

Tree #12 has the greatest TPZ radial distance (8.90m), Tree #8 has the smallest TPZ radial distance (2.40m). Tree #7 has the second lowest TPZ radial distance of 6.25m. For Tree #12 this equates to an approximate 14.10% TPZ total surface area breach, i.e. 30.55m² of 216.40 m². A 14.10% breach is just below the middle of the scale that equates to a 'major encroachment' by AS4970-2009 definitions. The Tree #8 TPZ radial distance is not breached by the proposal. Tree #7 has the next lowest TPZ radial distance breach, it presents with a TPZ radial distance breach of <5.2% (i.e. 4.50m² of 113.00m²).

For Tree #5 thru Tree #12; compliance with the Australian Standard (AS4970-2009 *Protection of trees on development sites*) requires an 'exclusion zone' to be created by installation of 'temporary metal mesh' boundary fencing supported by above ground plastic or concrete feet. This is to be established as close to the calculated line of excavation (approximately 6.00m from boundary fence) for below ground basement levels (x3). The proposed line of excavation required for the below ground basement levels (x3) does not breach any individual trees Structural Root Zone (from herein SRZ) radial distance. (Tree #10 & Tree #12 both have the greatest SRZ radial distances of 2.90m.) See page 16 'Line of Excavation' specifications.

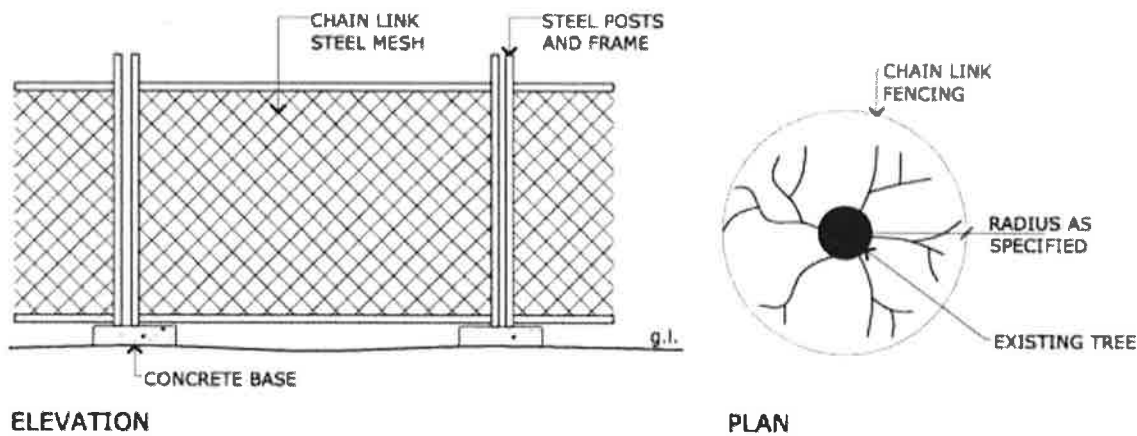
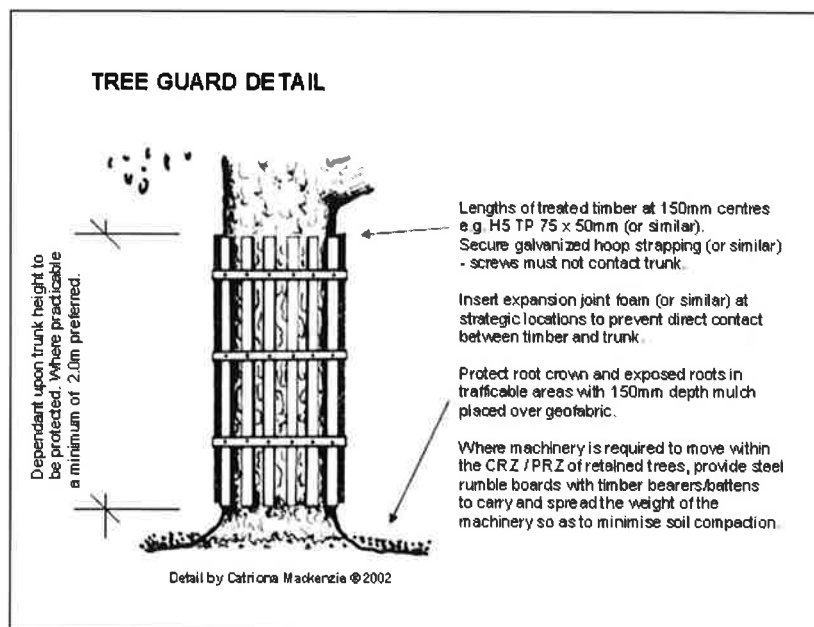
The installation of Tree Protection Zone (TPZ) fencing is to be carried out prior to commencement of all works. The most suitable fencing material is 1.8m tall chain link mesh with 50mm metal pole supports, see **detail 1: tree protection fencing**.

A mulch layer of composted leaf & woodchip to a depth of 75mm is required within the TPZ to aid in retention of soil moisture & to protect soil from contaminants. Water is to be applied by hand held or soaker/leaky hose within TPZ as required & in Accordance with Stage 3 Water Restrictions. Watering is to be carried out by either an Arborist or is to form part of the Builder's/Contractor's contract, with recommended monthly checks by an Arborist.
