**Preliminary Geotechnical  
Assessment**

114 Old Pittwater Road, Brookvale NSW

Report No: E26637.G01

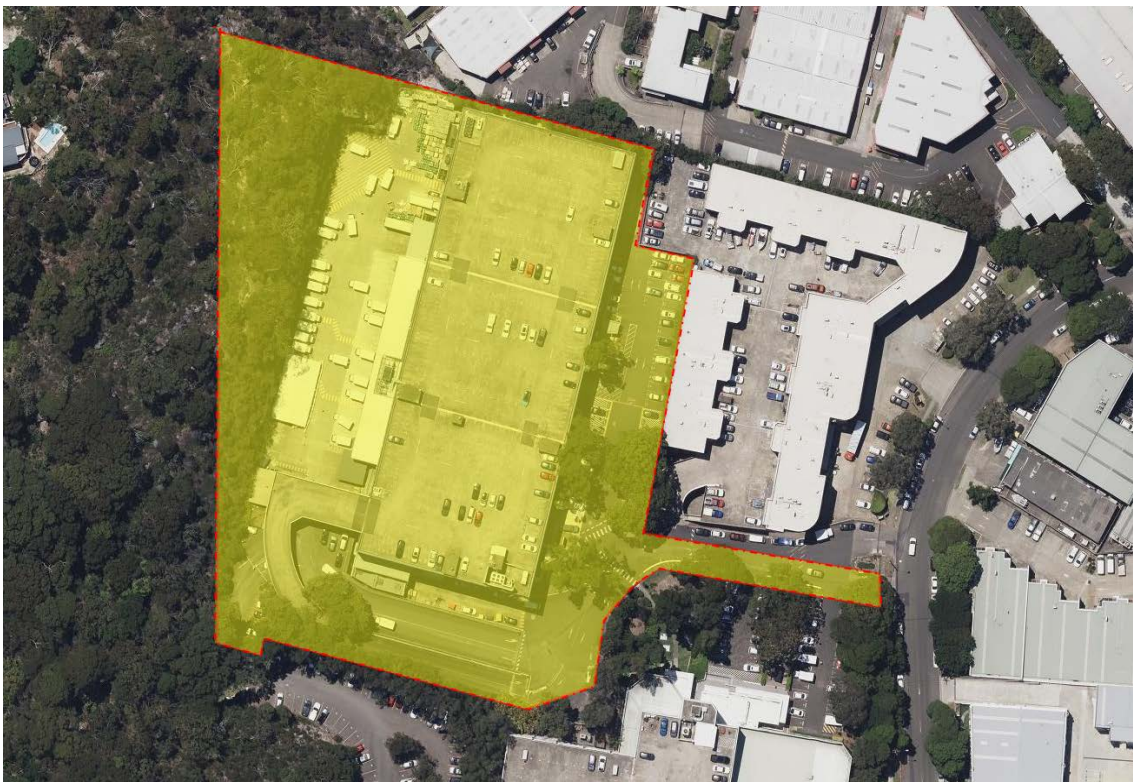
**Plate 1 Aerial Photograph of Site (Source SIX Maps, accessed 22/01/2025)**

| Information | Detail |
|---|---|
| Brief Site Description | The site consists of a large commercial building housing various services and businesses, paved areas with parking spaces, and green zones with medium to tall trees surrounding the lot. The area is primarily surrounded by commercial buildings, factories, and small businesses. |
| Site Area | The site area is approximately 2.0 ha (based on the provided information from Six Maps website). |

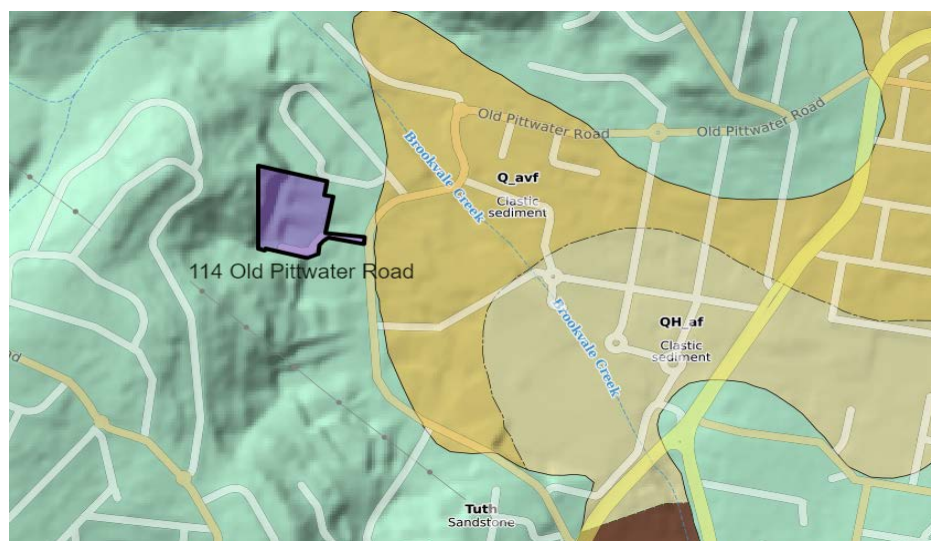
**Plate 2 Excerpt of Geological Map**

| Attribute | Description |
|---|---|
| Regional Geology | Information on regional sub-surface conditions, referenced from the Department of Mineral Resources Geological Map Sydney 1:100,000 Geological Series Sheet 9130 (DMR 1983) indicates the site to be underlain by Hawkesbury Sandstone (Rh), which consists of medium to coarse-grained quartz sandstone with very minor shale and laminite lenses. |
