GEOTECHNICAL INVESTIGATION REPORT

**No. 1 Fern Creek Road
Warriewood, NSW 2102**

DEP (Warriewood No. 2) Pty Ltd

Report No. GS5895/2A

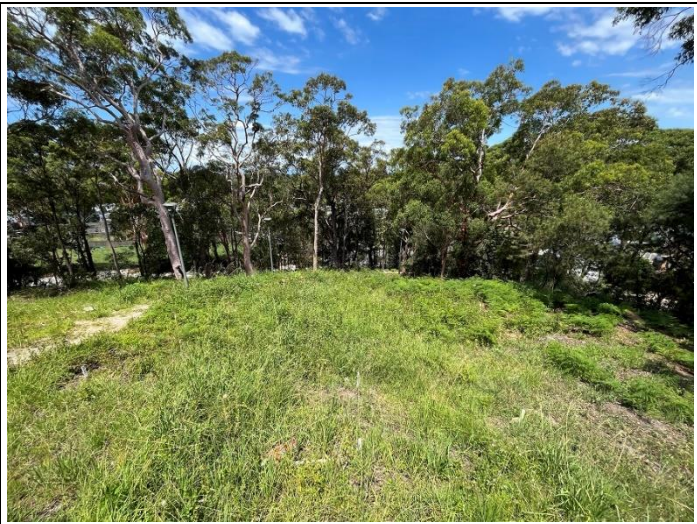
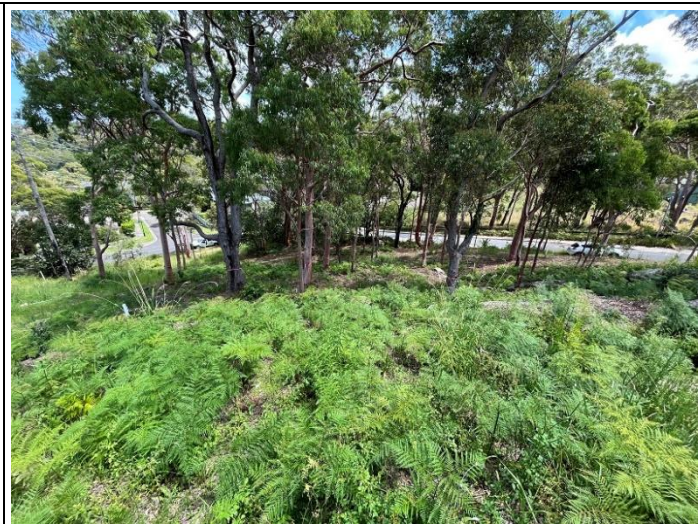
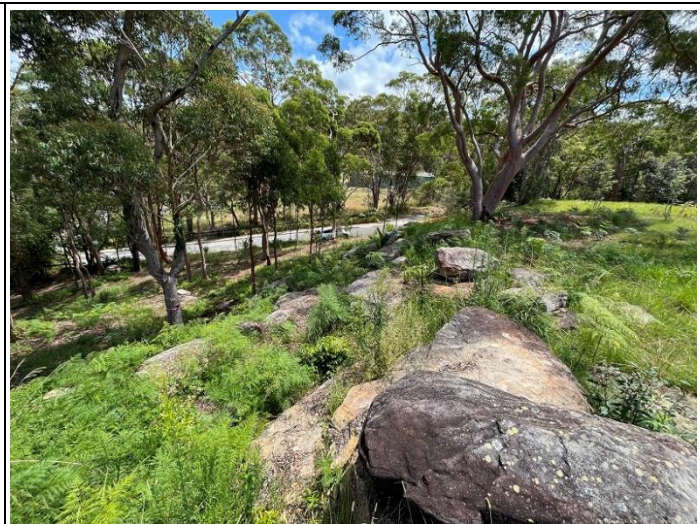
Figure 3 – Site Photographs

<p>Photograph 9 Looking south across Lot 4</p>	<p>Photograph 10 View looking south-west across Lots 3 (right) and 2 (left) towards the intersection of Orchard Street and Knight Street</p>	<p>Photograph 11 View looking west across Lots 3 (left) and 17 (right)</p>
