## **REPORT ON GEOTECHNICAL SITE INVESTIGATION**

### **PROPOSED NEW GARAGE**

**21 HERBERT STREET, MANLY**

**Project No.: 2019-163**

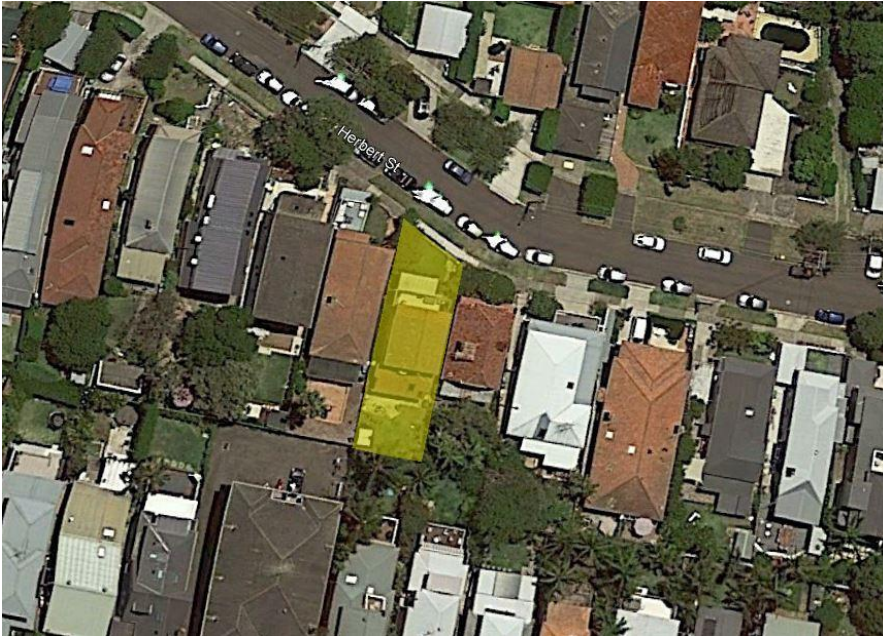
*Photograph 1: Aerial view of the site and immediate surrounds*

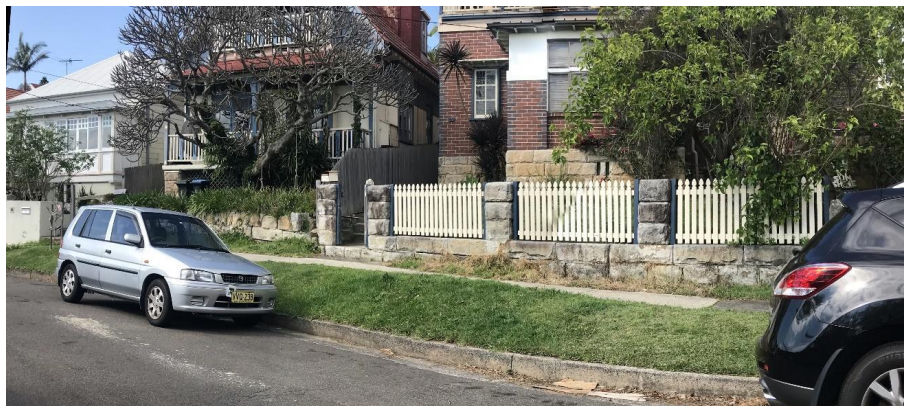
Herbert Street comprises an asphalt road which dips slightly to the west and is bound by a concrete kerb beyond which lies a grass easement and pedestrian pavement. The front of the site contains a gently north dipping lawn west of a concrete access pathway and to the south of a low sandstone wall on the front boundary. The site dwelling is constructed of brickwork formed off sandstone blockwork creating a sub-floor void. A concrete pathway provides access to the rear of the property which contains a paved patio and elevated lawn supported by a concrete block retaining wall. A general view of the site is provided in Photograph 2.

*Photograph 2: View of the front of the site and immediate surrounds looking broadly south.*

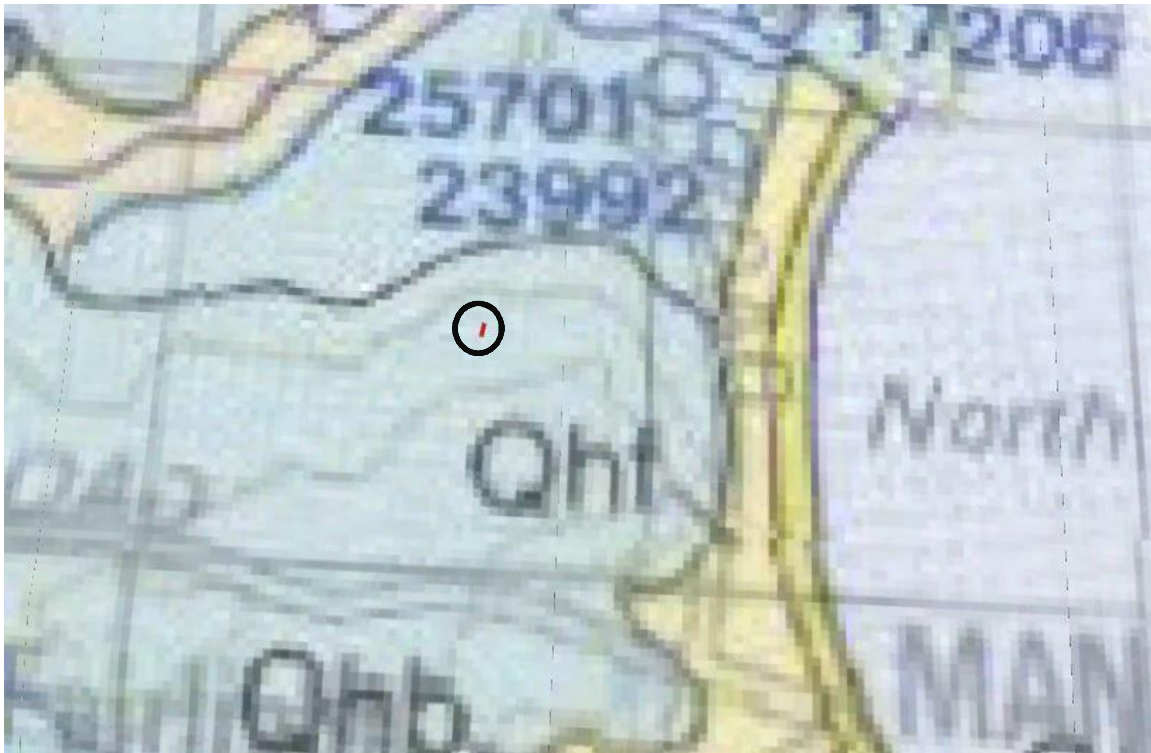
Reference to the Sydney 1: 100,000 Geological Series sheet (9130) indicates that the site is underlain by Hawkesbury Sandstone (Rh) which is of Triassic Age. The rock unit typically comprises medium to coarse grained quartz sandstone with minor lenses of shale and laminite. An extract of the 9130 Geological Series sheet is provided in Extract 1.

*Extract 1: Geology underlying the site (circled and shown in red)*

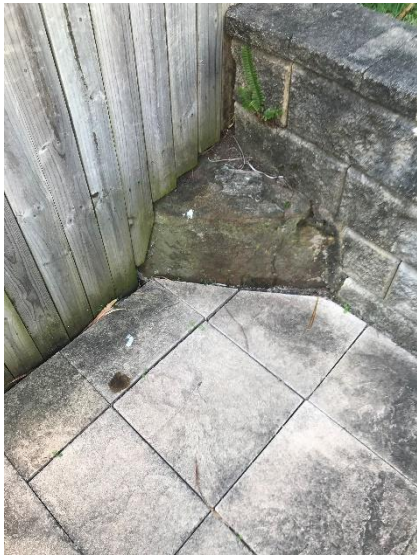
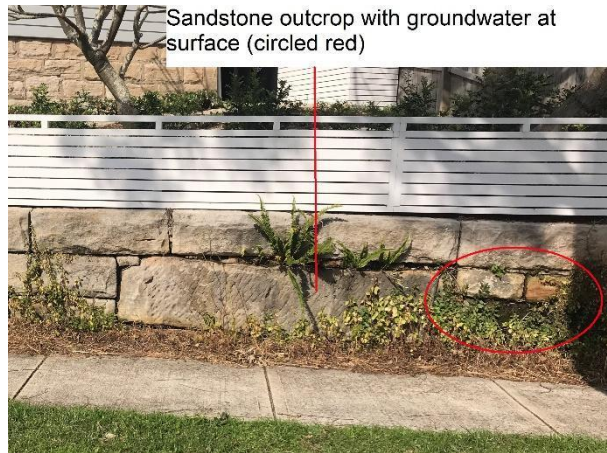
The site contains a one and two storey brick house within gently north dipping topography. The existing dwelling is in good condition and no signs of cracking were observed within the external walls of the dwelling. A low retaining wall within the rear garden of the property displayed some signs of rotation/degradation however this is likely due to insufficient construction methods rather than a deep-seated stability issue as it appears the retaining wall is at least partially founded on bedrock (See Photograph 3). The bedrock observed in outcrop within the rear of the property comprised medium strength sandstone. Bedrock was also observed elsewhere adjacent to Herbert Street (Photograph 4) to the west and within the neighbouring property to the east (No.19).

*Photographs 3 and 4: Bedrock outcrops within and adjacent to the site.*
