ABORIGINAL OBJECTS DUE DILIGENCE ASSESSMENT

Royal Far West, 14-22
Wentworth St and 19-21 South
Steyne, Manly NSW,
Gameraigal Land

Prepared for
ROYAL FAR WEST
10 June 2022
HR-RPT-0003

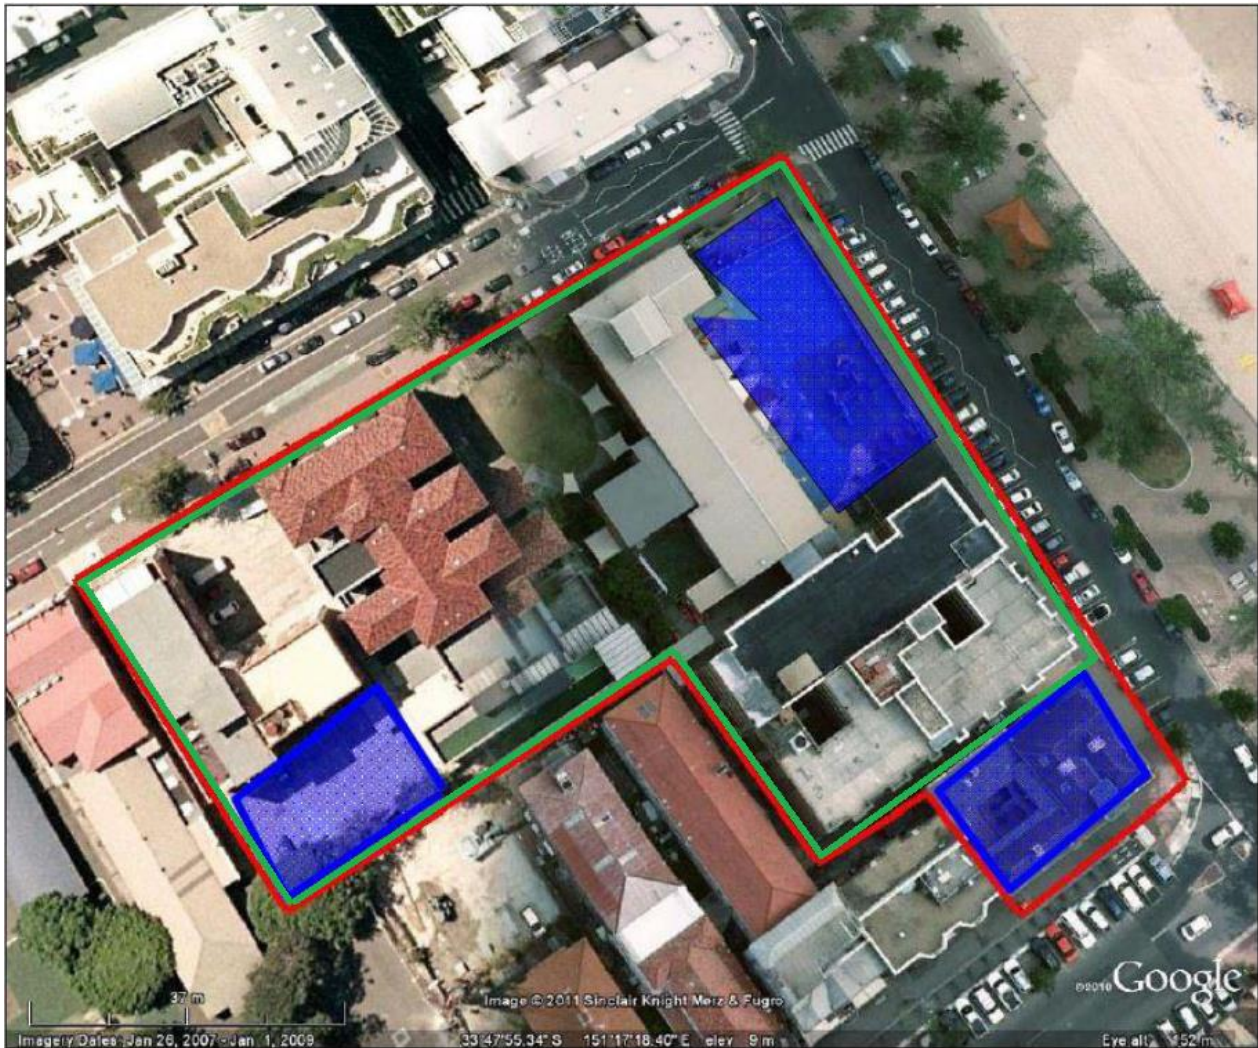
Figure 8- 2011 Royal Far West Scheme subject area is noted in red. The current subject area is noted in green. Areas of Aboriginal archaeological sensitivity is in blue.

In 2011 MDCA did not know the structure or condition of the sand deposits underlying the site. There remained a possibility for Aboriginal burials (either in situ or human remains disturbed by previous land use activities) and similarly a possibility for isolated remnants of former (now buried) land surfaces to be present in less disturbed areas of the site within which Aboriginal archaeological remains may also survive. In 2011 there was little information on the sand body across the isthmus which could have guided an archaeological examination of the sand body. MDCA stated that it is possible the sand deposits are greatly truncated and there remains little of the upper units which might contain artefact bearing deposit.

3. An Aboriginal archaeological test excavation be conducted within the areas identified as archaeologically sensitive immediately following demolition of the court surfaces of the Far West School and the concrete slab surface of the rear car park of the Elsie Hill building and across the footprint of the Terrace should it not be retained. These areas should be investigated before neighbouring demolition to avoid contamination of sediments. The test excavations should be co-ordinated with any historical archaeological investigations as may be recommended.

Based on the findings of this study, the subject area is determined to have moderate Aboriginal archaeological potential at the subject area for Aboriginal objects due to the sand body present within the subject area.

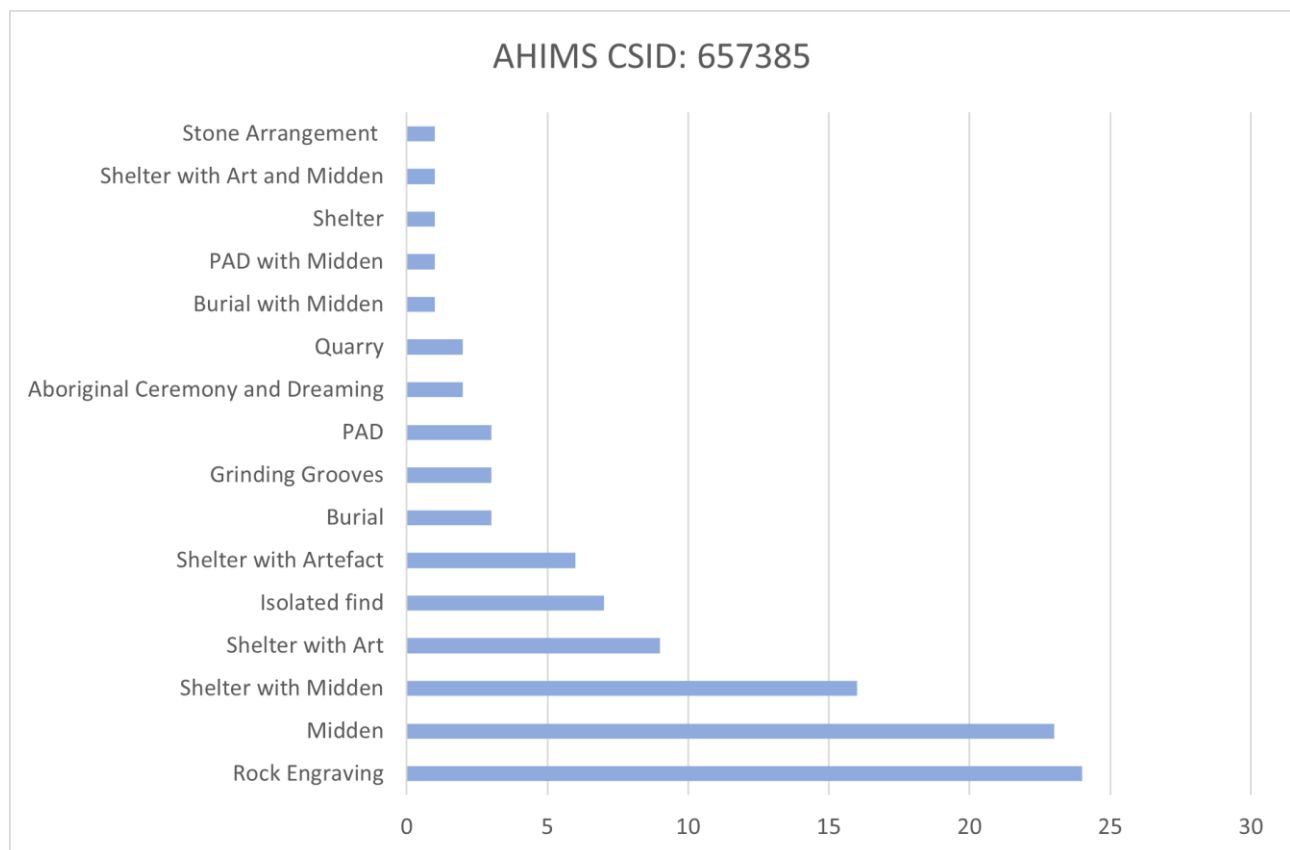
Figure 9- Site types within the extensive search area

- The AHIMS Extensive search found 112 Aboriginal sites were present within a 3km search radius, with the most frequent site type being Rock Engravings and Middens. Additionally, two Aboriginal Places were registered on the AHIMS Search as being within the broader vicinity, which are Reef Beach Resting Place (ID No. 79) and the Quarantine Station Resting Place (ID No. 80). Neither Place is located within the subject area.

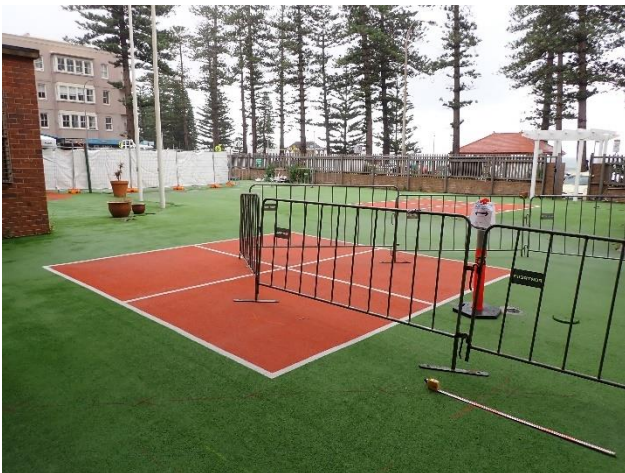
Figure 14 – View north-east, playground area to east of Far West School building

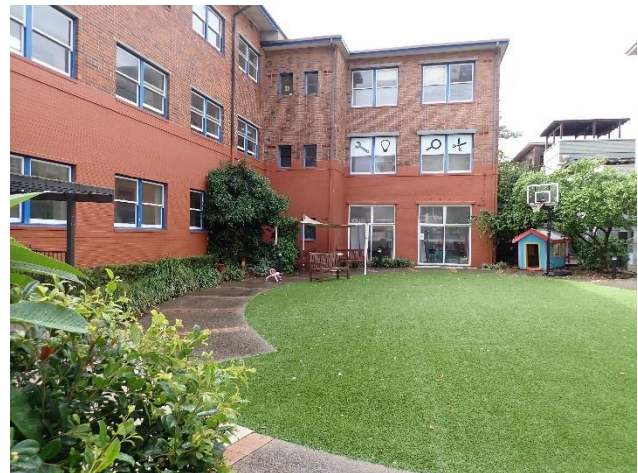
Figure 15 – view south, playground area and garden, to west of Far West School building.

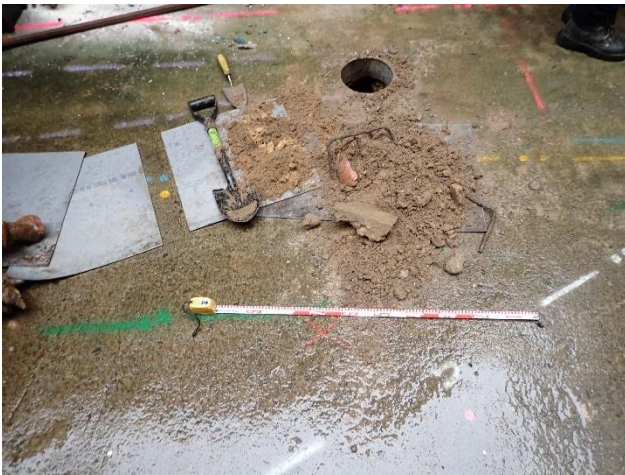
Figure 16 – Geotechnical investigation area, note mixed sandy fill removed from corehole (hand-augered), west of George Moncrieff Baron Wing.

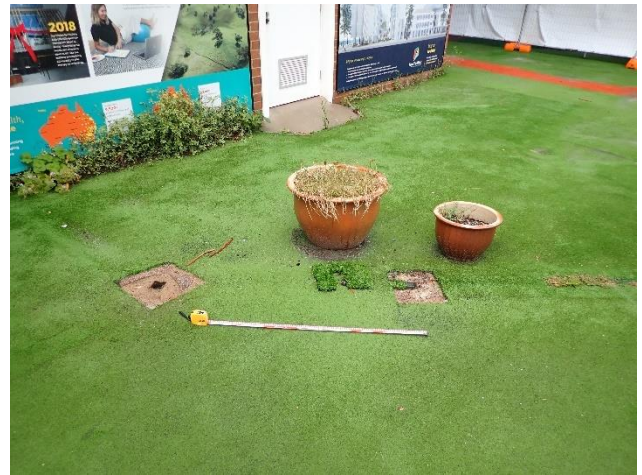
Figure 17 – area of exposure associated with previous geotechnical work, north-east playground.

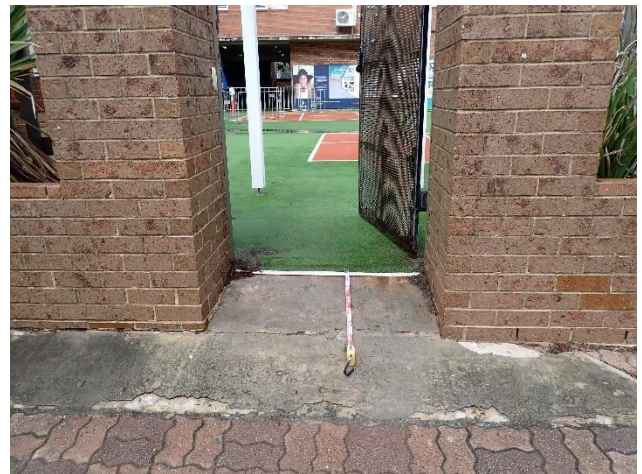
Figure 19 – view west, slope between playground area and footpath level.

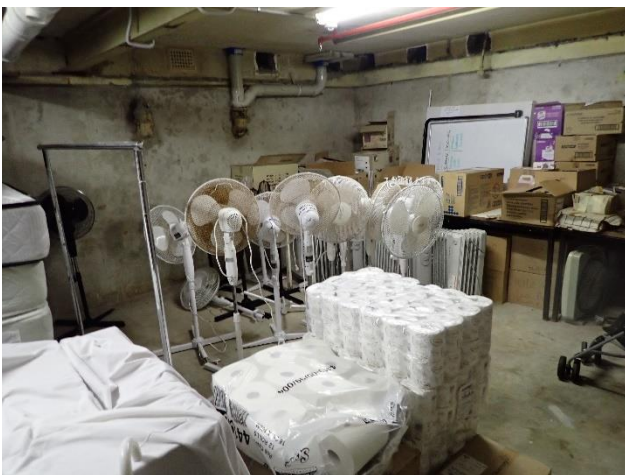
Figure 20 – basement level, Drummond House.

The site inspection identified that soils are likely to be intact in portions of the subject area, and that basement levels are not extensive across the site. Generally, disturbance is therefore unlikely to have removed archaeological potential.
