Detailed Site Investigation

43, 45, & 49 Warriewood Road, Warriewood NSW

Report No: 2148-DSI-01-280723.v1f

Report Date: 28 July 2023

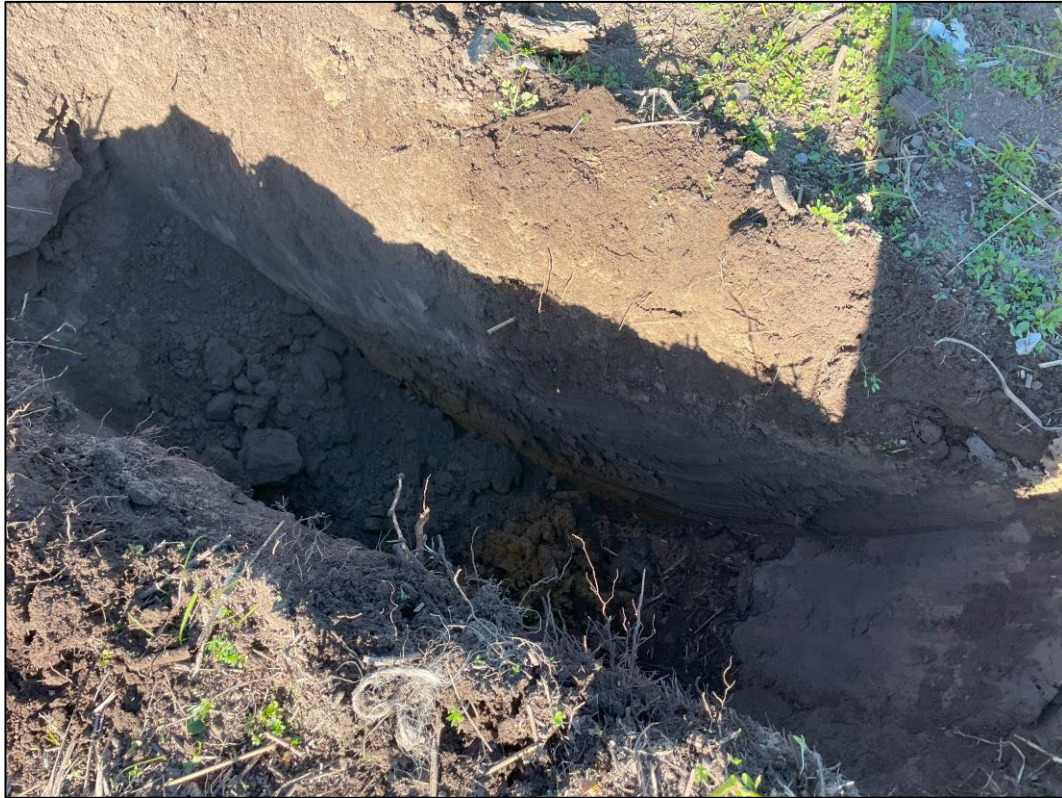
Photograph 9.2.1 Typical natural stratigraphy encountered within the site as observed in 'TP15'. As observed 19 July 2023.

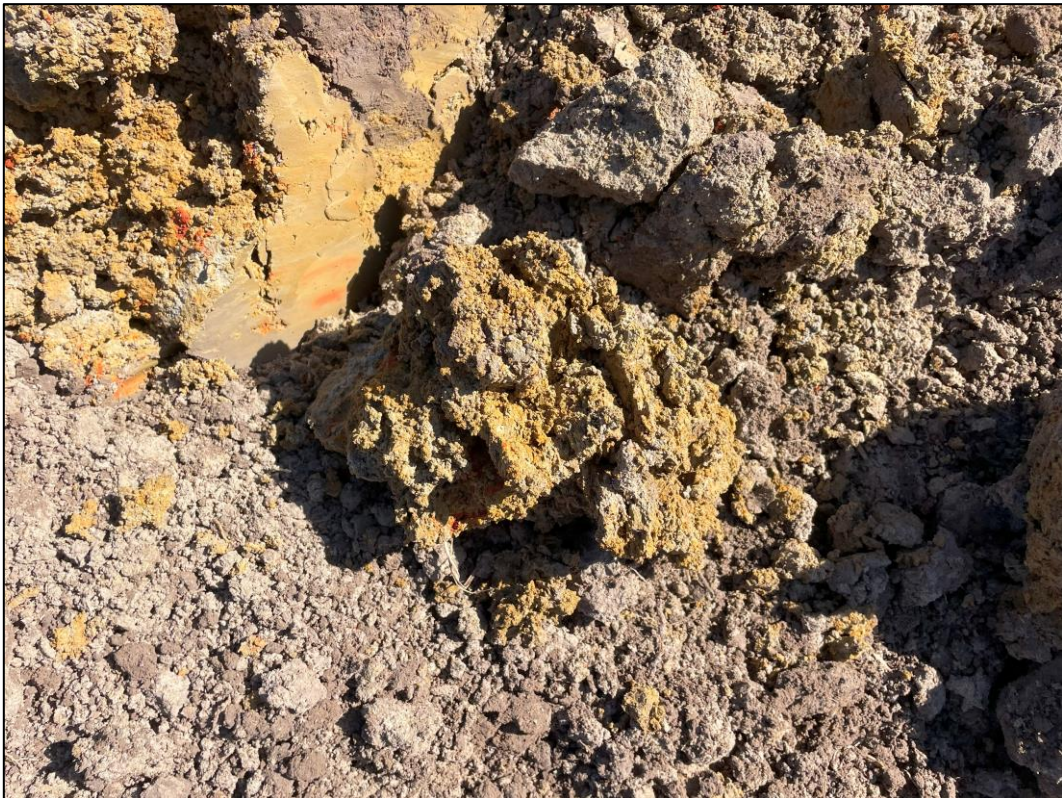
Photograph 9.2.2 Natural clay materials identified through the site, as observed within 'TP12'. As observed 19 July 2023.

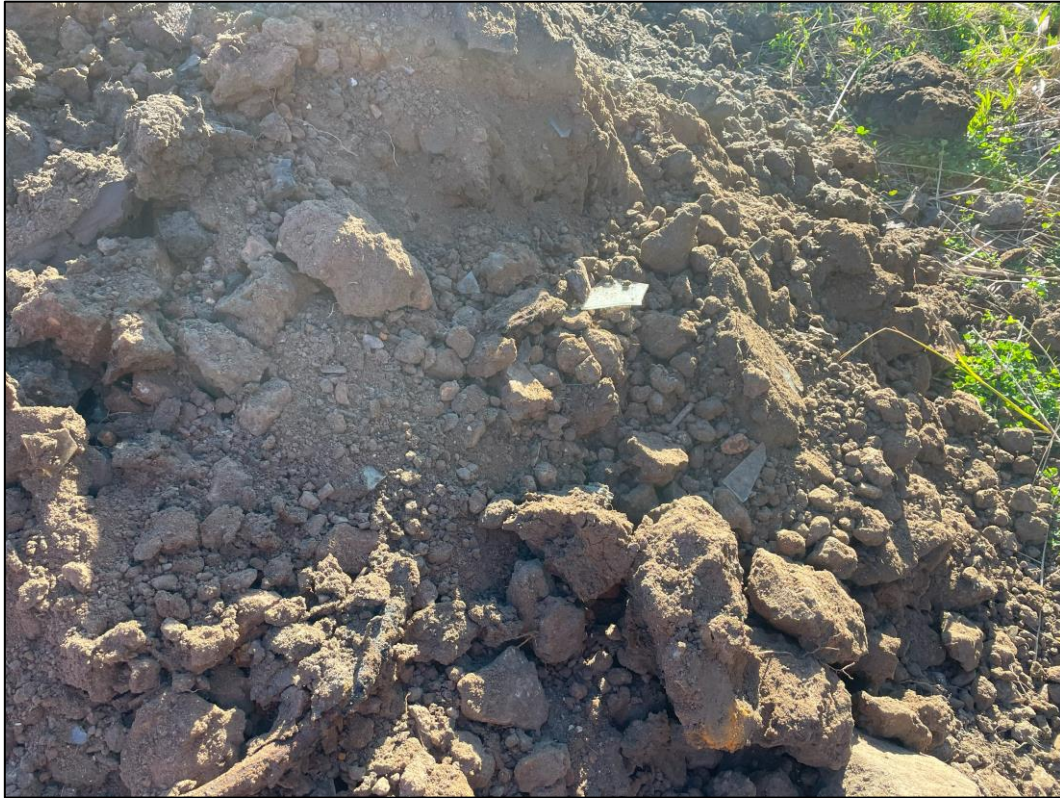
Photograph 9.2.3 FILL materials identified through portions of the site encountered within 'TP02', 'TP05', 'TP10', 'TP13' and 'TP15'. As observed 18 July 2023.

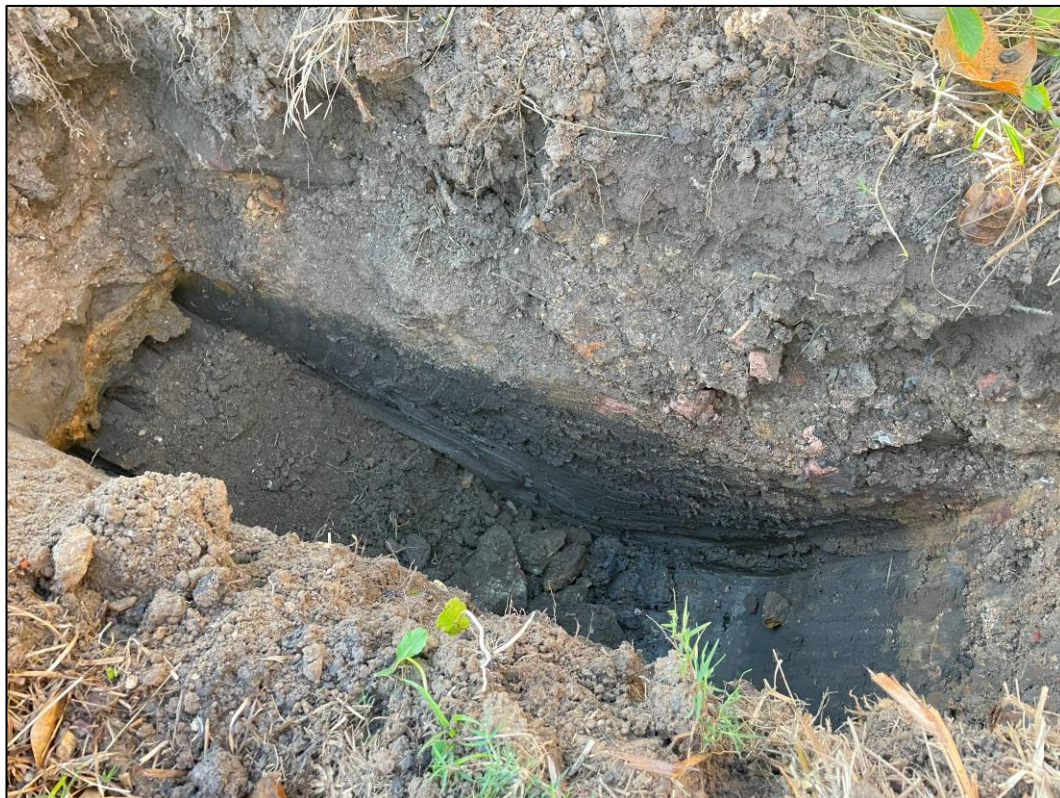
Photograph 9.2.4 FILL materials encountered within stockpiles across the site, encountered within 'TP03', 'TP06', 'TP07', 'TP11', 'TP14', 'TP16', 'TP21' and 'TP23'. As observed 18 July 2023.

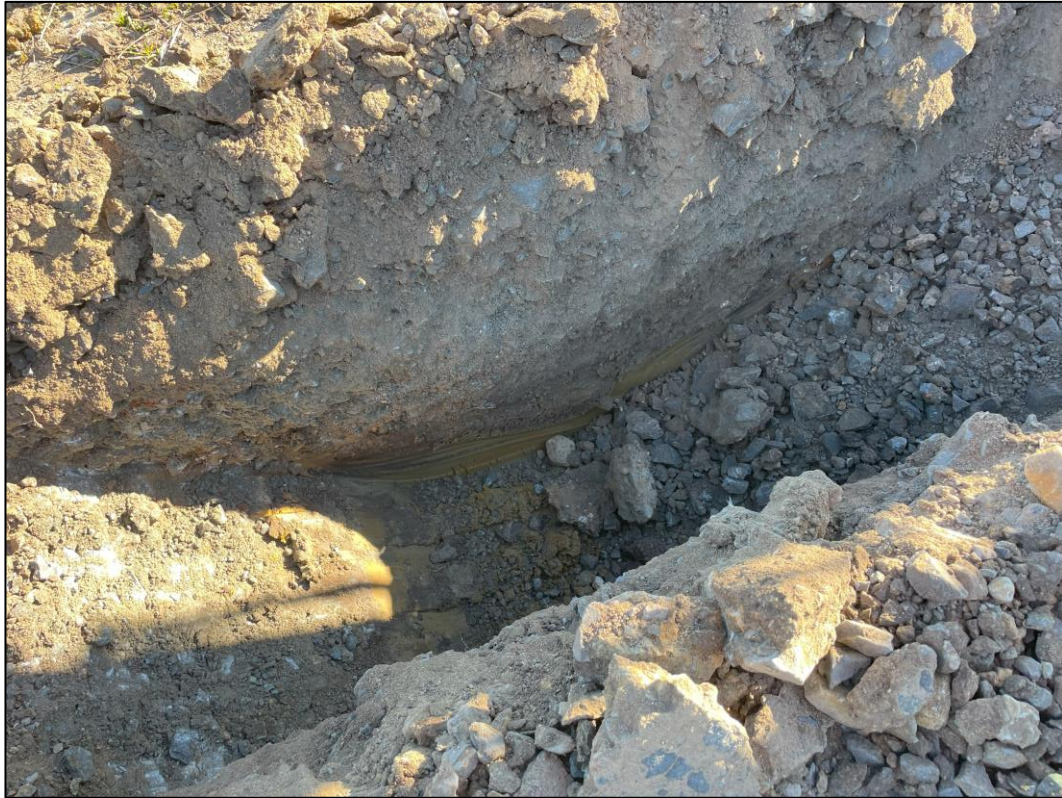
Photograph 9.2.5 FILL materials identified through portions of the site encountered within 'TP04' and 'TP09'.
As observed 18 July 2023.

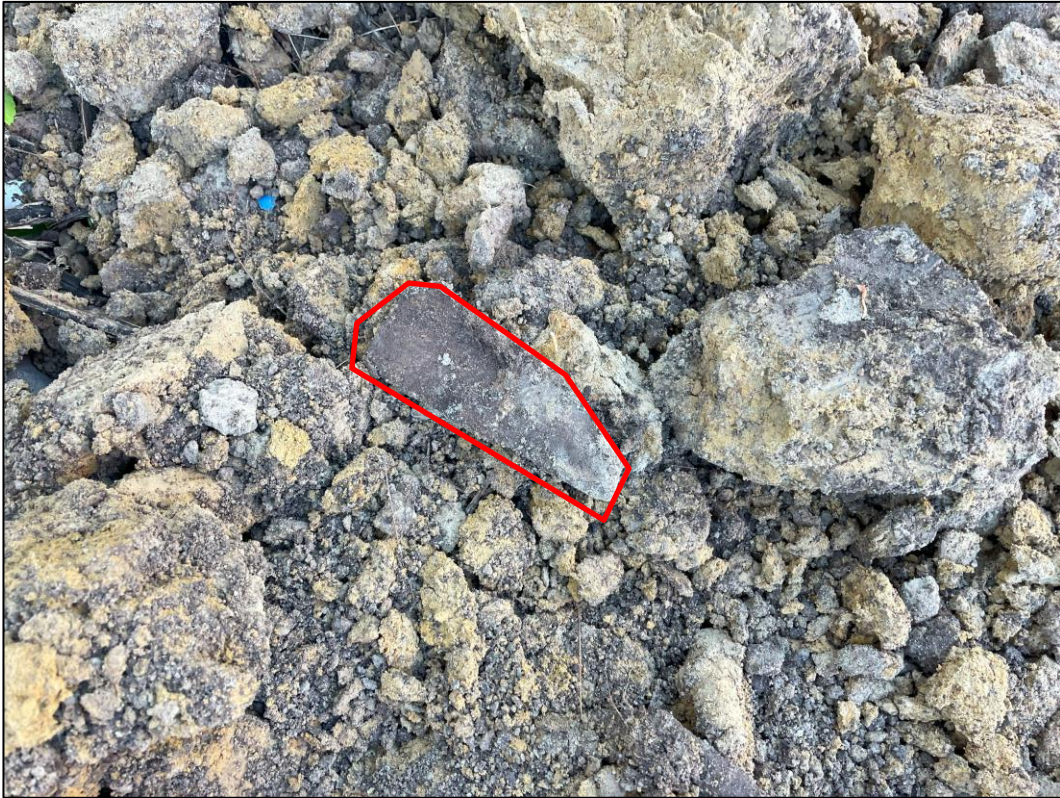
Suspected asbestos containing materials were identified in shallow soil materials at test pit locations 'TP08' and 'TP17', as well as on the residual soil surface within the vicinity of structures in the northern portion of the site. SE notes that due to vegetation overgrowth in the northern portion of the site visual assessment was generally limited to sampling point locations.

Site Photograph 9.5.1 Potential Asbestos Containing Material observed within shallow fill materials encountered within TP17, as observed 18 July 2023.

Asbestos was detected within the two (2) fibre cement fragment submitted for analysis. Sample 'FC01' measured 40 x 35 x 3 mm, and was detected to contain Chrysotile and Amosite Asbestos, while sample 'TP08-FC' measured 60 x 55 x 5 mm, and was detected to contain Chrysotile and Amosite Asbestos. As the fibre cement fragments analysed were greater than 7 mm in two or more dimensions, could not be crushed by hand and were in good condition, the asbestos materials were classified as **Non-Friable**.

- Preparation of a Remedial Action Plan to outline the methodology to remediate minor localised shallow non-friable asbestos impacts and to further characterise previously inaccessible soils situated beneath the existing building footprints following demolition;
- Undertake a hazardous building materials survey of the structures present on-site prior to demolition;
- Following removal of hazardous building materials (if identified) and subsequent demolition of the onsite structures, a clearance inspection should be carried out by an appropriately qualified occupational hygienist / NSW LAA;
- A supplementary contamination assessment is to be undertaken beneath the building footprints following demolition by an appropriately experienced environmental scientist; and

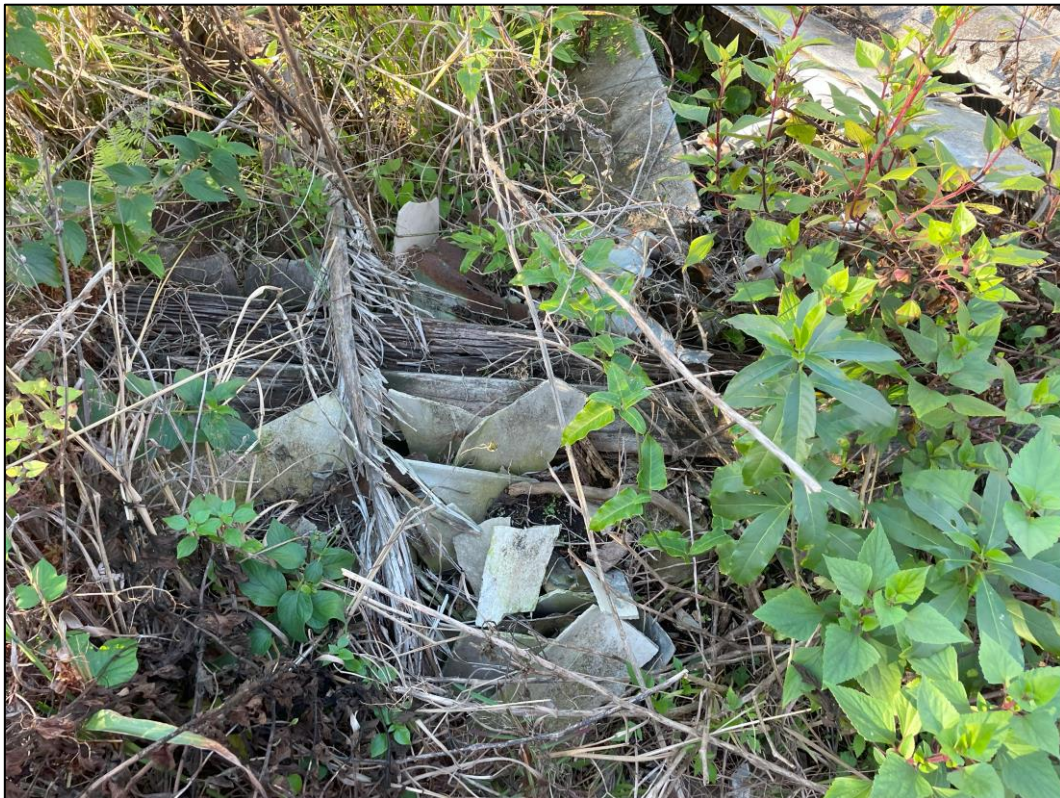
Site Photograph 9.5.2 Stockpiled Potential Asbestos Containing Materials observed within the vicinity of TP17, as observed 18 July 2023.

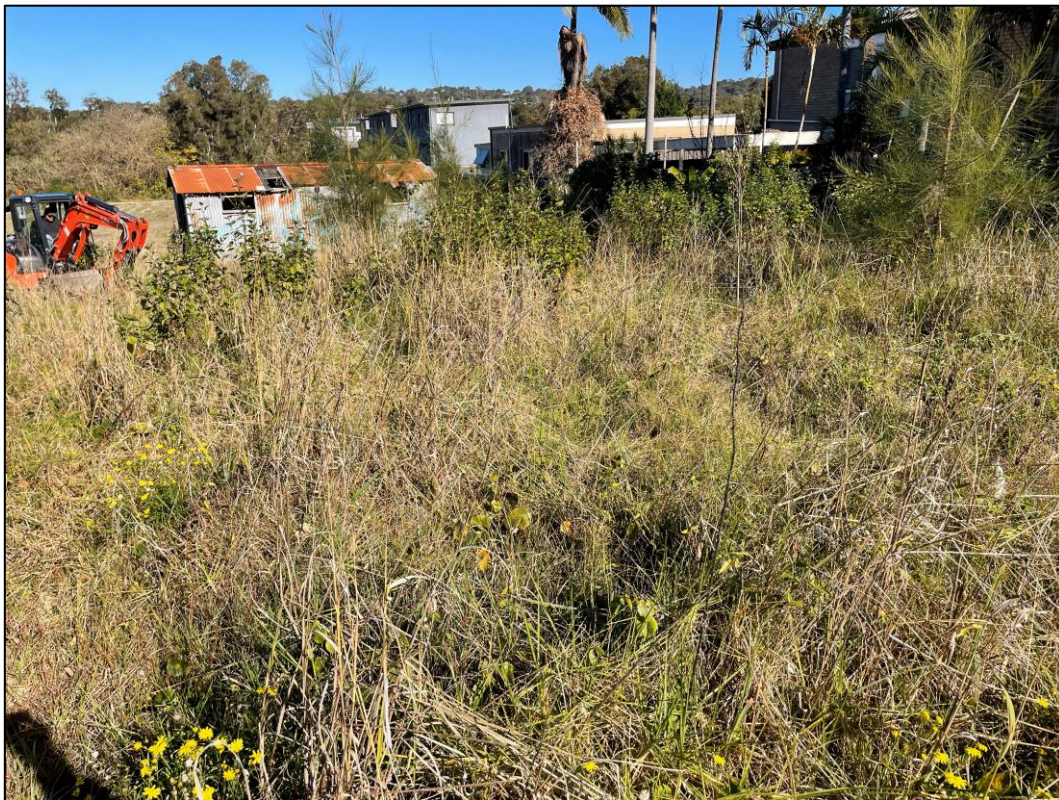
Site Photograph 9.5.3 Overgrown vegetation encountered within the northern portion of the site, limiting visual assessment of surficial soils within the area, as observed 18 July 2023, facing east.
