ARBORICULTURAL IMPACT ASSESSMENT (AIA) REPORT

Prepared For: Ms Symone Riddle
Site Address: 76 Queens Pde East Newport
Inspection Date: 22 November 2024
Report Date: 26 November 2024

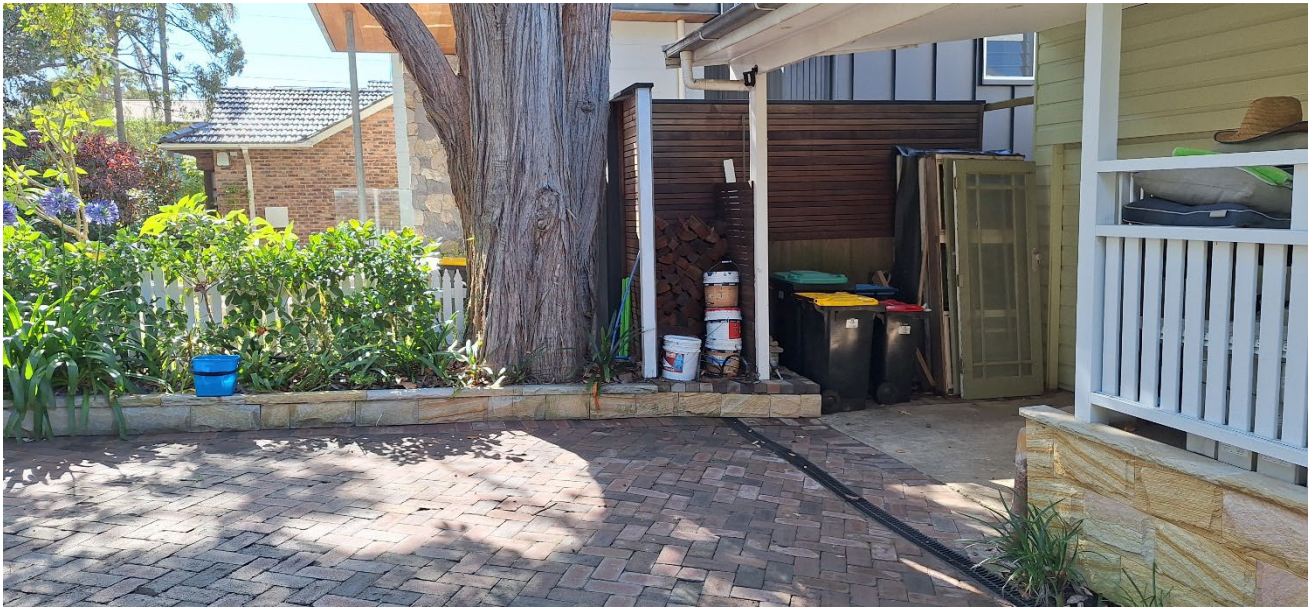
Proposed is the construction of a carport forward of the dwelling. The carport is to be supported by isolated piers and stormwater is to connect to the existing strip drain located to the north of the carpark (photo 2). The carport above ground will not impact any trunk or canopy.

Photo 2: T1 Turpentine and existing stormwater drains.

5.1.1 Pilot holes to be dug to determine the location of required footings. The holes are to be hand dug to the approximate width and depth in accordance with engineering specifications. Any encountered tree roots 3cm or greater in diameter are to be retained and protected and the footings to be relocated to prevent impact the trees.

5.1.2 Stormwater should be directed to the northern side of the carport roof and connect in with existing stormwater drains in order to negate potential damage to tree roots.

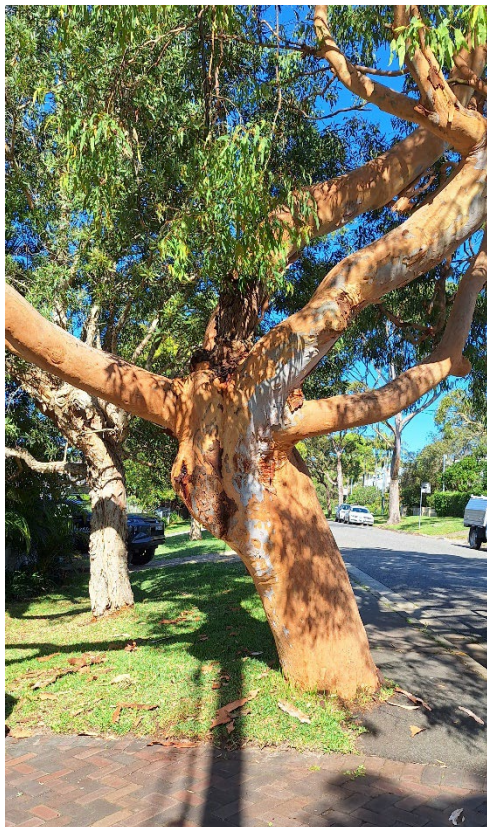
Photo 3: T4 Angophora (foreground) and very close to driveway: T5 Melaleuca (rear Left).

Tree Id	Species	Fencing	Trunk Armouring
T1	Turpentine	No	Yes
T2	Eucalypt (neighbouring tree)	No	No
T3	Sydney Red Gum (neighbouring tree)	No	No
T4	Sydney Red Gum (Street tree next to driveway)	No	Yes
T5	Broad leaf paperbark (Street Tree) Fencing is not to block footpath or roadway.	Yes at 2m trunk offset.	No
T6	Palms (Front Garden)	No	No
