5 Kooloora Avenue, Freshwater

Geotechnical Comments for Section 4.55

GEOTECHNICAL INVESTIGATION:

Alterations and Additions at **5 Koolooro Avenue, Freshwater**

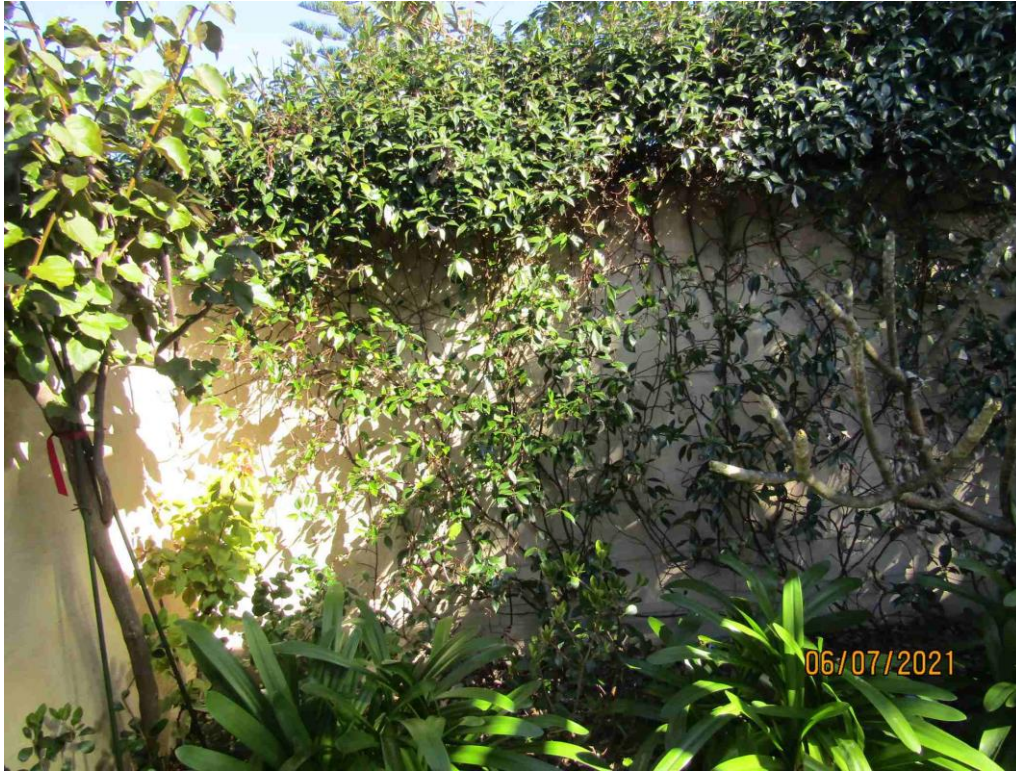
Photo 7

- Flush with a low rendered masonry retaining wall on the subject property (Photo 6).
- ~1.3m from the SW rendered masonry boundary fence/retaining wall (Photo 7) and ~1.5m from the SW neighbouring pathway (Photo 8).
- ~1.0m from the NW common boundary.

The low retaining wall, SW boundary fence, SW neighbouring pathway and NW common boundary will be within the zone of influence of the excavation.

Due to the depth of the sand and the proximity to the surrounding structures and boundaries, all sides of the excavation will require shoring or underpinning.

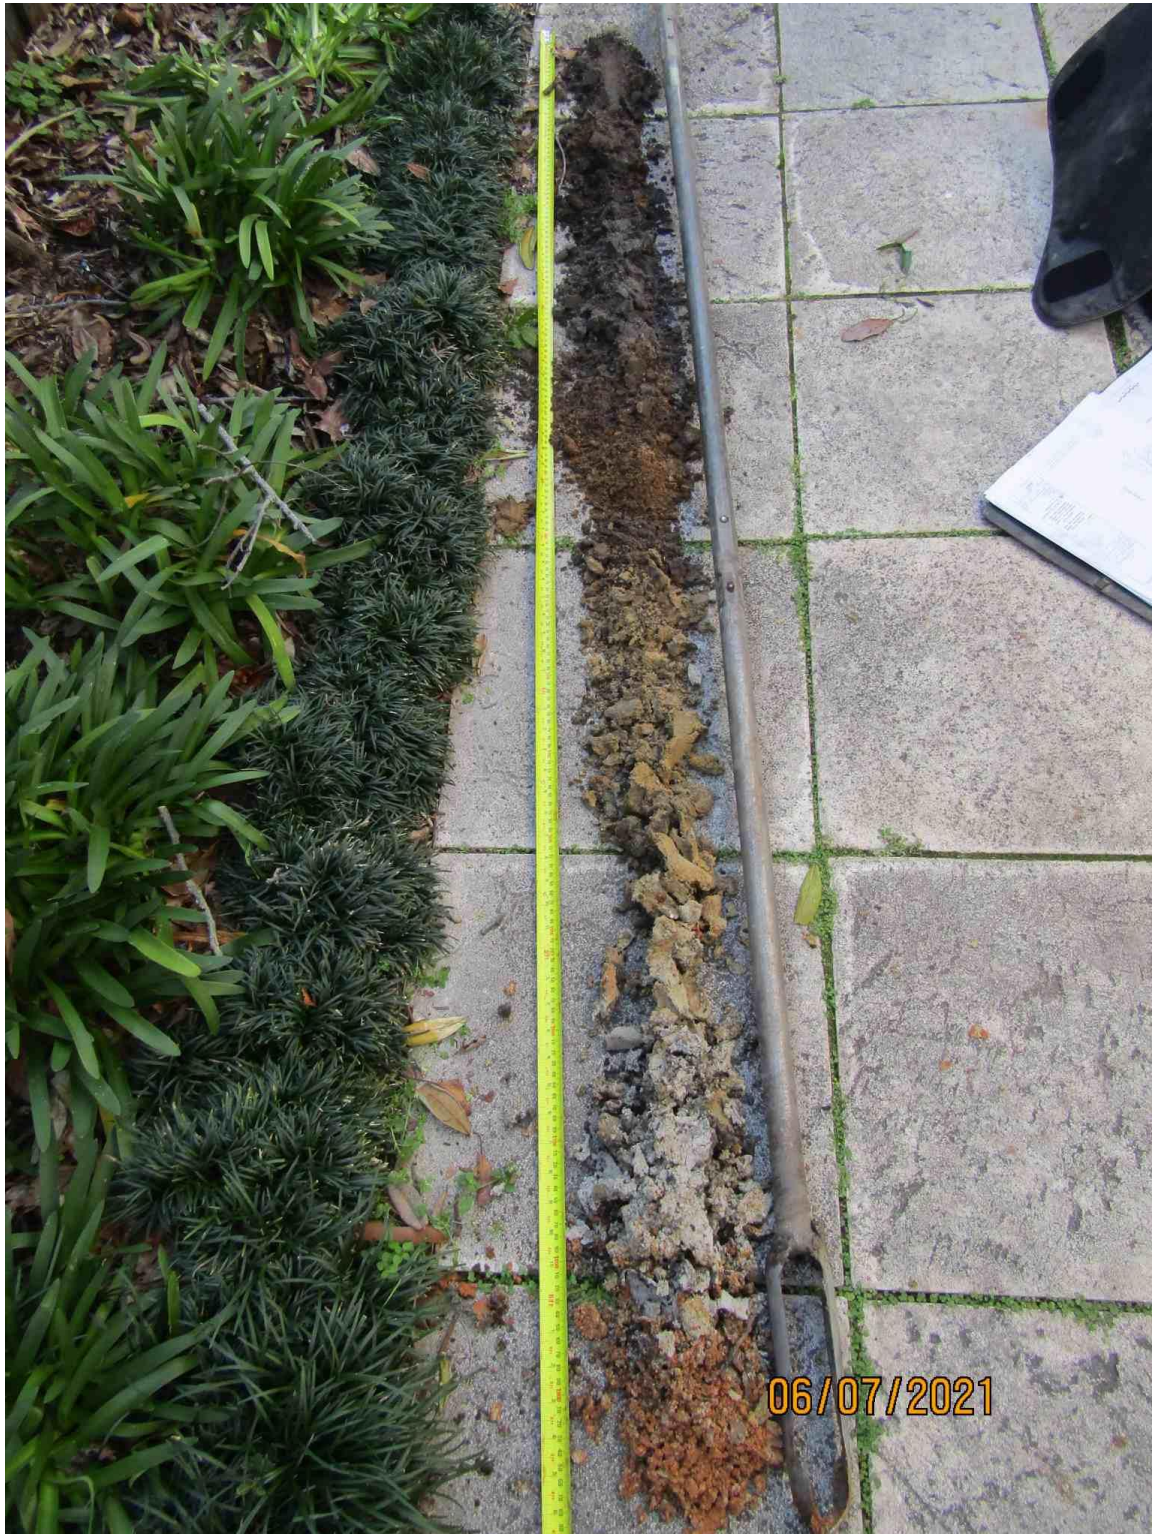
Photo 9: AH1 – Downhole is from top to bottom.

AUGER HOLE 1 (~RL8.4) – AH1 (Photo 9)

Depth (m)	Material Encountered
0.0 to 0.4	TOPSOIL , sandy soil, dark brown, damp, fine to medium grained with fine trace organic matter.
0.4 to 1.0	SILTY SAND , dark grey and brown, moist, loose to medium dense, fine to medium grained.
1.0 to 1.4	SAND , light orange brown, damp, medium dense, medium grained.
1.4 to 1.8	SANDY CLAY , light brown and light grey, firm, moist to damp.
1.8 to 2.0	SANDY CLAY , derived from Very Low Strength Sandstone, orange, moist, sugary texture.

End of Hole @ 2.0m in sandy clay. No watertable encountered.

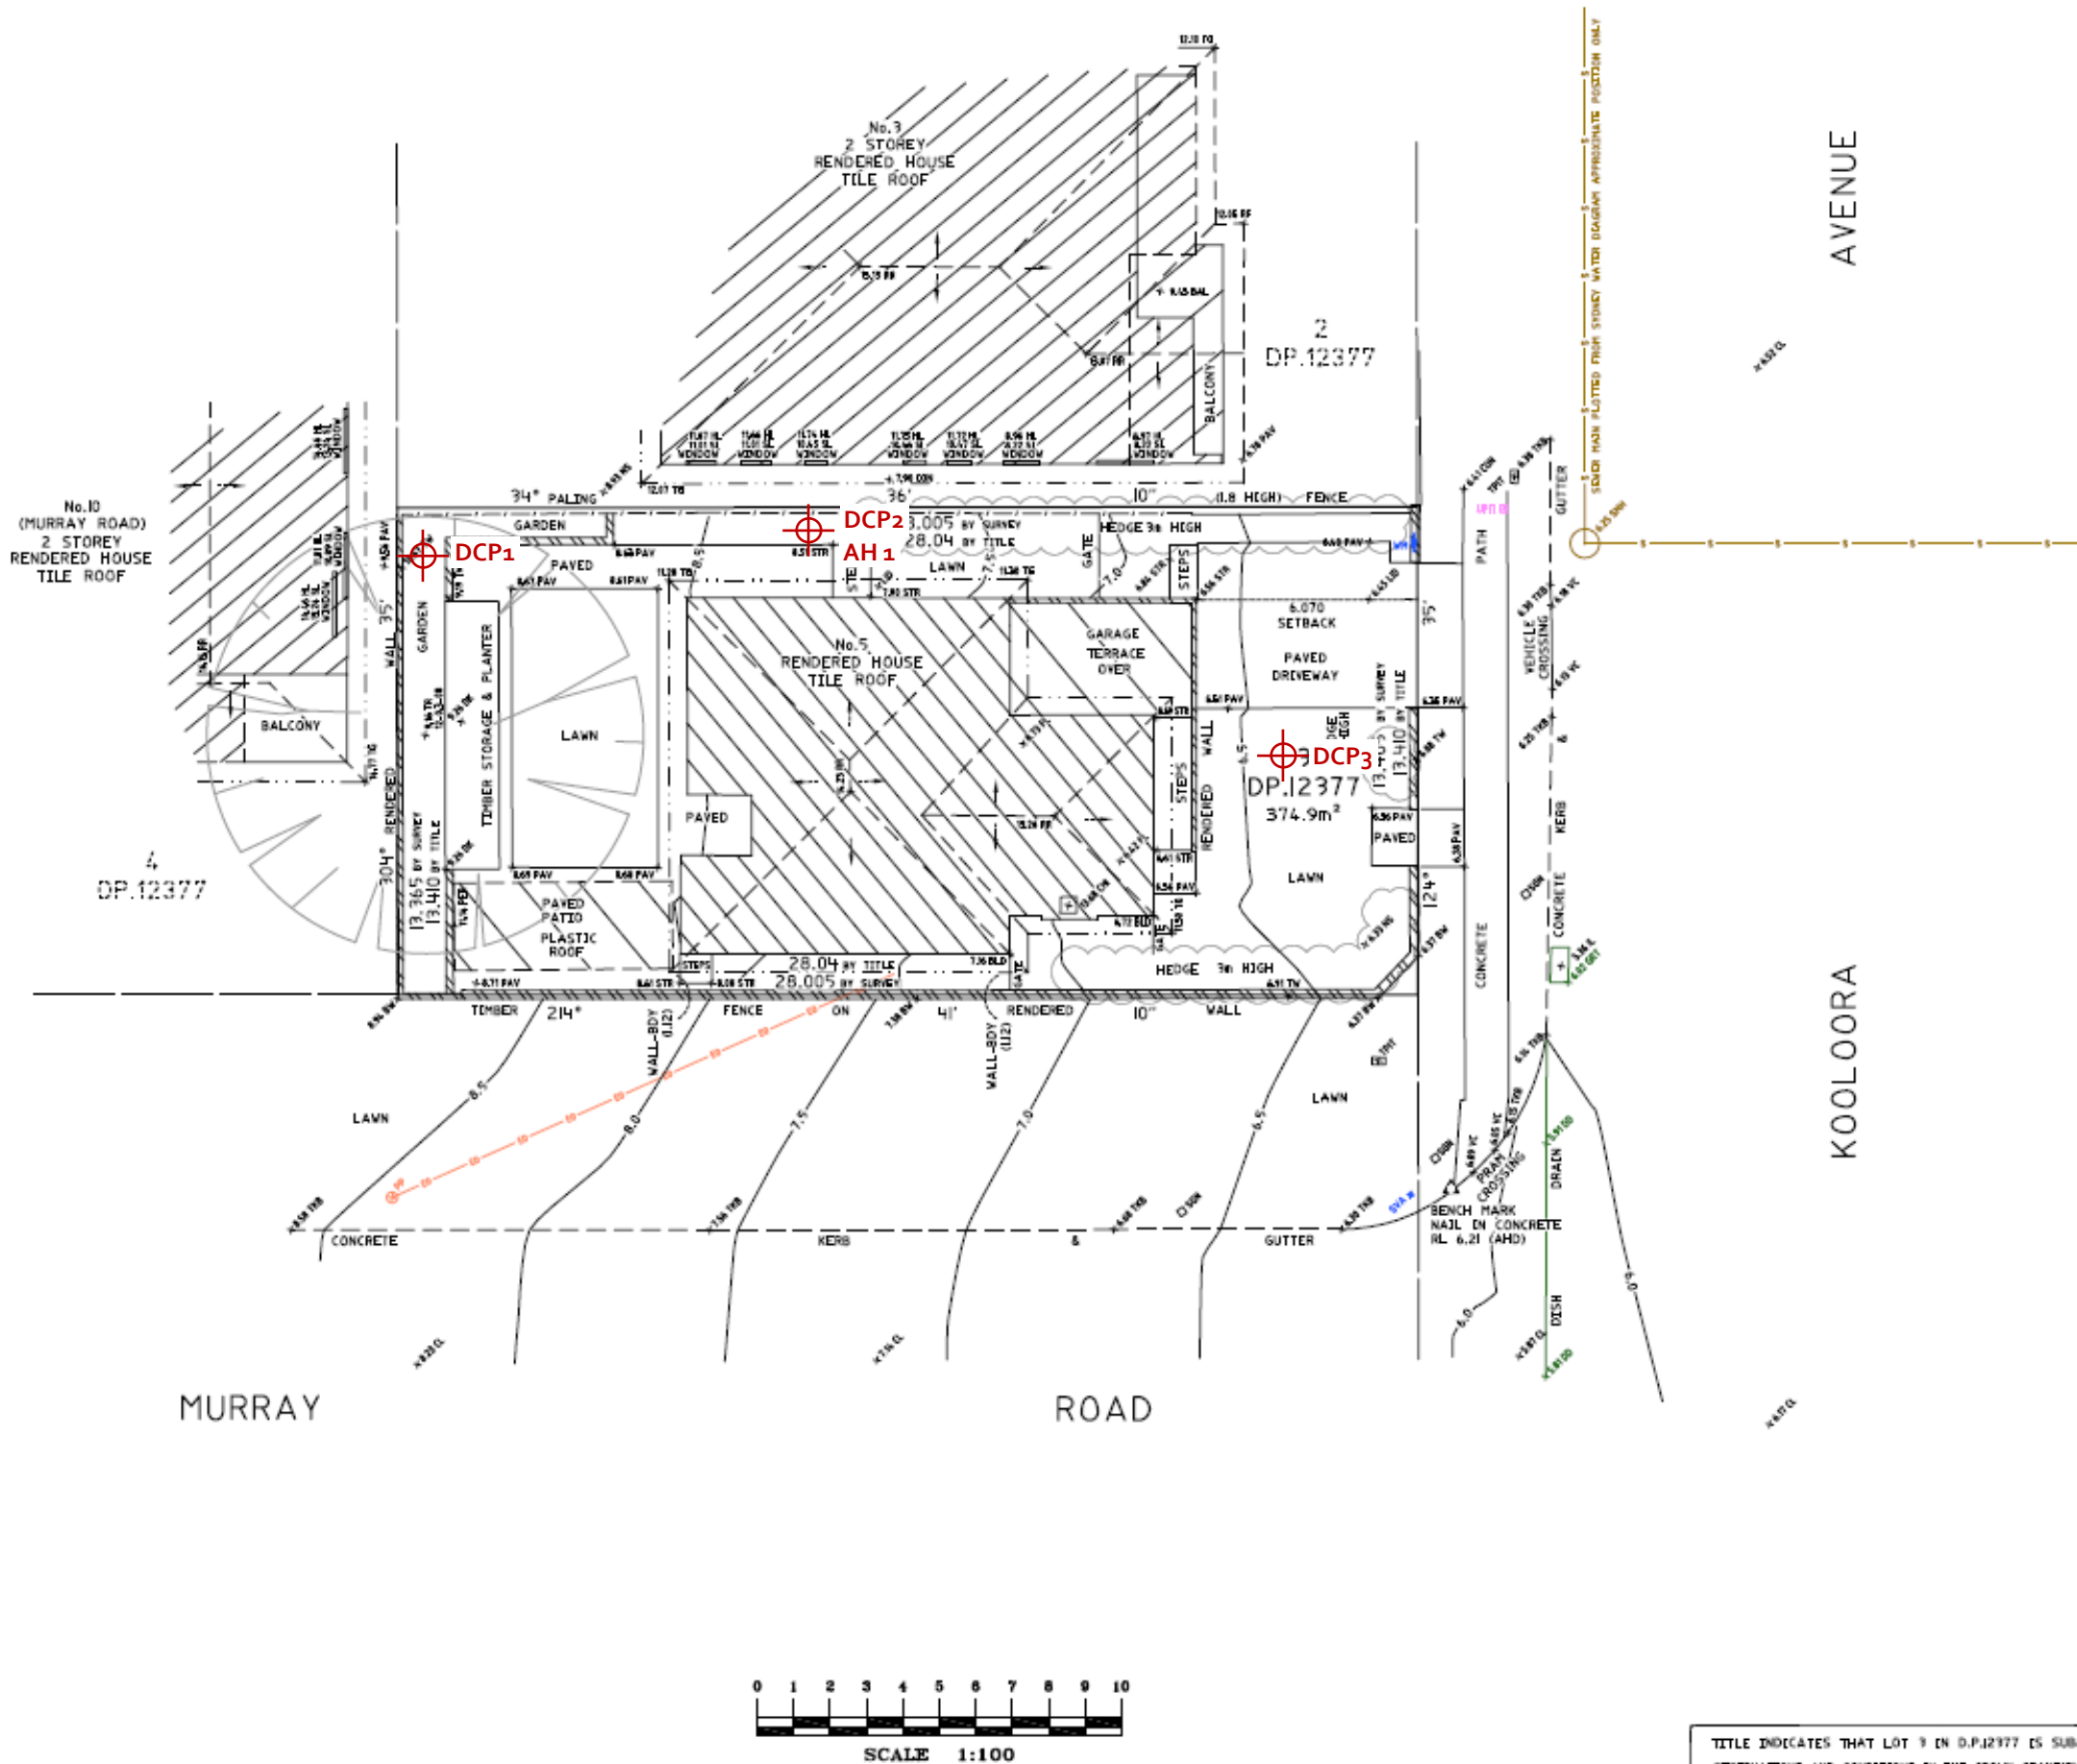
SURVEY – showing test locations

One auger hole was put down to identify the soil materials. Three Dynamic Cone Penetrometer (DCP) tests were put down to determine the relative density of the overlying soil and the depth to weathered rock. The locations of the tests are shown on the site plan. It should be noted that a level of caution should be applied when interpreting DCP test results. The test will not pass through hard buried objects so in some instances it can be difficult to determine whether refusal has occurred on an obstruction in the profile or on the natural rock surface. This is not expected to be an issue for the testing on this site. But due to the possibility that the actual ground conditions vary from our interpretation there should be allowances in the excavation and foundation budget to account for this. We refer to the appended "Important Information about Your Report" to further clarify. The results are as follows:

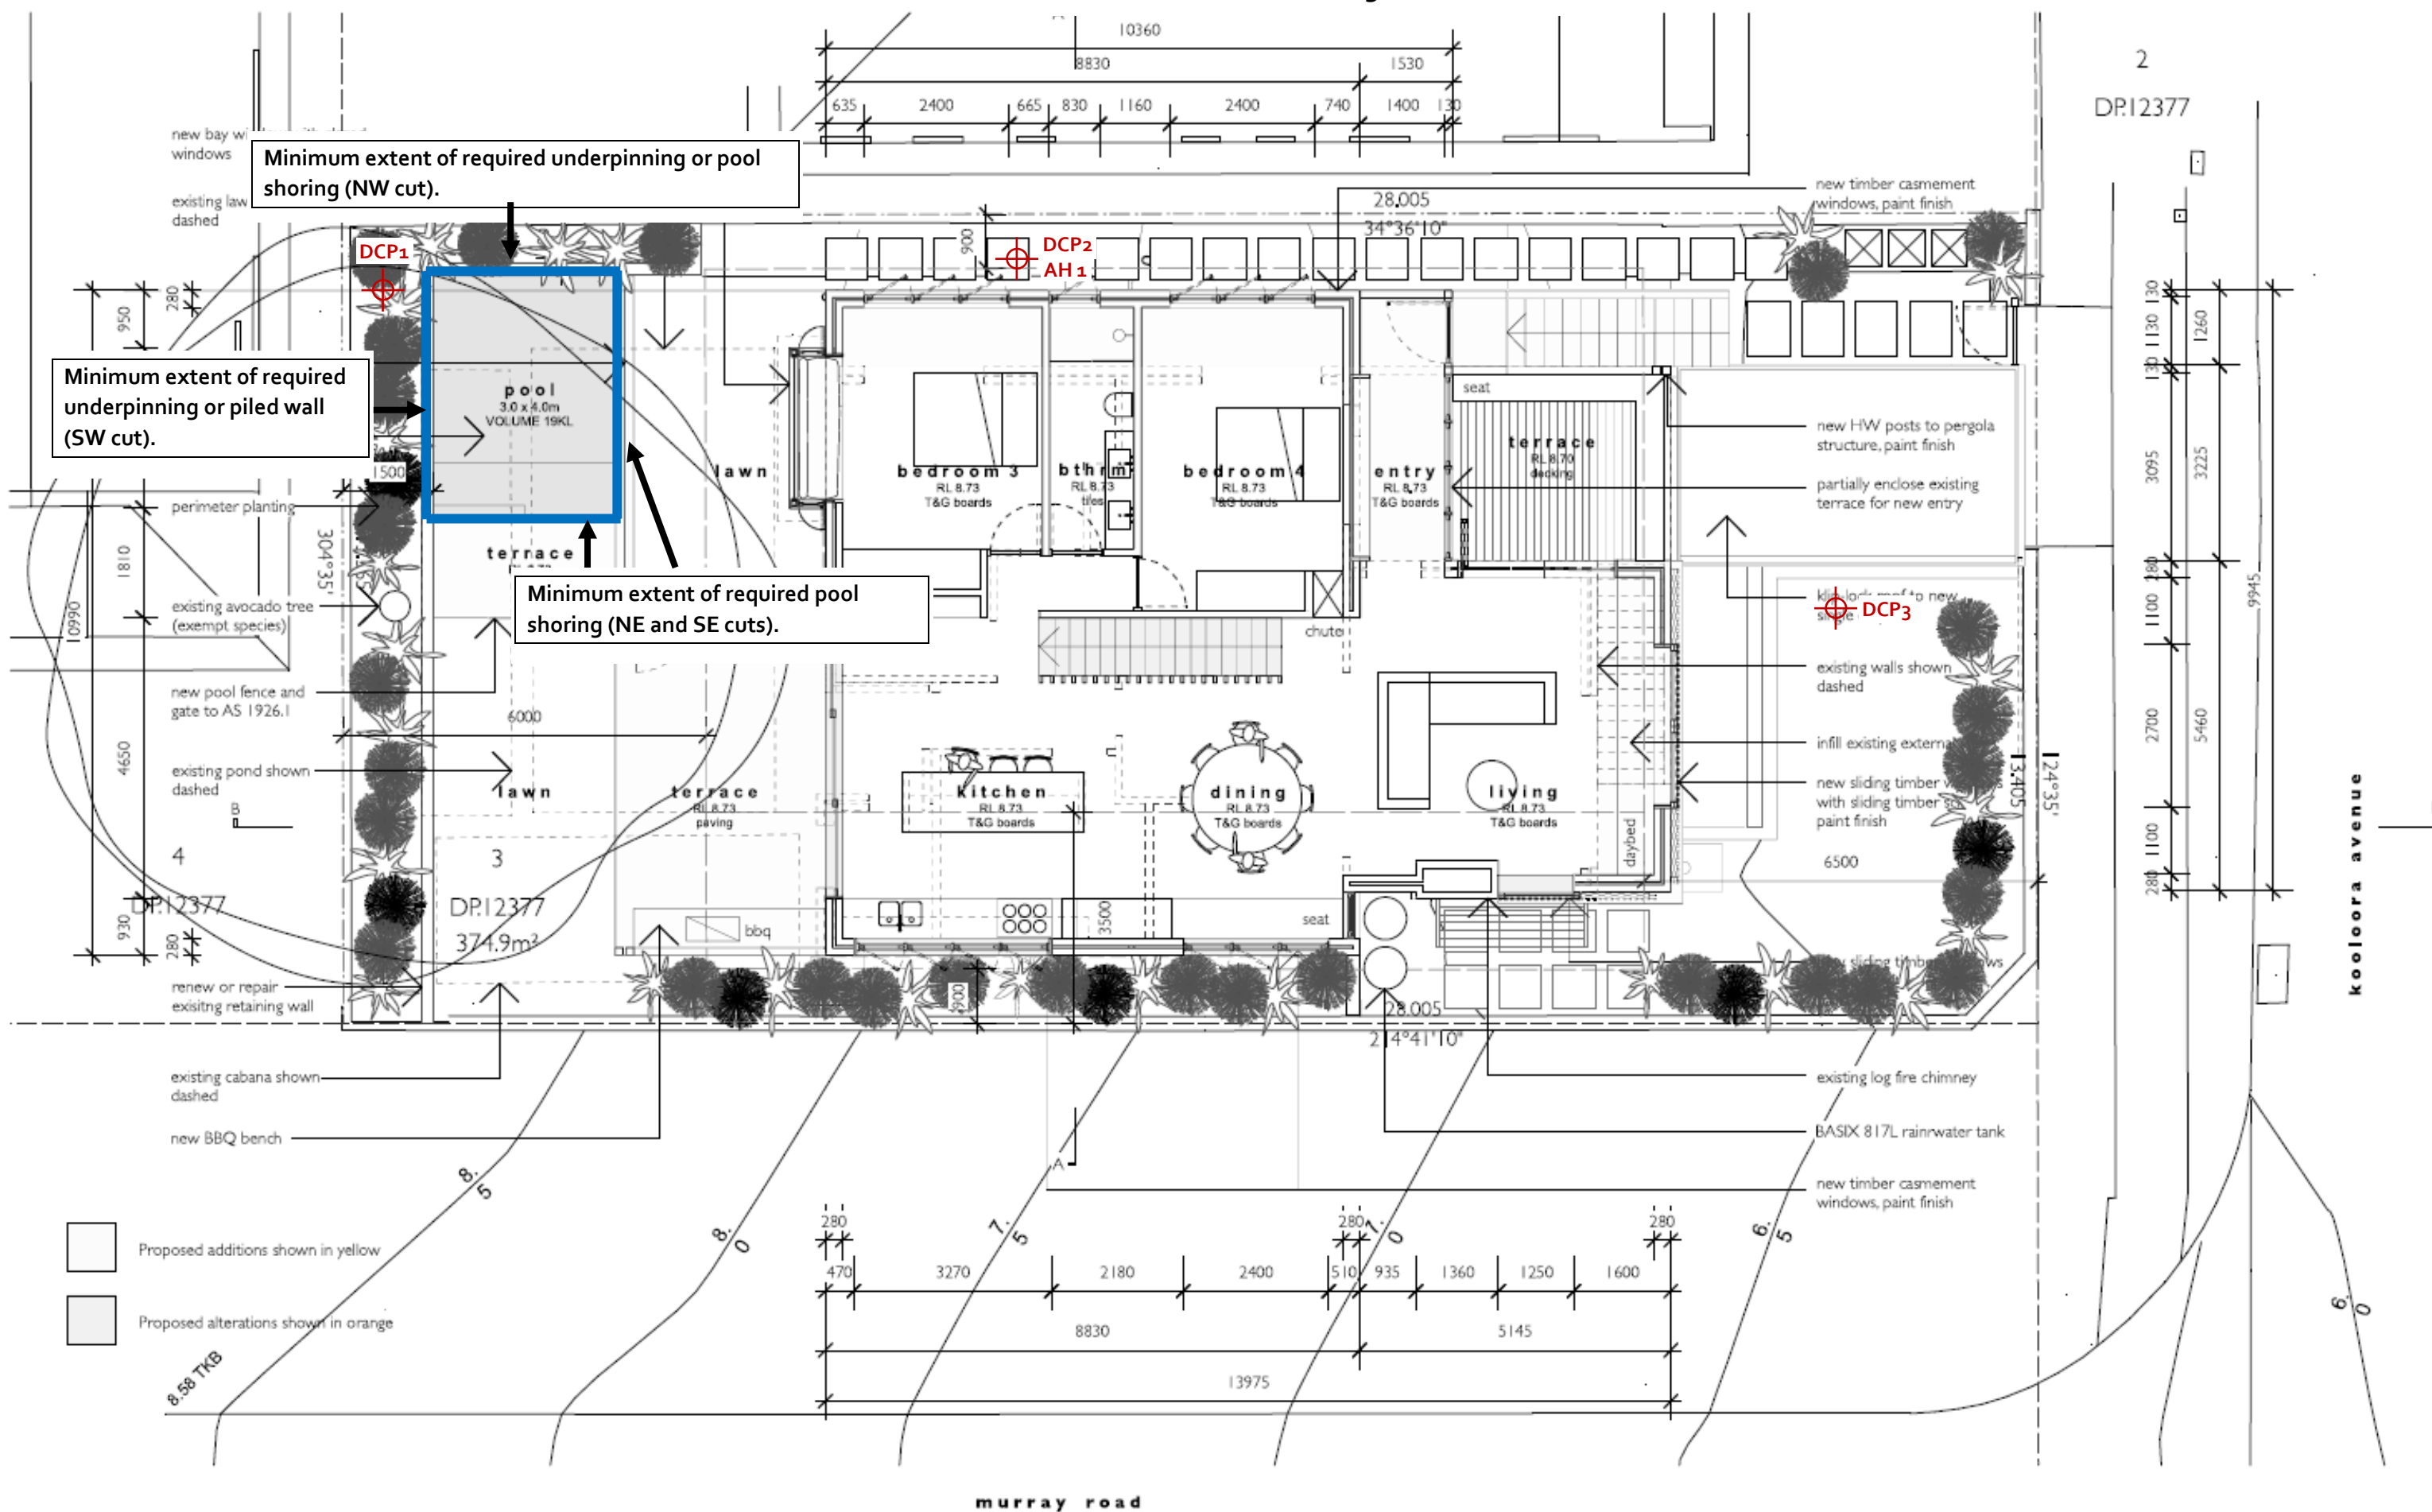
MID FLOOR PLAN – showing test locations

See the Mid Floor Plan attached for the minimum extent of the required underpinning or shoring shown in blue.

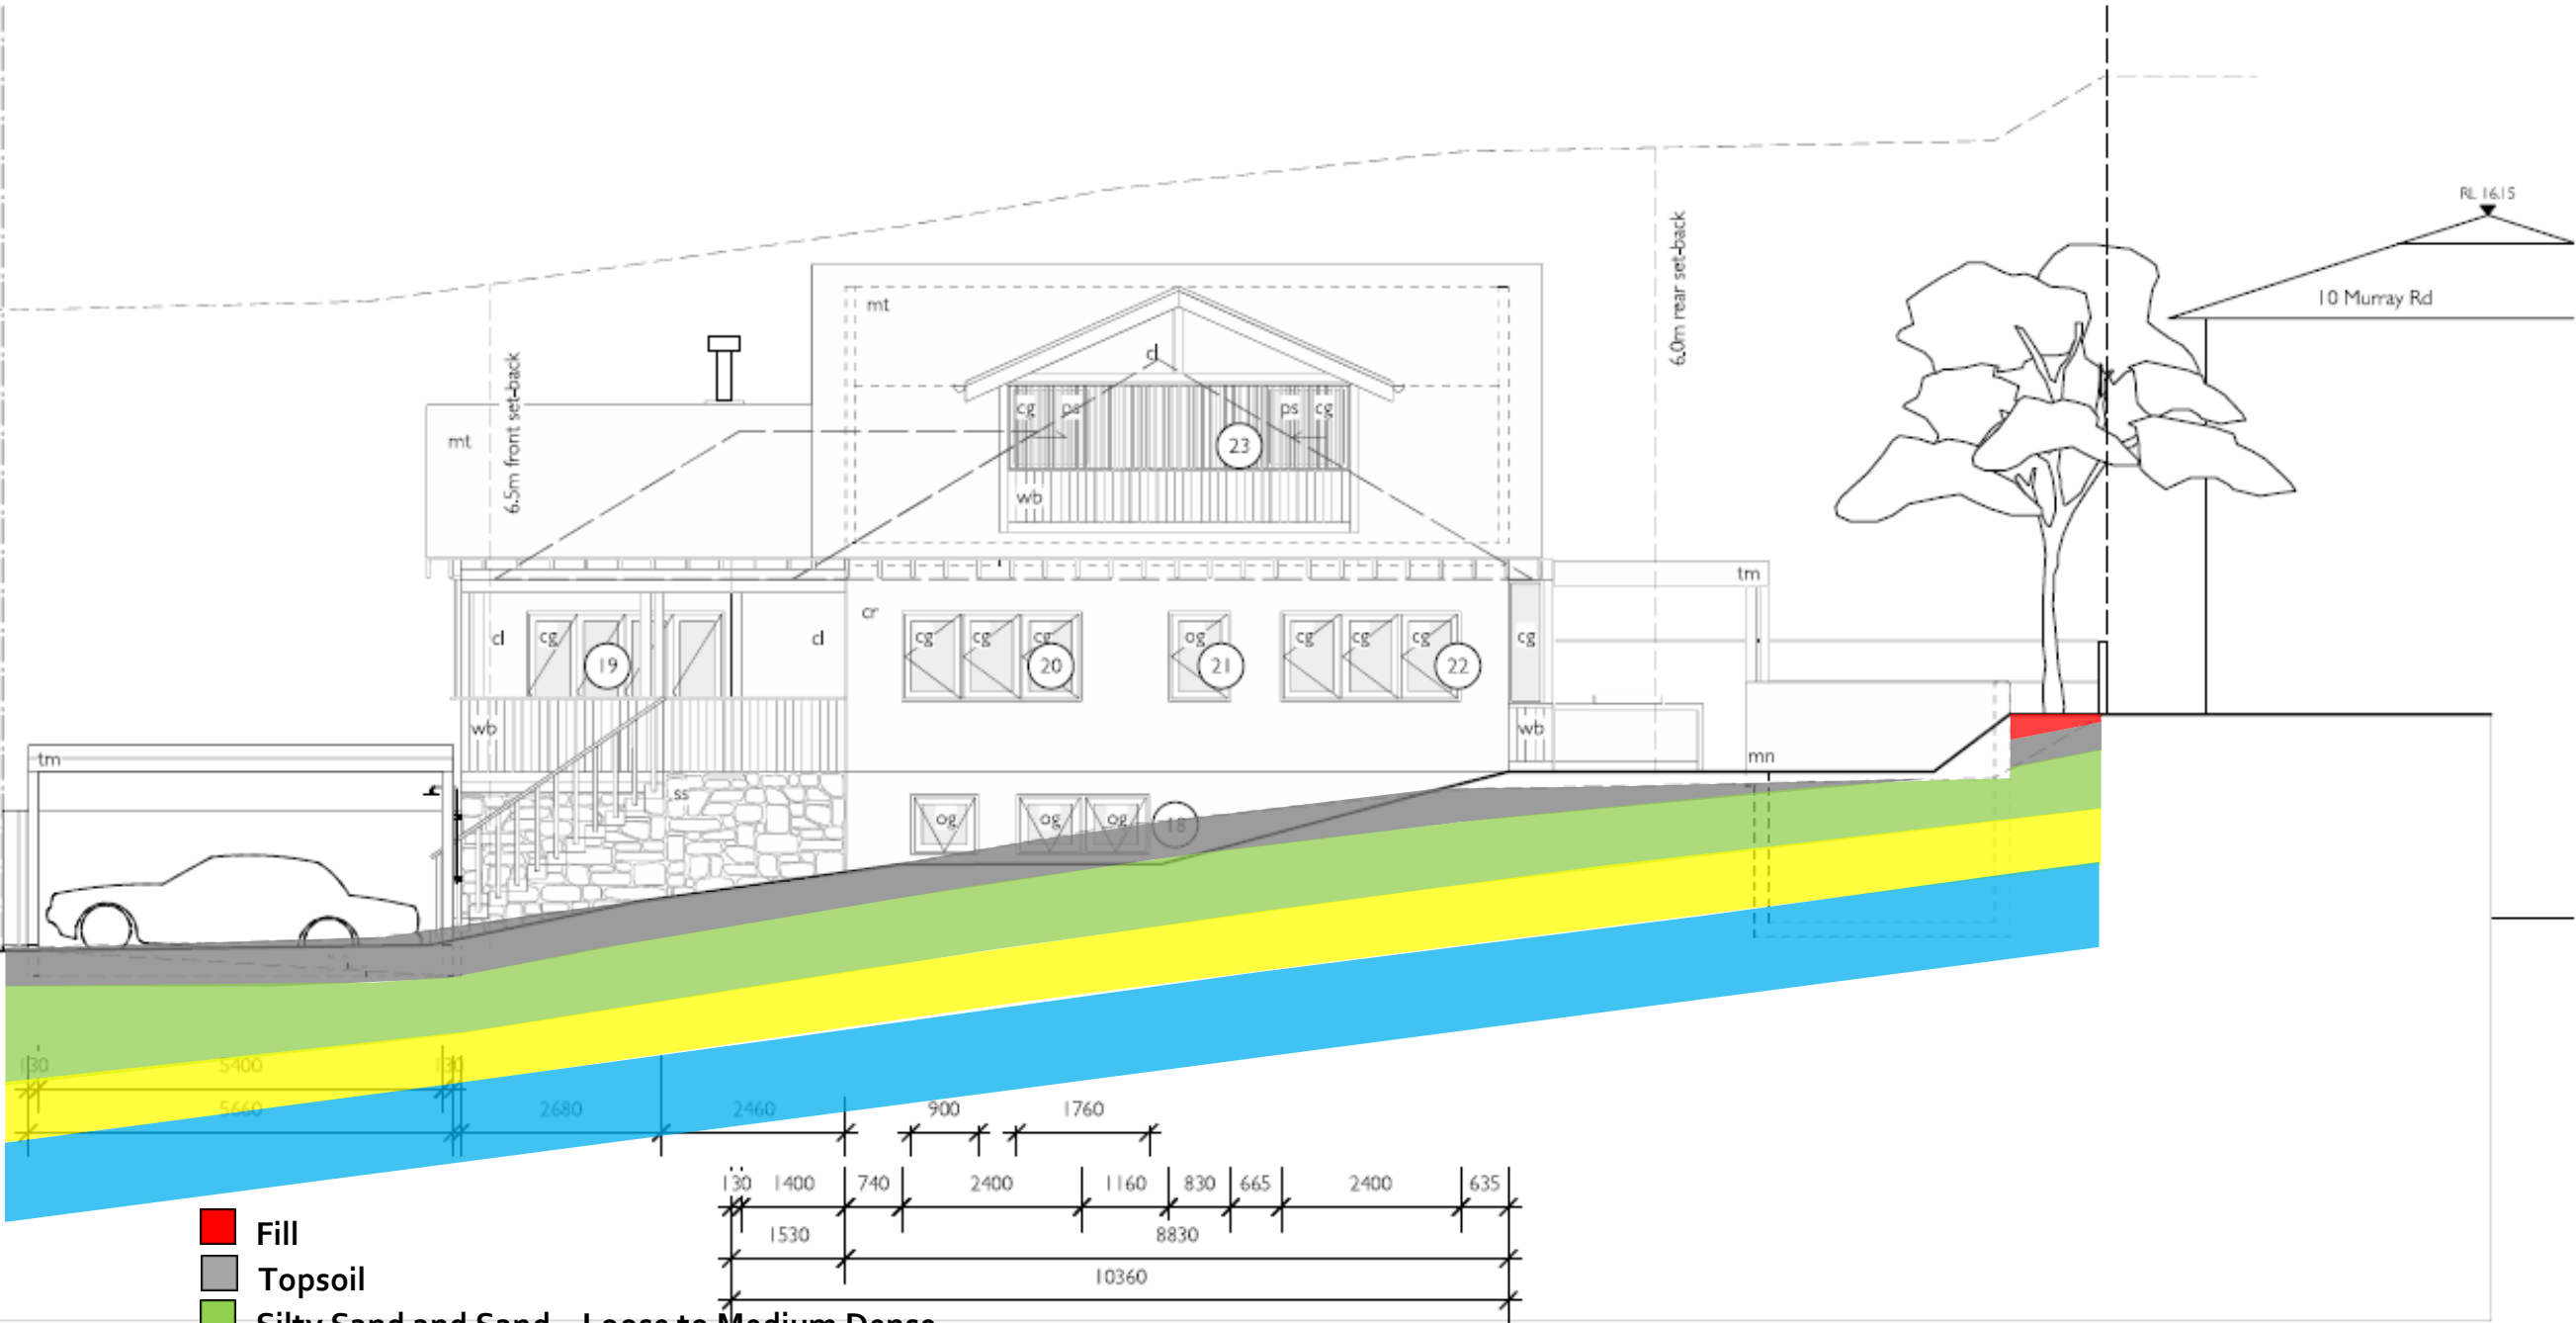
TYPE SECTION – Diagrammatical Interpretation of expected Ground Materials

In the test locations, the ground materials consist of a sandy topsoil, Loose to Medium Dense silty sand and Medium Dense sand over sandy clays. The clays merge into the underlying weathered rock at depths from between ~2.1m to ~2.4m below the current surface. The weathered rock is interpreted to be Very Low Strength Rock or better. See Type Section attached for a diagrammatical representation of the expected ground materials.

- Fill
- Topsoil
- Silty Sand and Sand – Loose to Medium Dense.
- Sandy Clay
- Very Low Strength Rock or better.
