J4594. 21st October 2022. Page 1.

GEOTECHNICAL INVESTIGATION:

Alterations and Additions 82 Clontarf Street, Seaforth

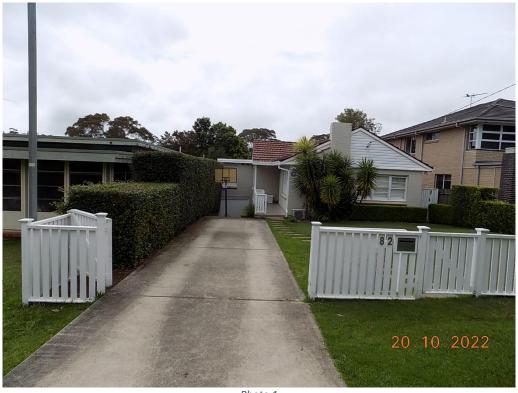
Photo 1

- 2.3 At the road frontage, a concrete driveway runs to a garage under the N side of the house (Photos 1 & 2). The cut for the driveway is supported by stable brick retaining walls up to ~1.2m high (Photo 2). Between the road frontage and the house is a gently sloping lawn. The single-storey brick house is supported on brick walls. The supporting brick walls show no significant signs of cracking. Access to the foundation space of the house was unavailable at the time of the inspection. A timber deck extends from the downhill side of the house. The deck is supported by posts which

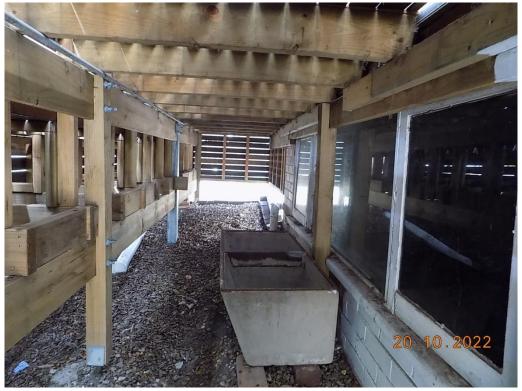
Photo 3

appear to stand vertical (Photo 3). The deck will be partially demolished and rebuilt as part of the proposed works. A gently sloping lawn extends from the E side of the property to the E property boundary.

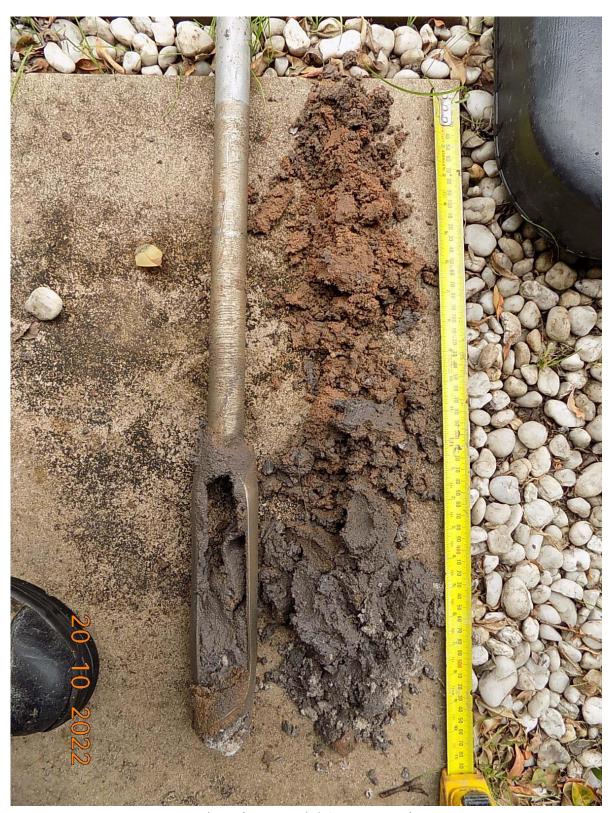
Photo 5 (AH1 – Downhole is Top to Bottom)

AUGER HOLE 1 (~RL69.5) – AH1 (Photo 4)

Depth (m)	Material Encountered
0.0 to 0.3	SANDY CLAY, brown, soft to firm, damp, fine to medium grained.
0.3 to 0.5	SANDY CLAY, grey-brown, grey-white near bottom, stiff, wet fine to
	medium grained.

Refusal @ 0.5m in Sandstone. No water table encountered.
