ESSEX DEVELOP PTY LTD

Acid Sulfate Soil Assessment and Management Plan

122 Crescent Road, Newport, NSW 2106

E25561.E14_Rev2
28 October 2022

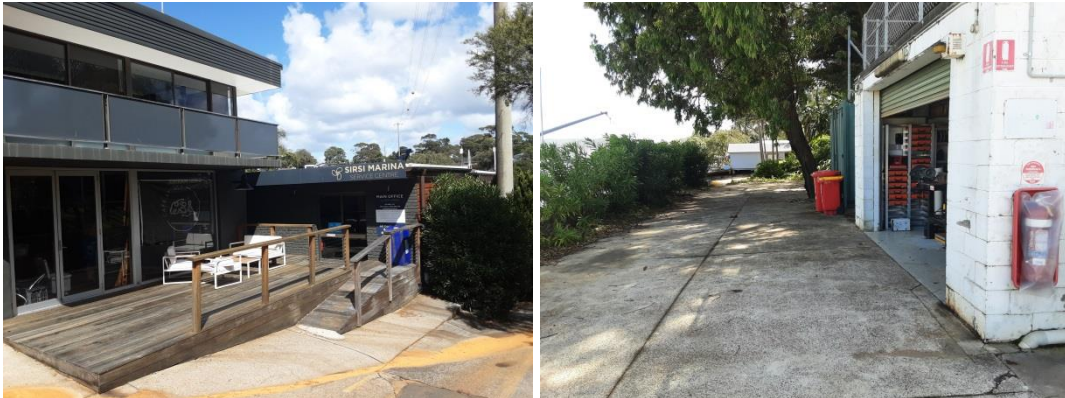
- The site is currently situated within a steep slope grading from Crescent road to Winji Jimmi Bay surrounded predominantly by low density residential properties.
- Building footings (brick) and slabs (concrete) were in moderate condition. There was evidence of corrosion, salt scalding and iron oxide (i.e. orange brown) colouration.

Figures 3-2 and 3-3 showing iron oxide discolouration identified onsite

- Signs of corrosion, iron oxide staining and salt scalding were present across paving and at the bases of the buildings onsite;
- Laboratory analysis of representative soil samples confirmed that natural clays collected below 1.0 mBGL recorded TPA as S% concentrations between 0.08 – 0.11% w/w and therefore marginally above the adopted action criterion of 0.03% w/w (ASSMAC, 1998).

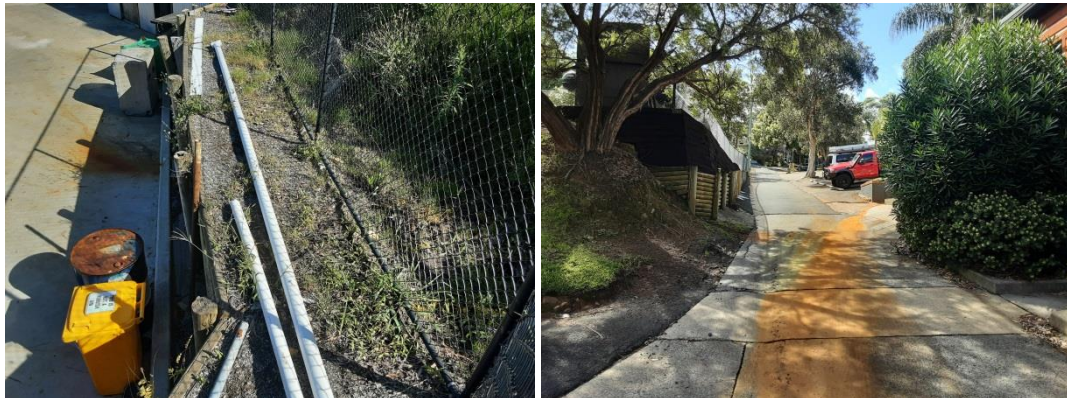
- Paving was in moderate condition, displaying signs of corrosion and iron oxide (i.e. orange brown) colouration or staining.

Figures 3-4 and 3-5 showing iron oxide discolouration identified onsite
