# TARGETED PRELIMINARY SITE INVESTIGATION REPORT

**PROJECT:** Manly Warringah Gymnastics New Facility Project  
**CLIENT:** MWGA  
**DATE:** 09 October 2023  
**REPORT NO:** NE1762

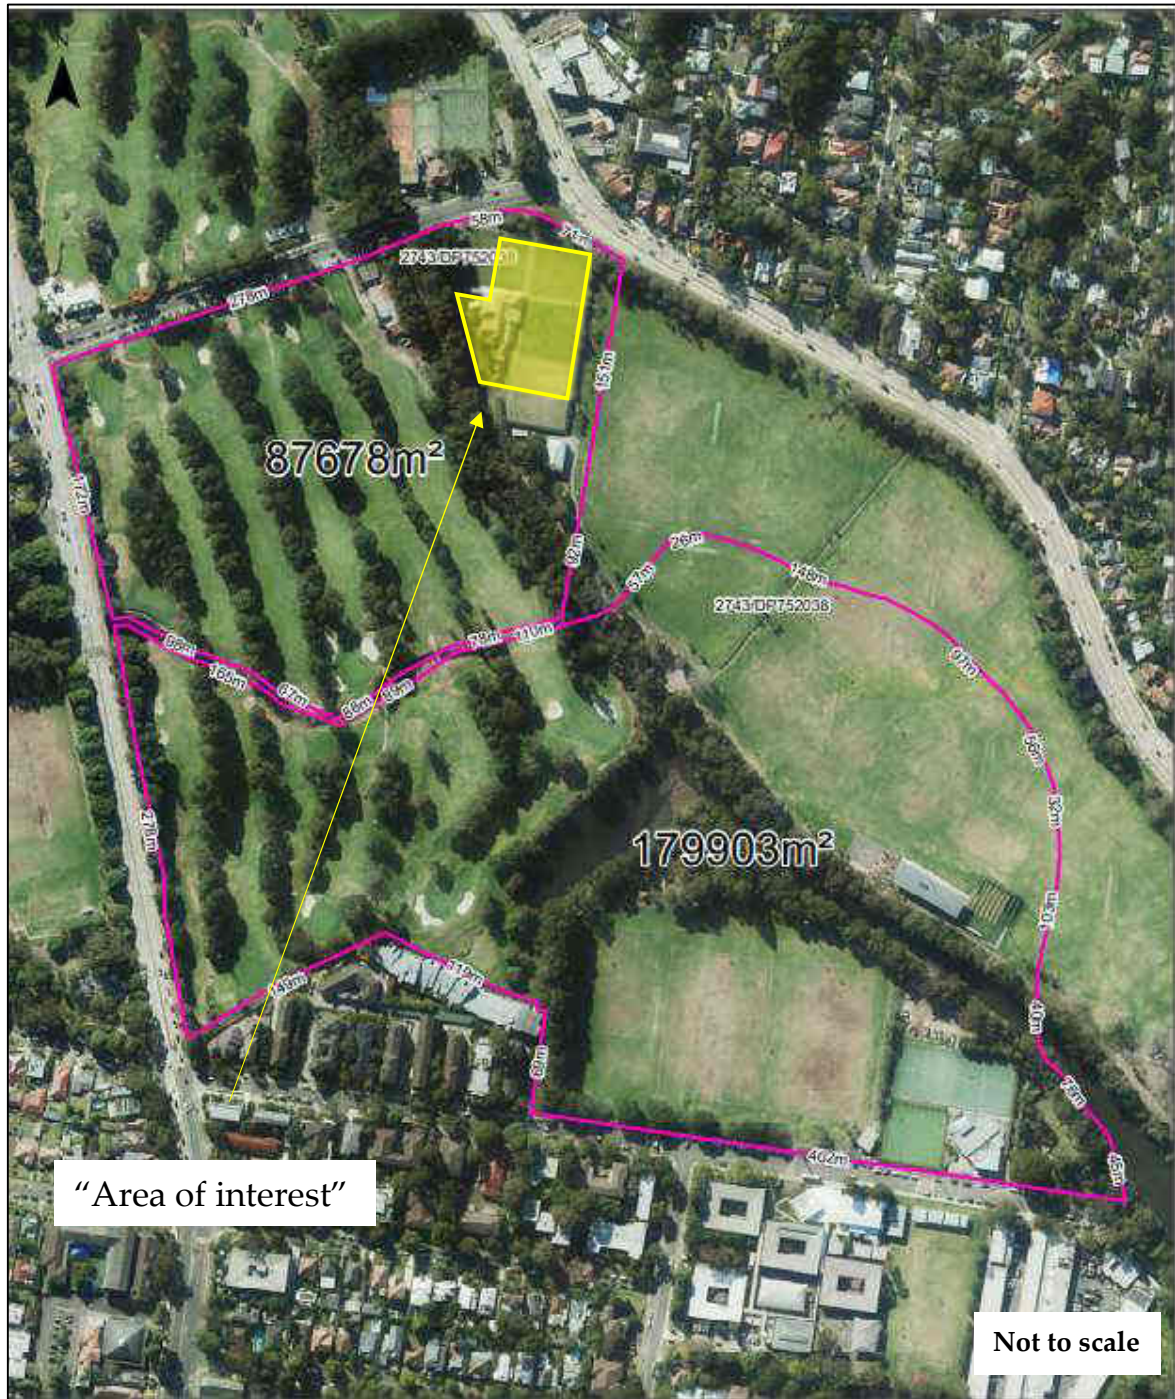
Figure 1. Site overview

The site was flat across the site (refer to Figure 1). Regional topographic maps indicate that the site is approximately 9 m above sea level, referenced to Australian Height Datum (AHD).

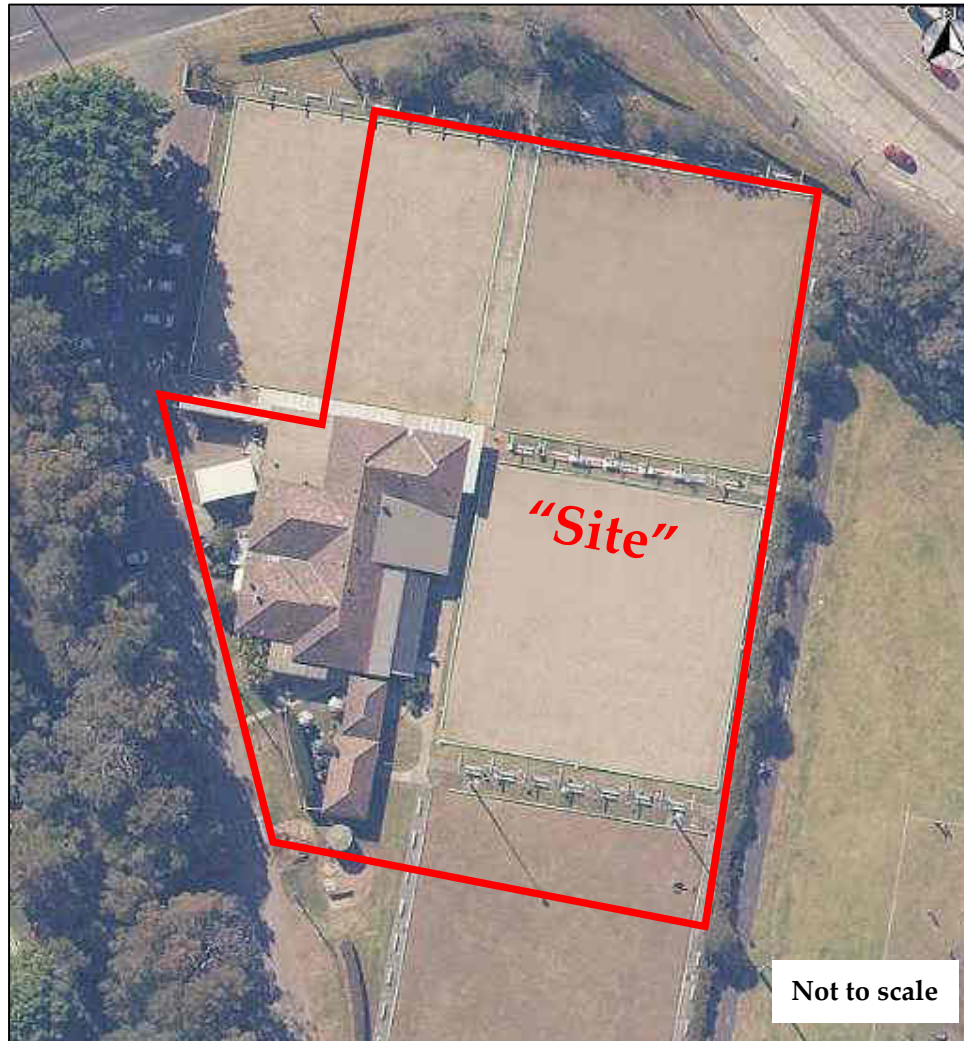
Figure 2. Site Location and Features

The site ('Area of Interest') under investigation is located at the North Manly Bowling and Recreation Club with the Bowling Greens within the northeastern section of 431 Pittwater Road, North Manly, NSW 2100 located (Lot/Section/Plan no: 2743/-/DP 752038), situated to the south of Kentwell Road and west of Pittwater Road, and is approximately 15.2 km to the northeast of Sydney CBD (by road). The site of the proposed development has a rectangular shape of approximately ~ 0.6 ha (Area of interest). The site is located within Northern Beaches Council. The site location is shown in Figures 1 & 2.

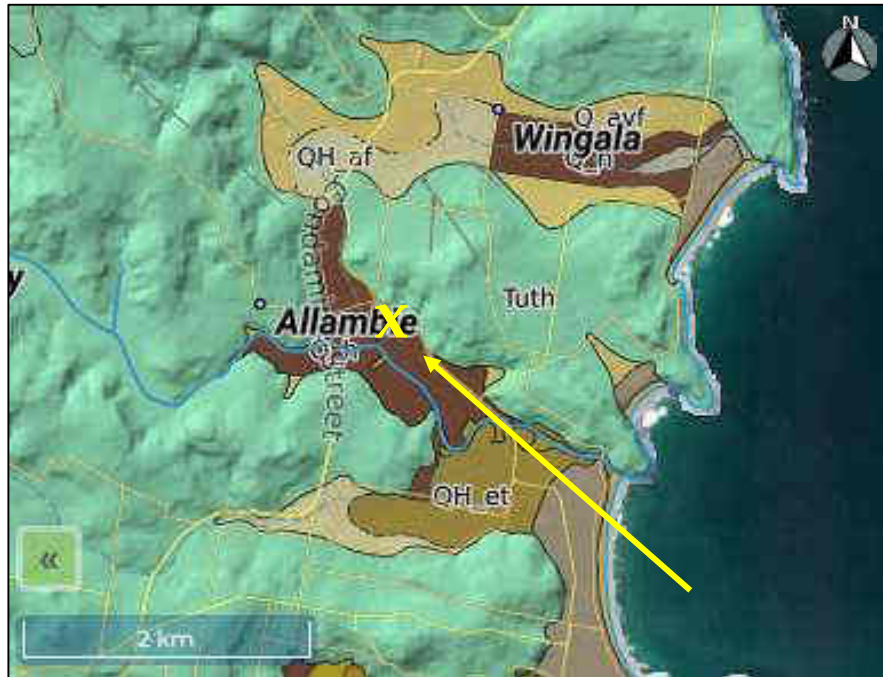
**Figure 3. Site Geology Map**

The local geology is of holocene silty to peaty quartz sand. Medium to fine marine sand with podzols. The site is underlain by Anthropogenic deposits (Q\_h) – Anthropocene deposits varying from large man-made clasts (concrete blocks to building demolition rubble) to quarried natural boulders, with interstitial sand-sized to clay matrix. Details of the site geology information is shown in the Figure 3.

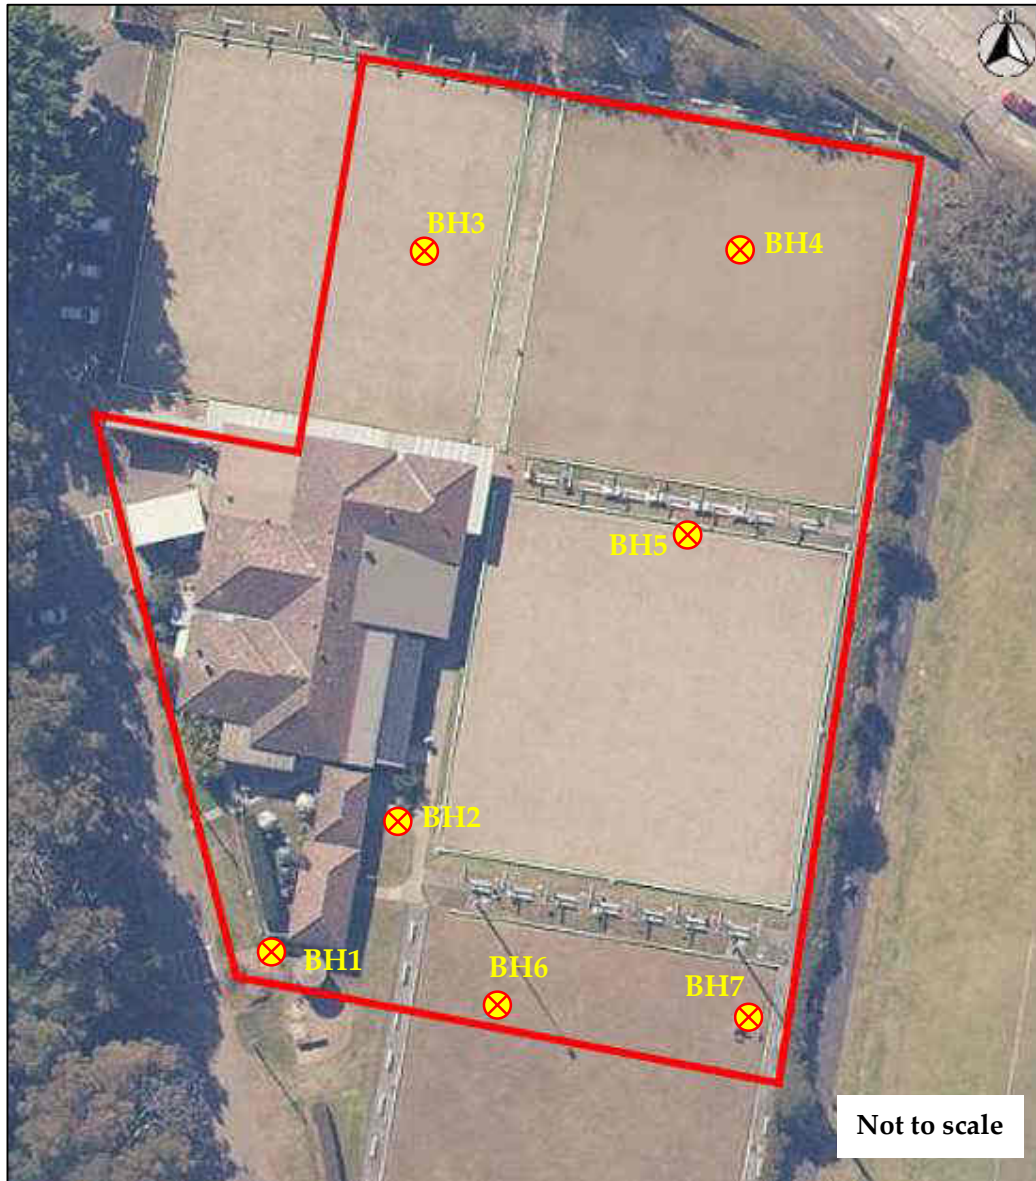
Figure 4: Soil Sampling Locations

Based on the fieldwork results, the site contained approximately 0.3-0.5 m thick Fill layer in most boreholes, comprising of SAND - brown (colouration), trace gravels, rootlets was observed in most boreholes.

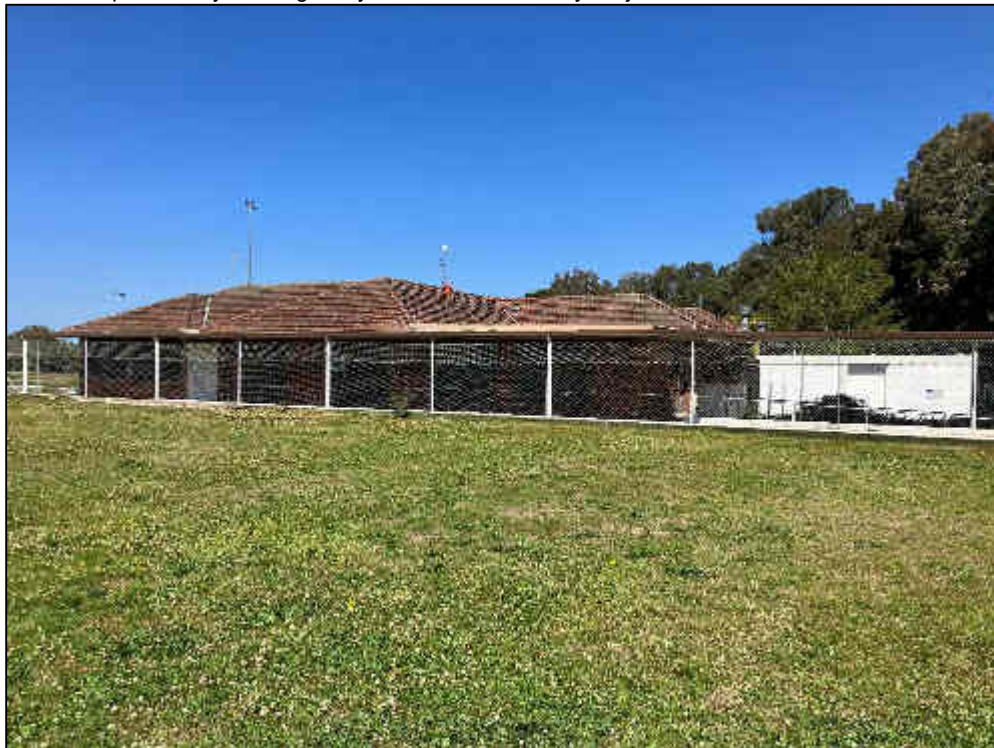
- The recreational structure was of full brick construction, approximately 800 m<sup>2</sup>. The structure was used as the recreational club. Two (2) single-storey dwellings of fair condition, approximately 40 m<sup>2</sup> and 60 m<sup>2</sup>, separately, were located to the adjacent south of the structure. The shed was located to the adjacent west of the structure, of good condition and approximately 35 m<sup>2</sup>. All of the buildings remained inaccessible during the site investigation and suspected hazardous materials could potentially be stored inside.

**Photograph 1:** View of the North Manly Bowling and Recreation Club.

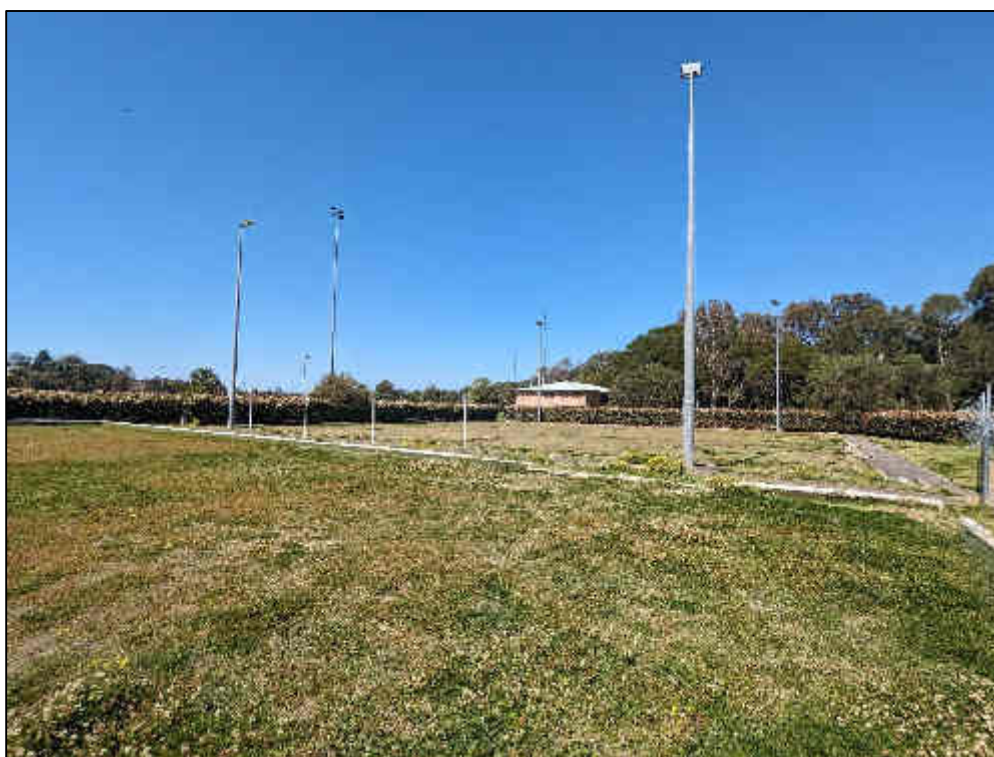
- The northern and eastern sections of the site were vacant, used as the bowling green areas for the bowling club, with paved walk lanes and utility poles. This area, of approximately 4,300 m<sup>2</sup>, was surrounded by plant hedges along northern and eastern boundaries covered by healthy grasses.
- No evidence of existing agricultural usage was observed in this inspection.
- The site was flat.

**Photograph 2:** View of the Bowling Greens located to the adjacent north and east of the club structure.
