# **Arboricultural Impact Assessment**

## **Proposed Alterations & Additions at 90 Griffiths Street, Fairlight**

**Date:** May 2021

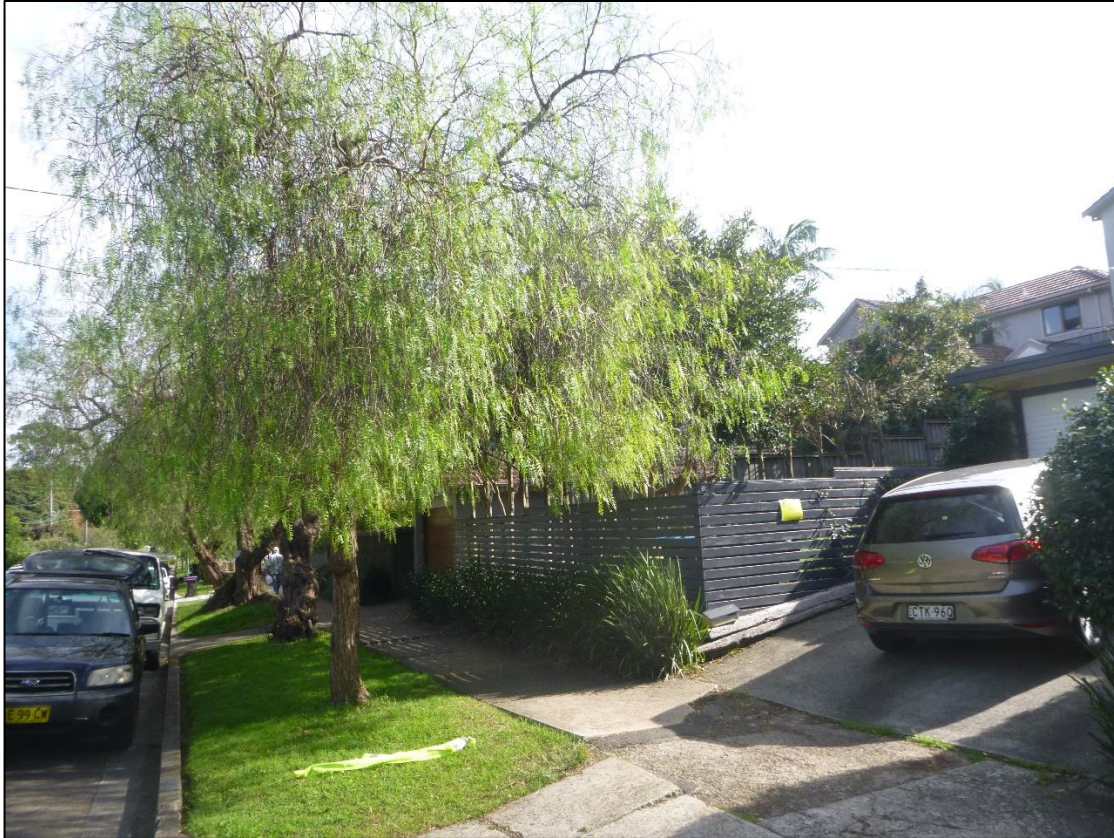
**Photo A: Tree 1**

Tree Number	Retention Value	Works proposed within the Tree Protection Zone (TPZ)
1	High	Shallow excavation for the driveway cross-over is proposed within the TPZ. This is to be outside of the Structural Root Zone and the encroachment will occupy less than 10% of the TPZ area. Some pruning of fine absorbing roots and woody transport roots may be required. It is likely that roots will be able to exist below the driveway depth. The tree is likely to tolerate the proposed works and remain viable in the long term.
2	Medium	Excavation for the widened driveway and retaining wall is proposed within the TPZ. Less than 10% of the TPZ area will be affected. Some pruning of fine absorbing roots and woody transport roots may be required. The tree is likely to tolerate the proposed works and remain viable in the long term.
13, 14, 15	Medium	The proposed pool pump and filter box is proposed within the TPZ. It will be possible to install the base slab entirely above existing levels with undamaged roots beneath. No notable impact is expected.

**Excavation for the Driveway Crossover (Tree 1):** Shallow excavation for the driveway crossover is proposed within the TPZ of Tree 1. Prior to machine excavation, hand trenching should be undertaken along the western edge of the crossover. The area where this is recommended is outlined on the Tree Protection Plan (Attachment C). All tree roots encountered within the trench should be cleanly cut using a sharp saw or secateurs. The purpose of this is to minimise the surface area of pruning wounds and avoid additional root damage (tearing/splintering) that typically occurs when roots are pruned using an excavator.

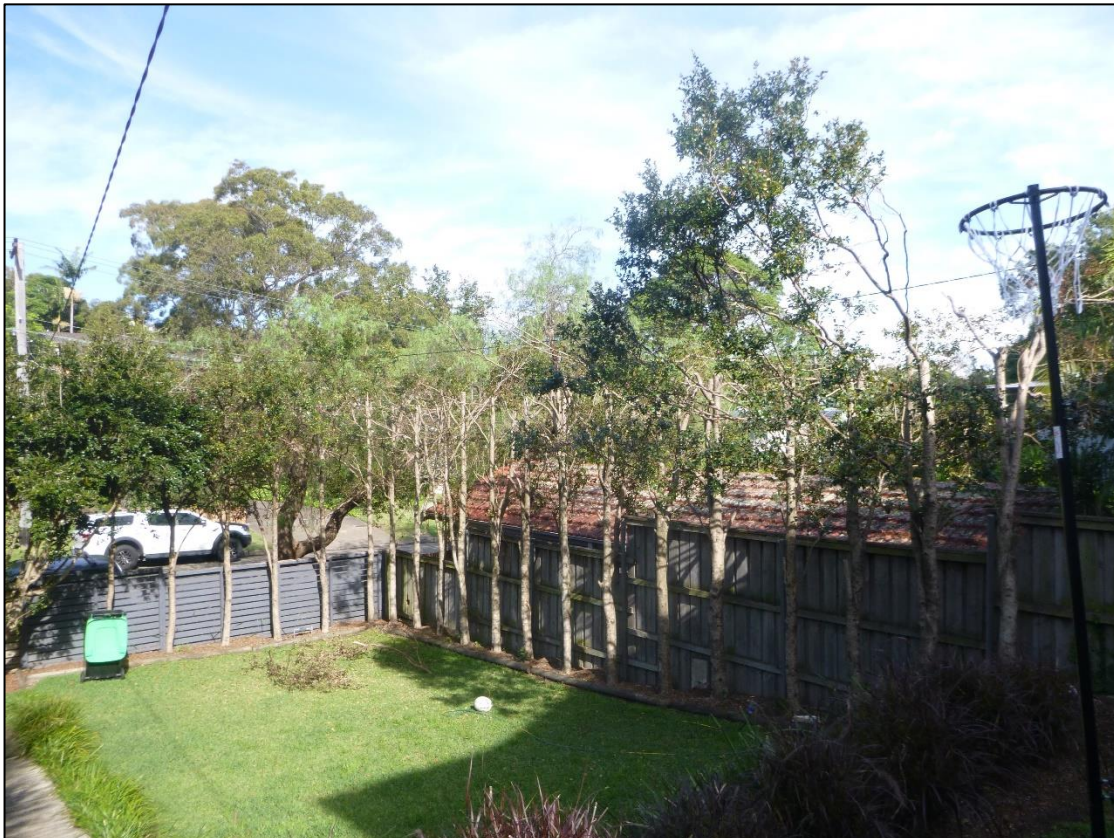
**Photo B: Trees 2-22**

Trees 3-22 (Brush Cherry, *Syzygium australe*) had been recently topped to a height of 4.0m to encourage a low compact screening hedge.

Trees 2-22 are exempt from protection within the Northern Beaches LGA as they are less than 5.0m height.

16, 17, 18, 19, 20, 21, 22	Medium	Excavation for the swimming pool is proposed within the TPZ. All excavation will be outside of the Structural Root Zone and occupy less than 10% of the TPZ area. It is likely that pruning of fine absorbing roots and woody transport roots may be required. The health and longevity of these trees is unlikely to be compromised by the root pruning.

**Excavation for the Swimming Pool (Trees 16-22):** Prior to machine excavation, hand trenching should be undertaken to a depth of 50cm along the western edge of the pool. The area where this is recommended is outlined on the Tree Protection Plan (Attachment C). All tree roots encountered within the trench should be cleanly cut using a sharp saw or secateurs. The purpose of this is to minimise the surface area of pruning wounds and avoid additional root damage (tearing/splintering) that typically occurs when roots are pruned using an excavator.
